AAV rebuild procedure:

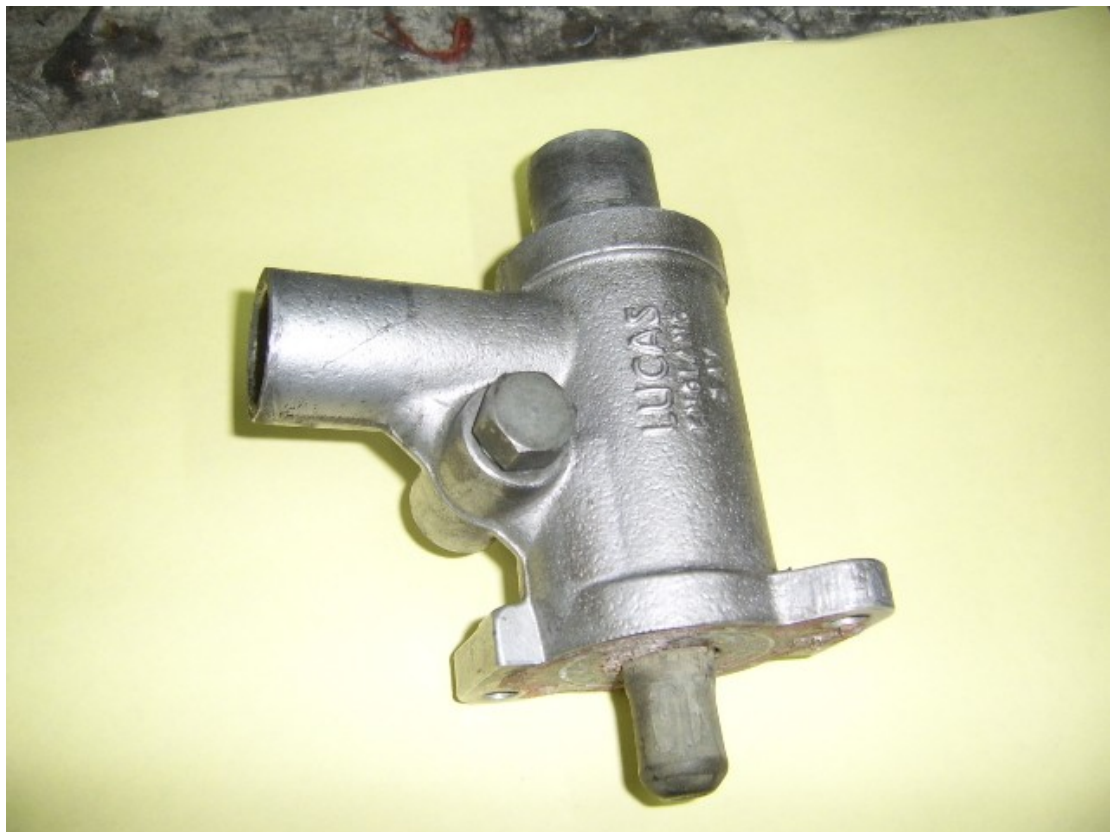
AAV as removed from the engine

Remove the 2 “torx” screws from the mounting face, and wiggle the AAV out of the cylinder head, and the hose that goes to the place you put your thumb. Be careful with that “inlet” hose, as it has a plastic elbow in its length to attach the vent hose from the distributor cap.

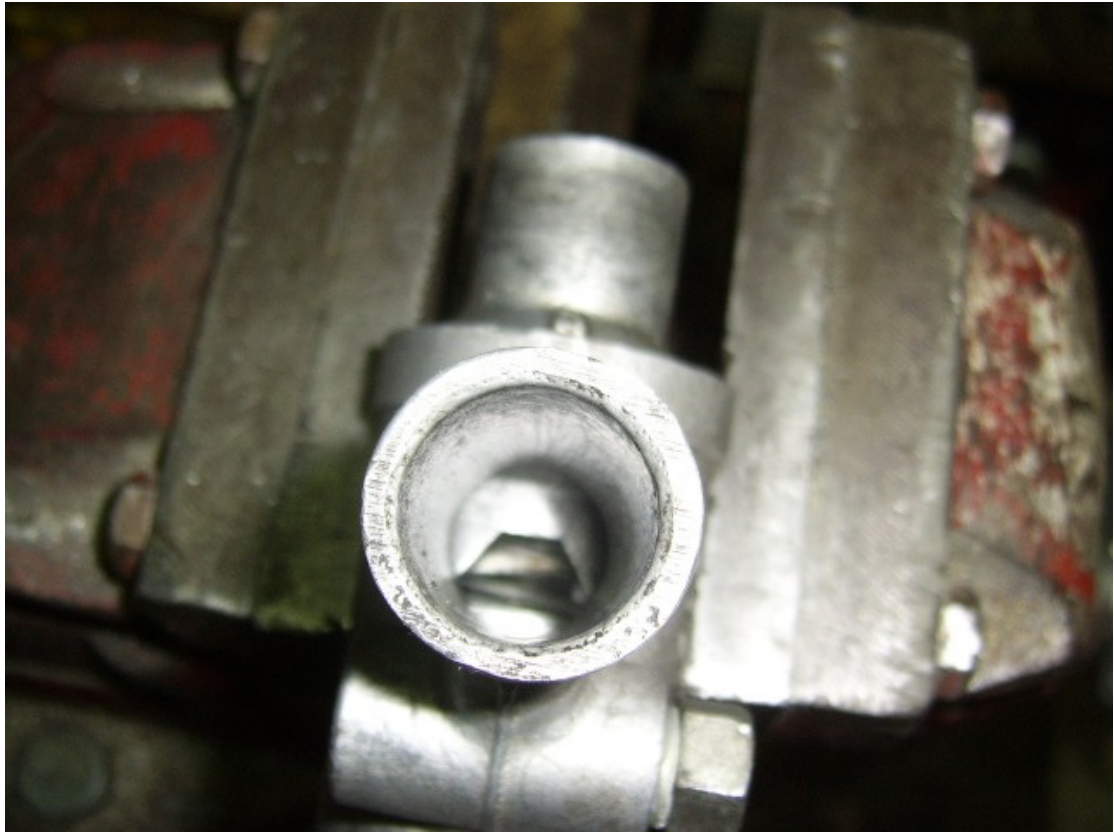
AAV as it is when cold or jammed

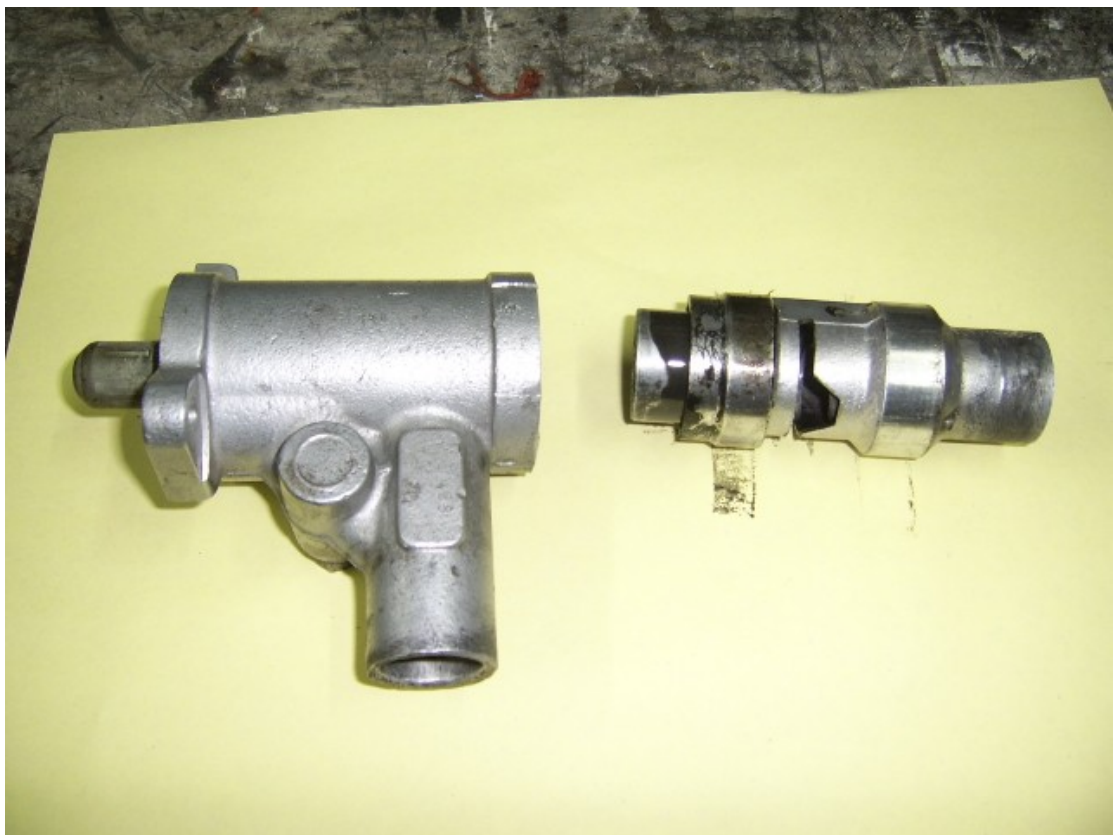
Body on the left and Tophat assembly on the right

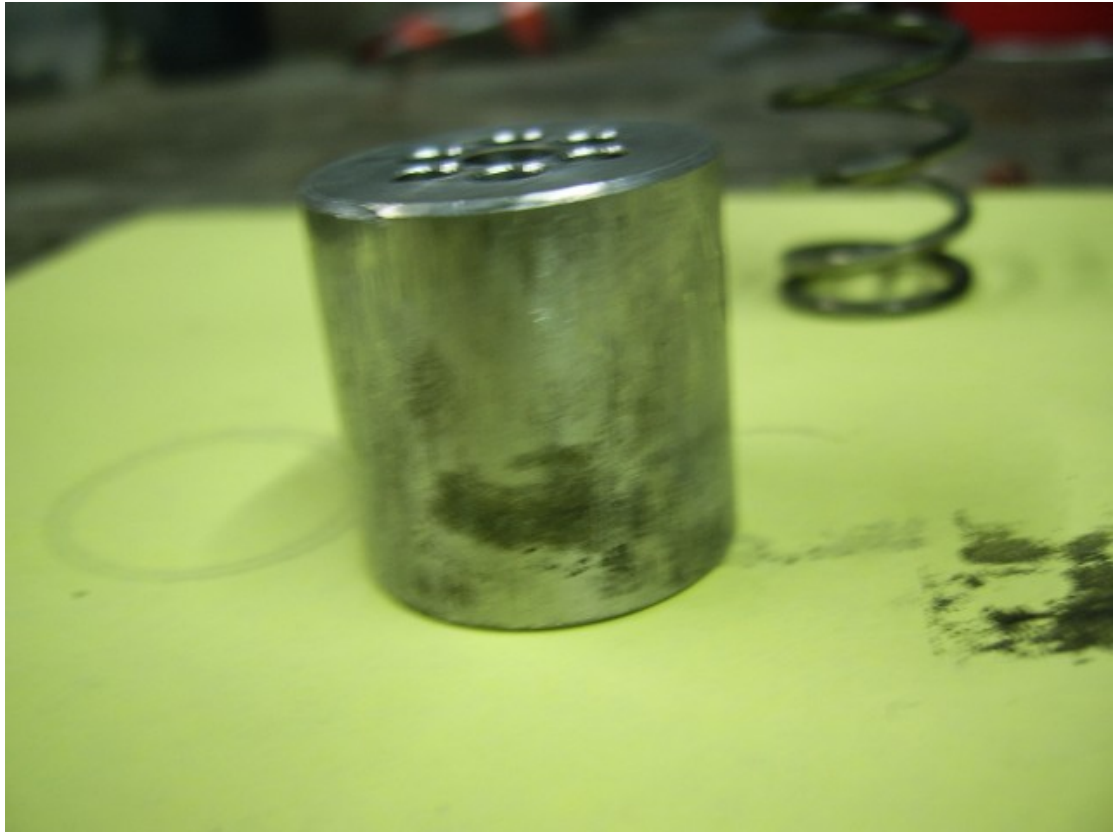
Some of these have an aluminium piston, and some have a stainless steel piston.

Alloy piston showing scores and carbon build up

If you have an aluminium piston, carefully inspect the outer face for scoring, and clean up as required, either with a fine file and wet and dry

paper. You are looking for a smooth slide in the housing, and this is time consuming, but essential.

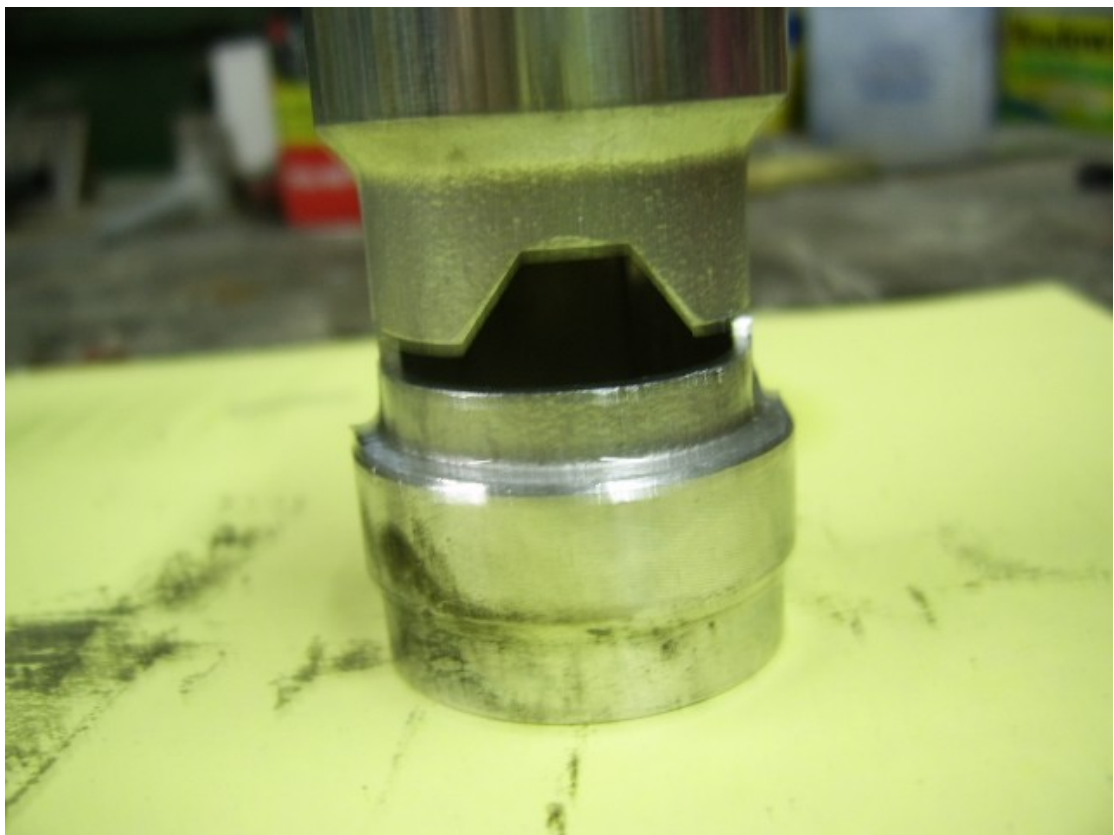
Tophat showing the cut outs that control cold idle.

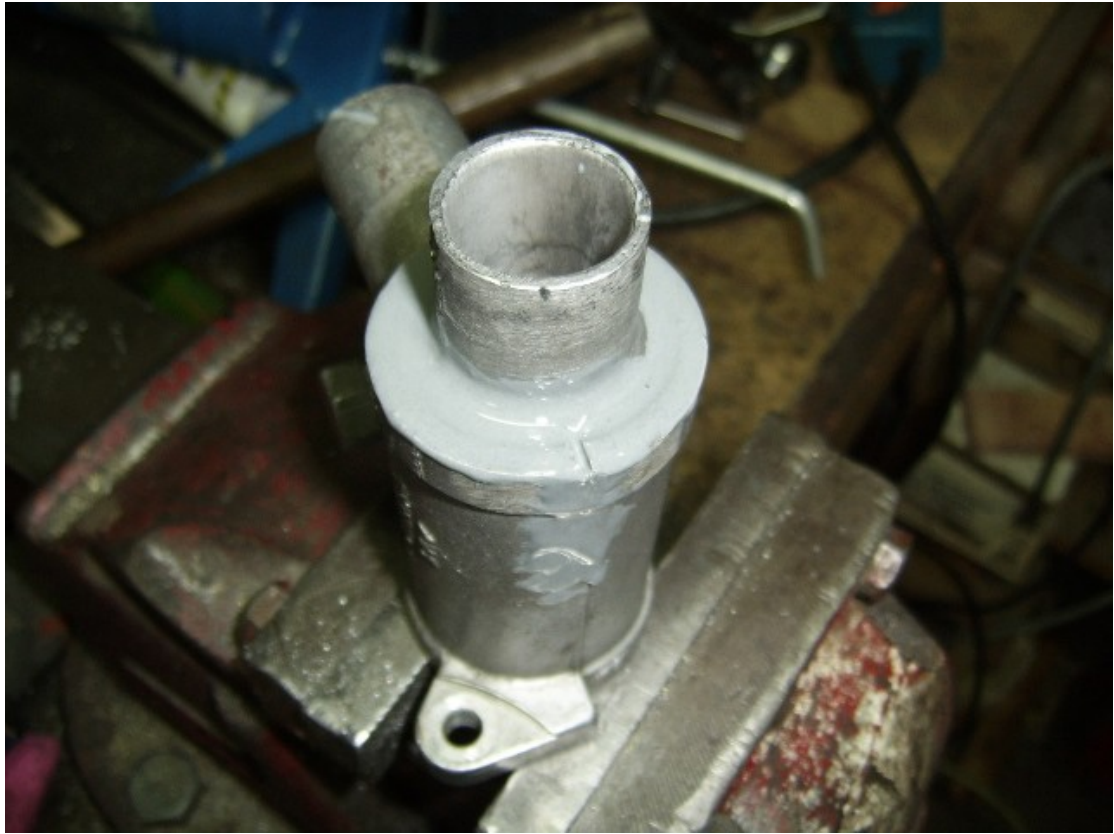
Completed unit with JB weld in place.

Once you are satisfied with your rebuild, take some epoxy filler (I use JB Weld) and fill the slot you cut, and pour some around the top of the rim of the outer casing taking up the 2mm gap somewhat. This stuff takes 24 hours to dry, bad luck, the fast dry stuff will NOT work, as it melts at about 100c, remember, haha.

Refit the AAV to the engine, using a new gasket, or a bead of RTV, bleed the cooling system as some coolant loss usually takes place, and start the beast, and see just how good you really are.
