Cooling system upgrade, modification.

This is a write up of the cooling system work I have carried out on my '85 XJ-S V12.

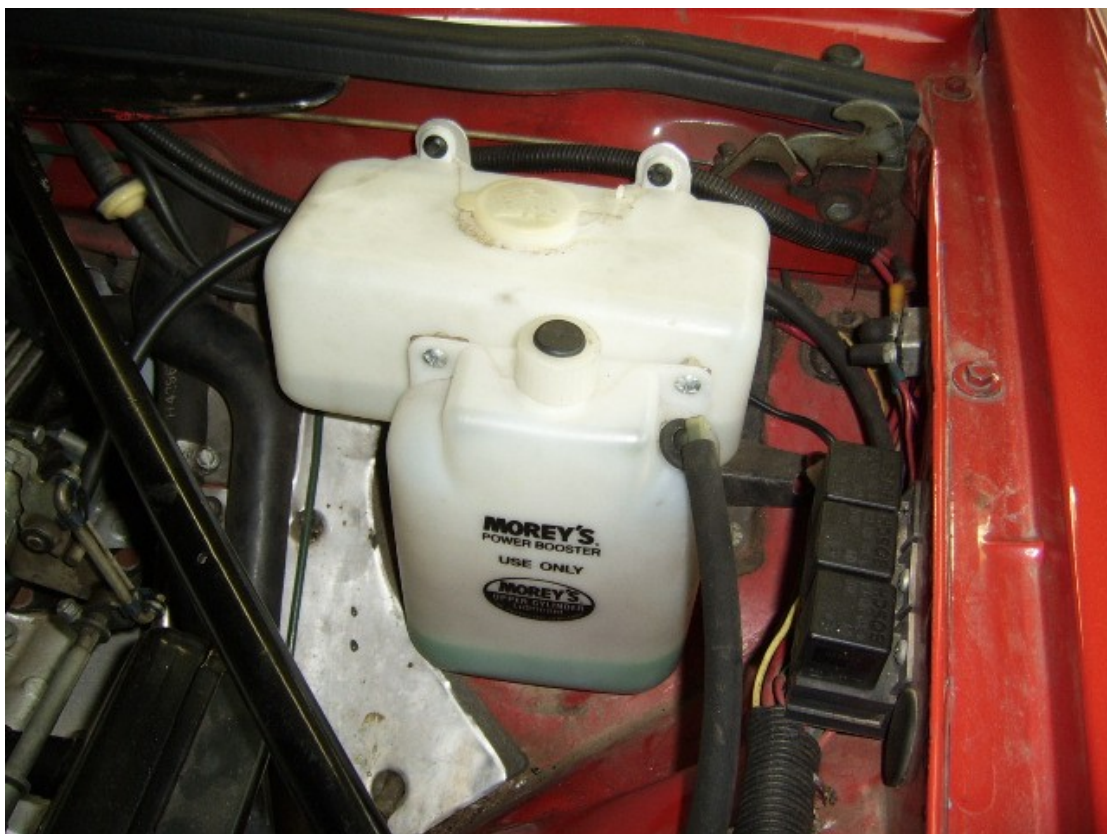
Radiator overflow bottle

Next BUG that had annoyed me for years was that STUPID atmospheric tank in the LH inner guard panel. That would have to have been the dumbest idea that Jaguar ever came up with. I removed all that junk in that LH area, closed the panel back up, it can remain empty. I located a slim 1ltr plastic container and decided this would be sufficient. The huge washer bottle was removed from the LH rear of the engine bay, and a smaller universal unit fitted in its place, then the “new” coolant bottle was fitted in front of that. The cooling system will purge approx 500ml when at operating temperature, so the size of the atmospheric tank needs be no bigger than 1ltr.

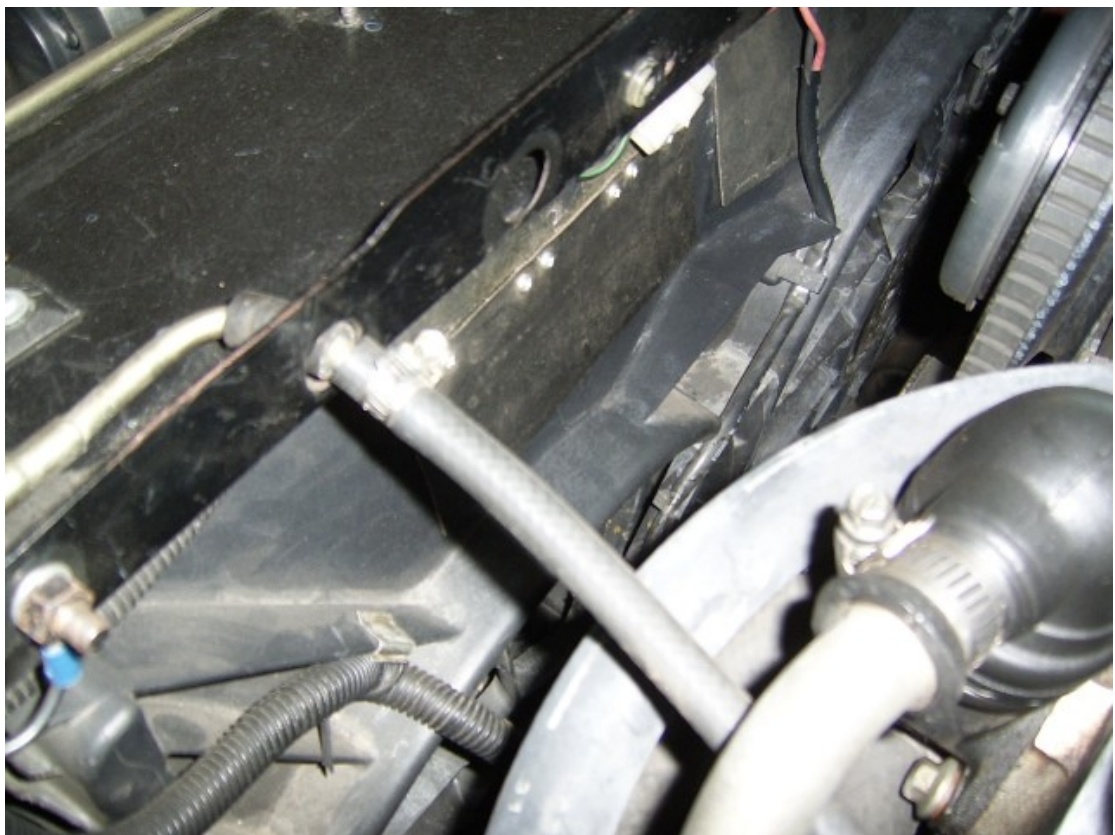
LH view of Ford fans

Twin thermo fans were installed. These were a Ford “twin fan assembly”, and of heavy duty specification. The LH fan is wired for a/c operation only. The RH fan is thermo controlled using the 85c temp switch already installed in the lower hose inlet spout.

The fans simply slid in, as if made for the car, and I reused the 2 small angle brackets that attached the lower OE cowling to the lower radiator support panel, as per original, and they provided a perfect “slide fit” for the lower corners of the Ford fans, again, as if made for this application.”

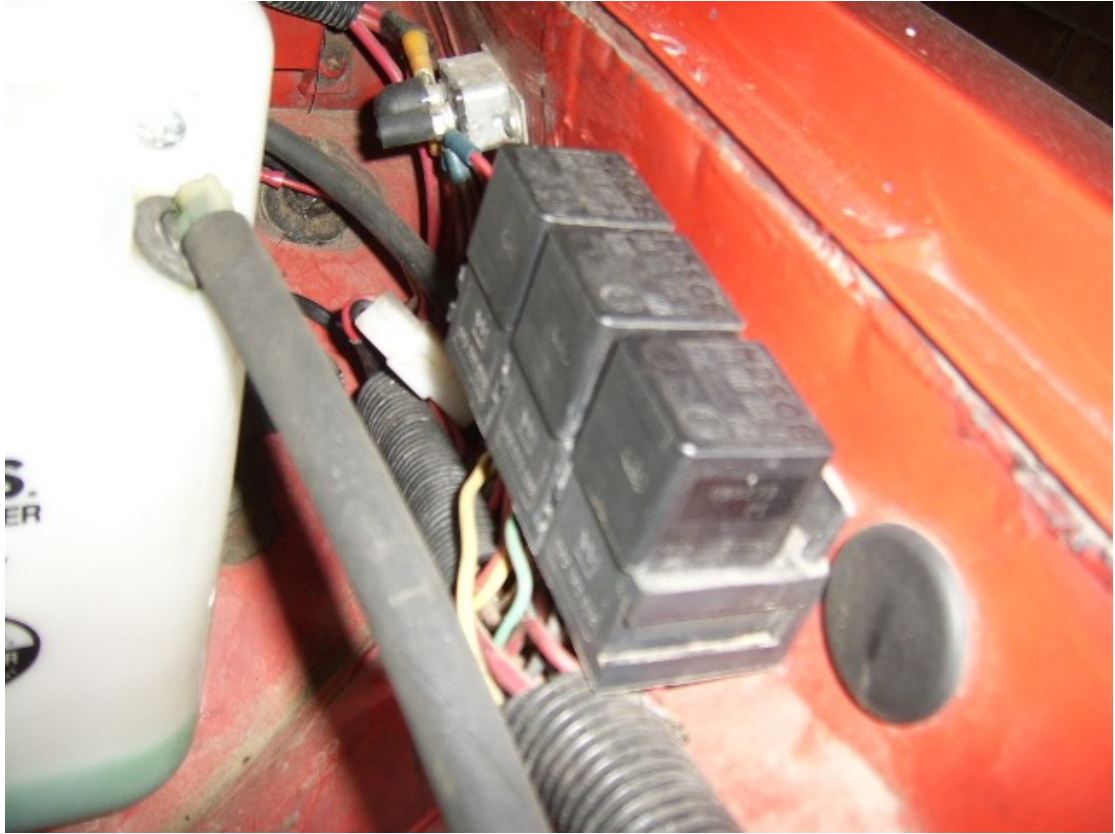
Relays for fans and a/c compressor
