**Cover Becomes Detached From CHMSL –  
Revised CHMSL –  
Installation Procedure**

MODEL  
1997-2001 MY  
XK Convertible  
VIN  
001001-A15347

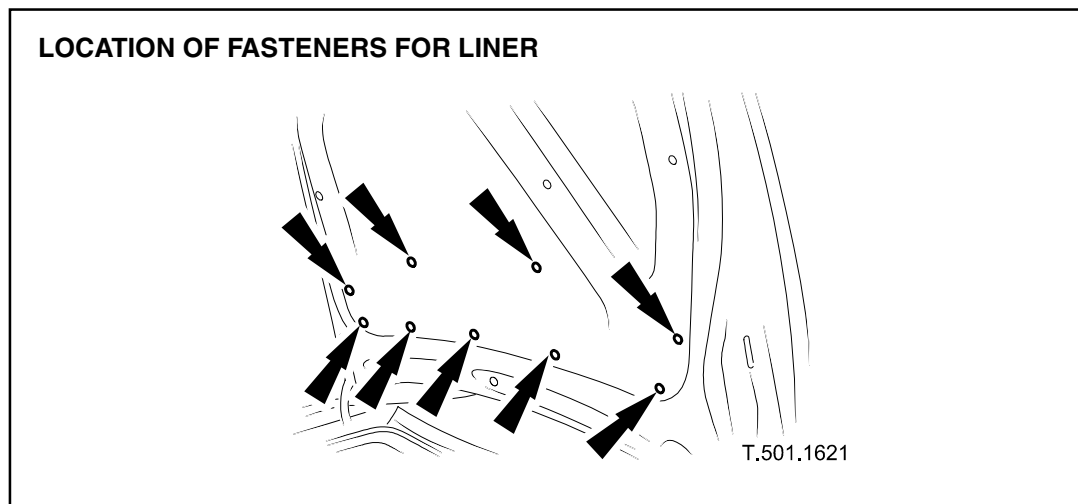
ILLUSTRATION 1

1. Open luggage compartment lid.
2. Remove the fasteners located on the forward edge of the luggage compartment lid liner (Illustration 1).

9. Route the CHMSL harness through the opening in the luggage compartment lid.
10. Reposition and install the CHMSL on the luggage compartment lid.
11. Tighten the nuts securing the CHMSL to the luggage compartment lid.
12. Insert and fully seat the blanking plugs.
13. Reconnect the CHMSL harness connector.
14. Insert and fully seat the securing fasteners for the luggage compartment lid liner.
15. Close the luggage compartment.

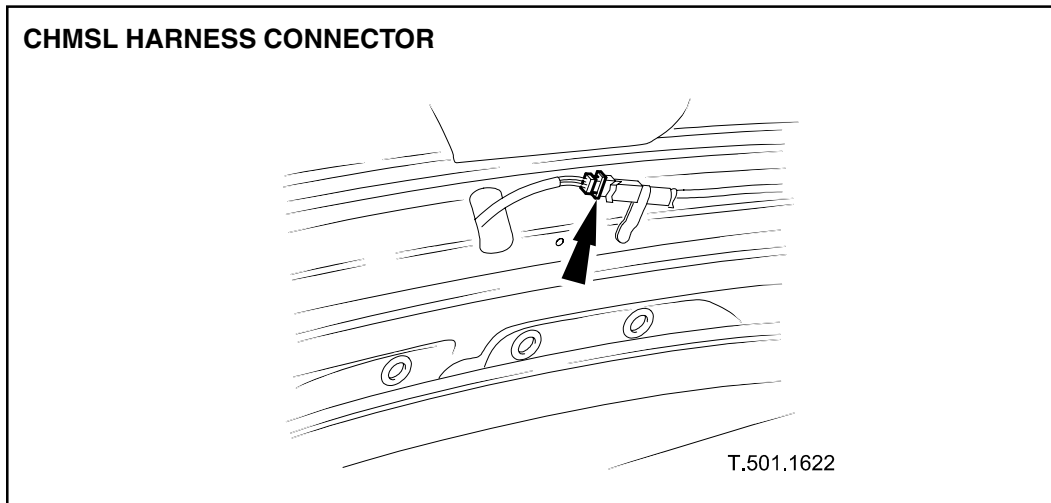
ILLUSTRATION 2

3. Behind the liner, locate and disconnect the connector for the harness from the CHMSL to the luggage compartment harness (Illustration 2).

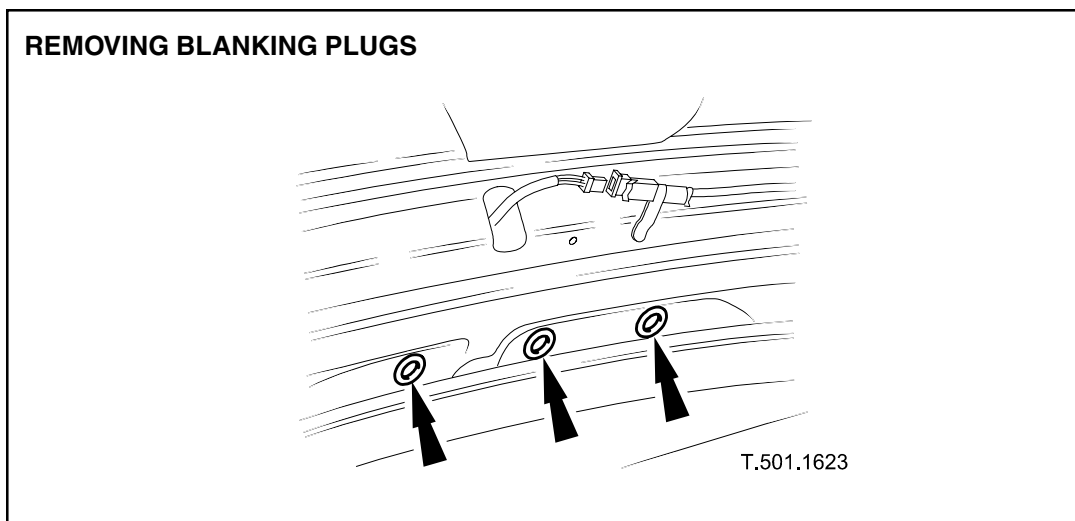
ILLUSTRATION 3

4. Remove the blanking plugs in the forward edge of the luggage compartment lid (Illustration 3).
