Update on my Brake Switch Replacement.

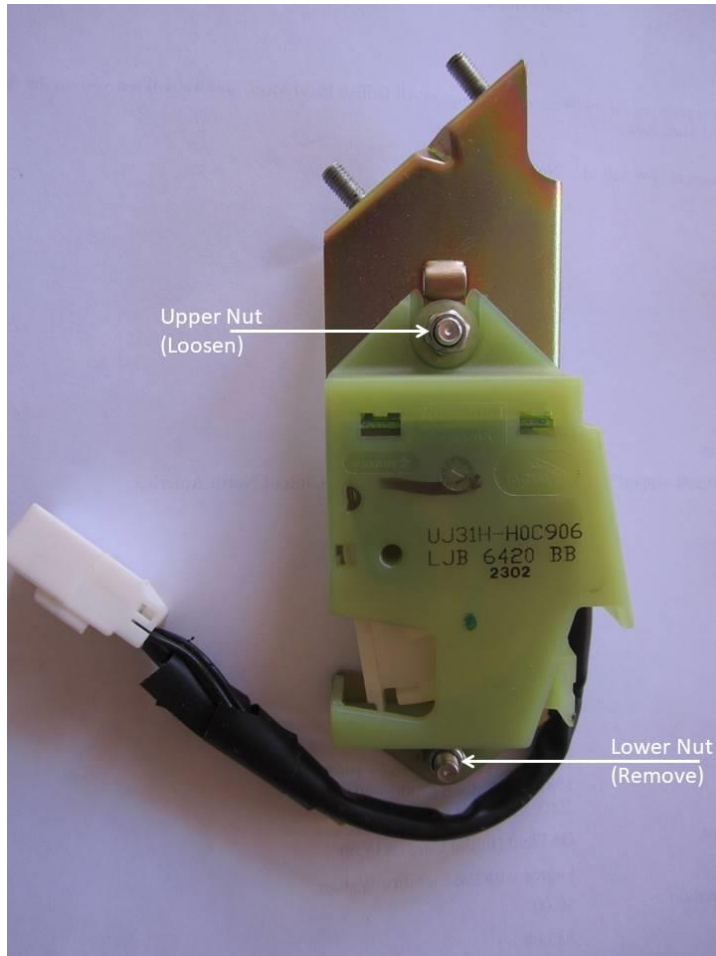
The first technique is to leave the old bracket in place and remove the switch assembly by undoing the 8mm (5/16") nut on the lower stud, then loosening the nut on the upper stud and sliding the old mechanism out. Others have had success with this method. The main problem you might encounter is that it's very difficult to reach the switch retaining nuts (especially for someone who has never done the replacement before.) Because the switch assembly is actually mounted BEHIND the brake pedal's pin, in order to even see the nuts the brake pedal must be pushed forward. To undo the nuts you must bend the bracket to the right by an inch or two. Of course you are weakening the bracket - and - you may find that the switch assembly will not return to its exact original position, resulting in the switch electrically engaged all the time. (So the brake lamps will be stuck ON.) To get the bracket in the right place you would normally have bend it back a little further than where it originally was but that can't be done because the top of the pedal arm is in the way.

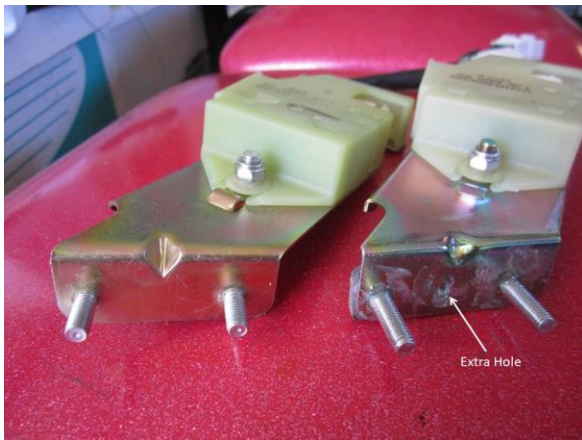
Before undoing the nuts in the engine compartment, drill a small hole inbetween the two studs and through the bracket. You might need a longer drill bit, 1/8 inch or slightly bigger. After removing the assembly you can either drill a corresponding hole in the new bracket or transfer the switch unit from the new bracket to the old bracket. To install the replacement assembly, thread an electrical wire through the new hole in the bulkhead, reach for the wire from underneath the dash, and push it through the top of the bracket. Tie a small knot on the underside of the bracket and tie a string to the knot. From the engine compartment, start pulling the assembly into place – a little at a time, going back and forth between the engine compartment and the switch assembly so that you slowly guide it into the right position. Eventually you will see the two studs come up to the mounting holes. At this point you can pull harder on the wire and bring the studs all the way up through the holes. Wrap the wire around something handy in the compartment to hold the assembly in position while you get the nuts started. Now you can loosen the wire and, using the string from below, pull the wire out of the switch assembly. Tighten the nuts the rest of the way (but not too tight!)

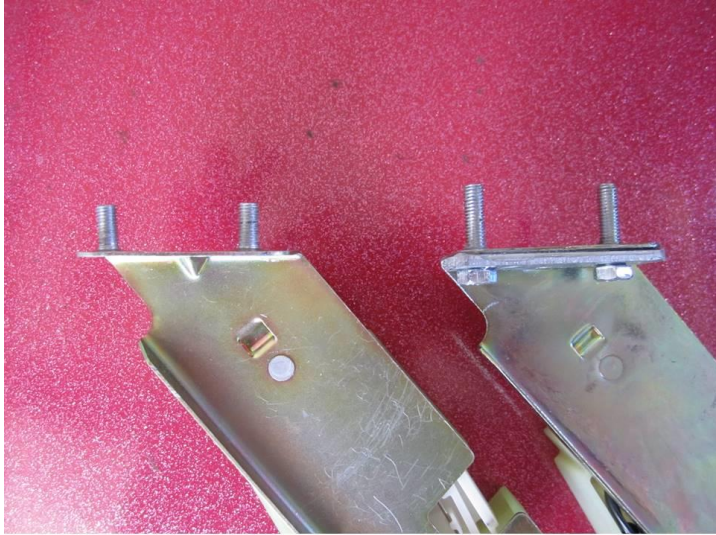
Because I was ham-fisted enough to overtighten the nuts on the bracket's mounting studs, I was forced to improvise a way to repair the situation. I cut a 1/8 inch piece of iron and drilled & tapped two holes to match the mounting stud's size. They need an M5-.8mm tap. I then installed a pair of M5-.8mm bolts that are 25mm long into the iron bar, applying cryoacetate glue where the last couple of threads go into the bar. Next, I glued the bar to the bottom of the bracket with a clear 5-minute epoxy. And waited until the next day to make sure the glue and epoxy were fully dry.

The installation was completed using the extra center hole as described in 2A above. The longer bolts really helped, and I did not have to worry about overtightening the nuts.
