XK8 front suspension bushes

Knocks and thumps from your car's front suspension? Worn bushes are the most likely cause – here we tackle the replacement process

Upper control arms and bushes

Lower control arms and bushes

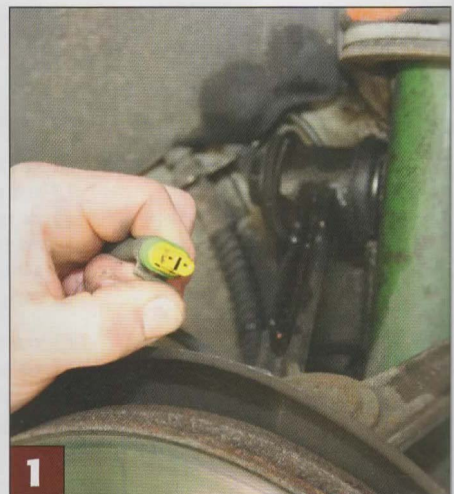
1 With the car raised and the front wheel removed, begin by unplugging the ABS sensor wire and cutting the cable ties securing it to the upper control arm

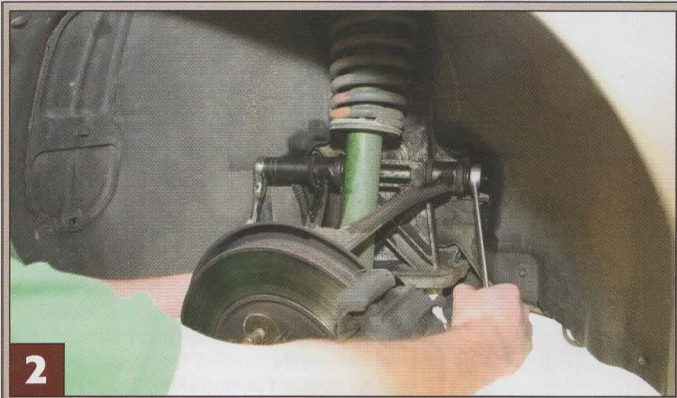
2

Before starting to dismantle, give the entire shaft and bush assembly a good soaking with penetrating oil. Then use a 24mm AF socket and spanner to loosen the main shaft. Note the special chrome plated shaped washers, they are positioned both sides of each bush and need to be retained even though they may look to be part of the old bush

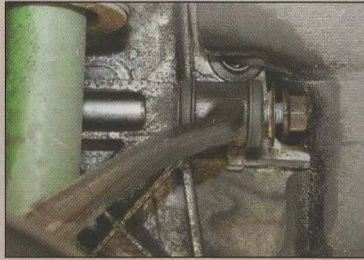
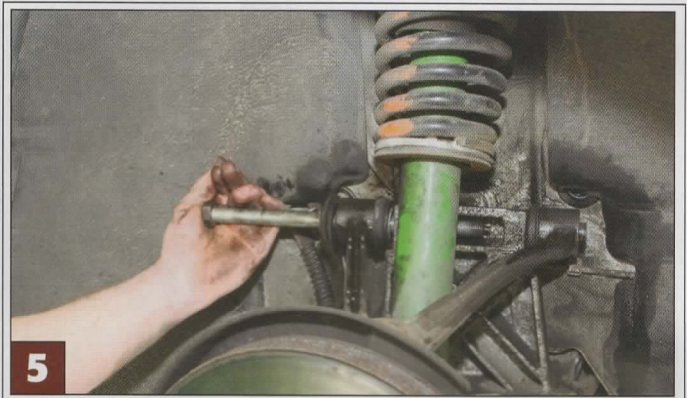
5

Then, as the shaft slides fully out of the sub frame, recover the forward shims and washers. Note that what appears to be a washer is in fact part of the collapsed bush, in many cases the entire bush has worn so far it can simply be twisted out of the control arm

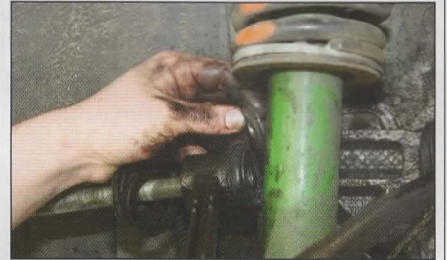
3

The shaft should be driven forwards, applying force first to the protective lug at the end of the thread and then via a chisel or lever to the back of the bolt head

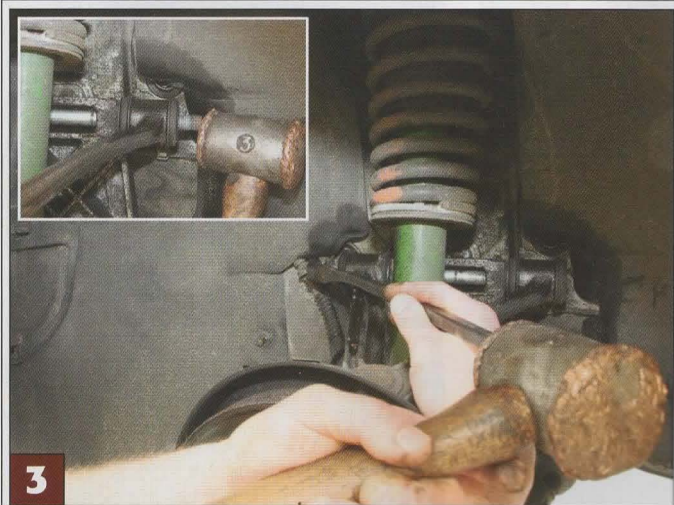
4

With the shaft halfway out, gently lever the rear arm and bush away from the subframe turret and recover any shims, together with the inner shaped washer

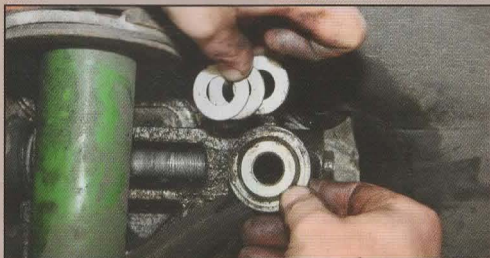
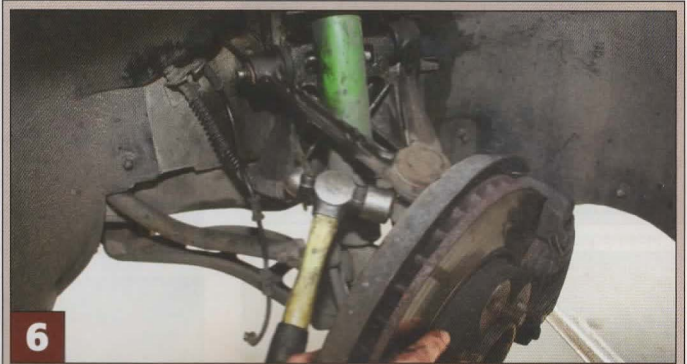
6

Use a punch or other slim bar to hold the arm loosely in place while the 18mm upper balljoint nut is undone (right). Then, with the nut still loosely on by a couple of threads, shock the housing (above) to release the taper; it will normally take several sharp hits. While the arm is removed be sure to support the hub assembly sufficiently to prevent damage to the lower balljoint

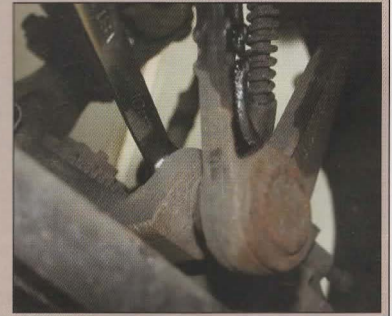
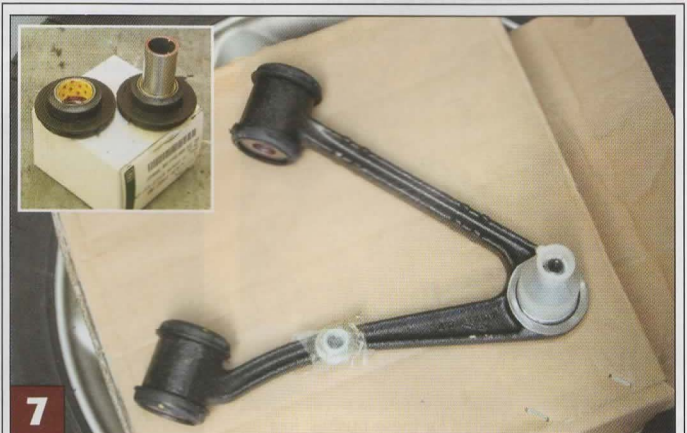
7

If the balljoint is still serviceable with its gaiter in place and untorn, replace only the bushes. If the ball joint is unserviceable a new control arm will be needed which will come with the bushes already fitted. Note that the bush is more like a bearing than a conventional rubber item and it is identical to those used on the XJ-S and XJ saloons prior to the 4.0-litre XJ40

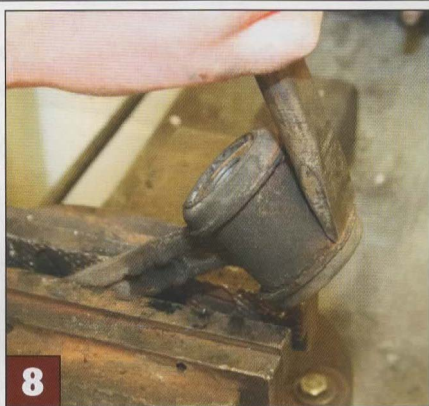
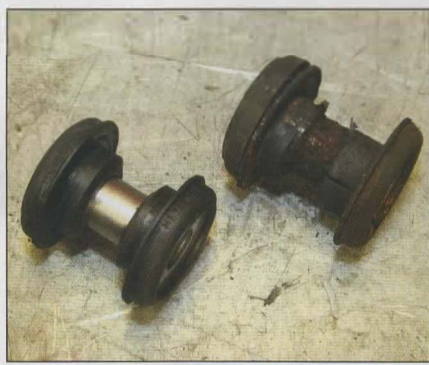
8

If the old bush refuses to come out easily, lock the arm in a vice and drive the bush out with a cold chisel. As can be seen below, over time the bearing material wears away and the sleeve then rusts, locking the two together and in turn causing the whole lot to turn in the arm

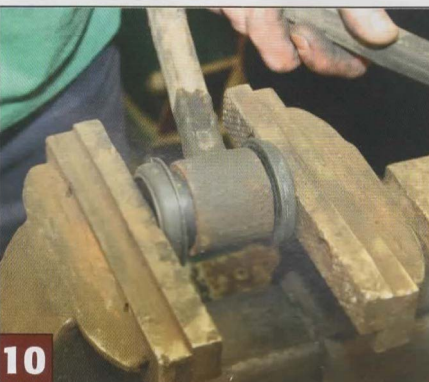
9

In many cases there will be corrosion in the arm itself. Within reasonable limits the rust can be cleaned away with a wire brush or finishing paper, but if doing this opens up the hole so far that the new bush remains loose, a new arm will be needed

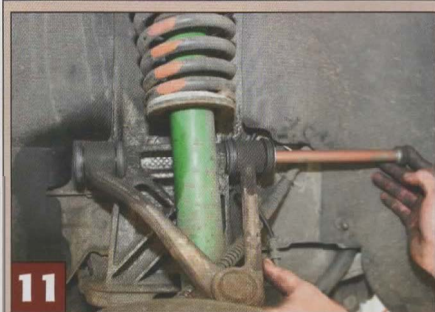
10

No special tools are needed for these bushes: just use the vice to push one half in, then fit the sleeve followed by the other half and push them fully in as well. Be sure to keep everything aligned correctly, however, as it is easy to damage the bearing material inside. If the halves seem not to seat fully, don't worry, they will when fitted and tightened

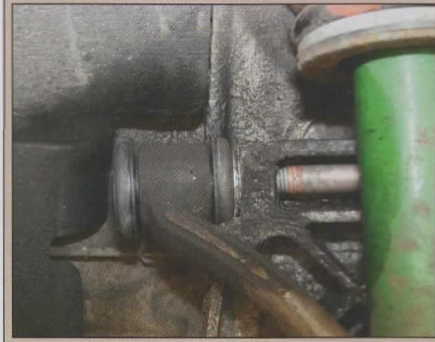
11

To reassemble, first coat the shaft well with copper grease, then assemble the various washers and shims around the forward bush, hold it up and feed the shaft through. With the arm supported, the washers and shims can then be positioned around the rear bush and the bolt slid fully home. As the bearing within each bush allows movement, the upper bush shaft can be tightened fully without weight on the suspension

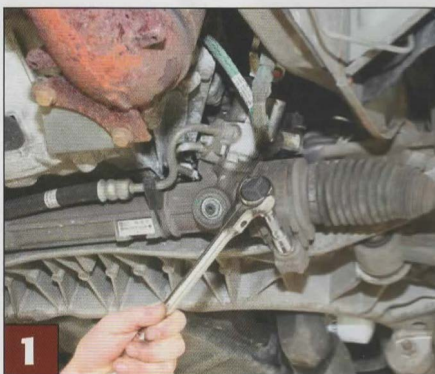
1

The first task is to undo the four 13mm bolts securing the steering rack to the subframe, as the rack ends and gaiters block the exit path of the lower rear securing bolt. It's not necessary to touch the hydraulic connections or even loosen the steering column, just ease the rack away and tilt it so that the lower control arm bolts can be removed

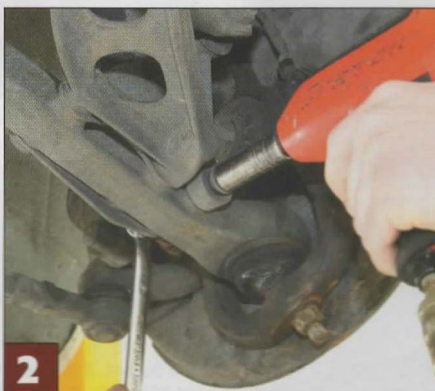
2

13mm and 15mm spanners/sockets are needed to unbolt the anti-roll bar vertical link. If either of the link bushes are torn/perished, fit a new pair of links

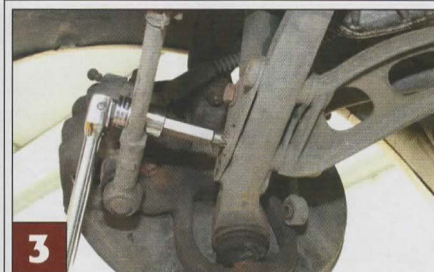
3

A pair of sandwich plates tie the two parts of the lower control arm to the spring/damper assembly, effectively taking the entire weight of the front of the car. Remove the two T60 Torx headed bolts – heat the threaded portion of the forward part if necessary to loosen. The suspension assembly should then drop free of the spring/damper

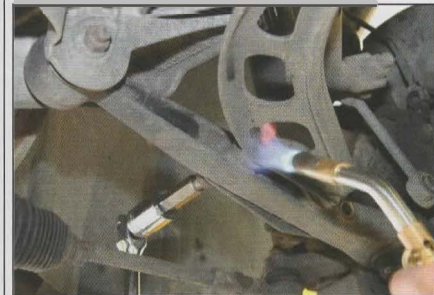
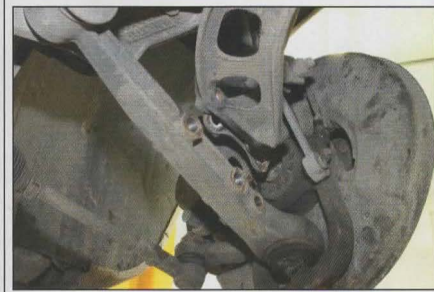
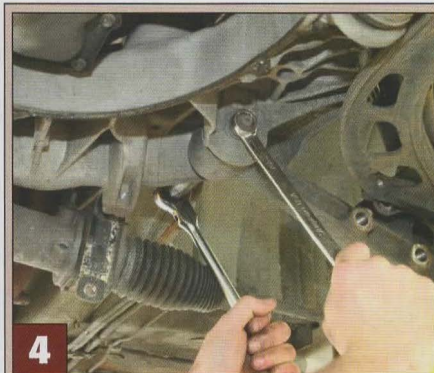
4

From VIN 031302, the 18mm bolt (and 22mm nut) securing the lower rear bush has an offset shank used to move the arm in or out slightly during camber adjustment – earlier cars may have had these bolts retro-fitted. The offset bolt can be identified by a raised strip on the bolt head flange (see below), the direction of which should be noted prior to disassembly

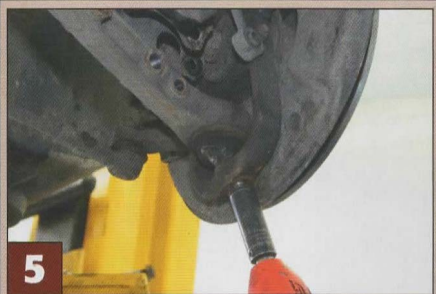
5

With the arm still located in the subframe, loosen the 19mm lower balljoint nut, leaving it on by just a couple of threads. The arm can then be manoeuvred out of the subframe and swivelled round to gain sufficient access for the hammer blows necessary to release the taper. If only changing the bush be very careful not to cause damage to the balljoint gaiter

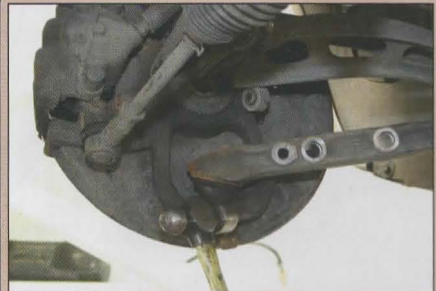
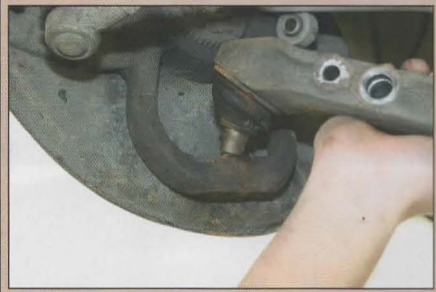
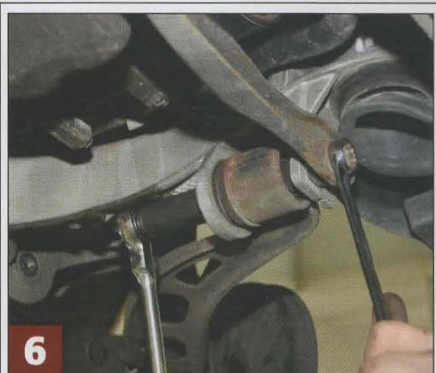
6

The forward lower bush has a conventional 18mm bolt and 22mm nut with no provision for adjustment. Note the position of the spacer between the alloy subframe and the steel bracebar

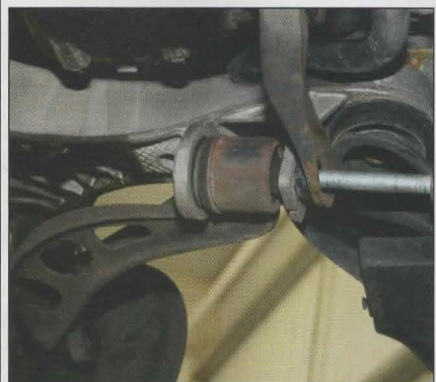
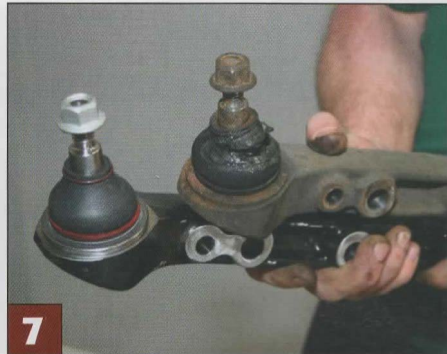
7

While technically available as a separate item, removing and replacing a lower balljoint successfully requires the skills and equipment of a professional engineer, and so it is almost always more practical to fit a completely new arm, especially if both the balljoint and bush are unserviceable

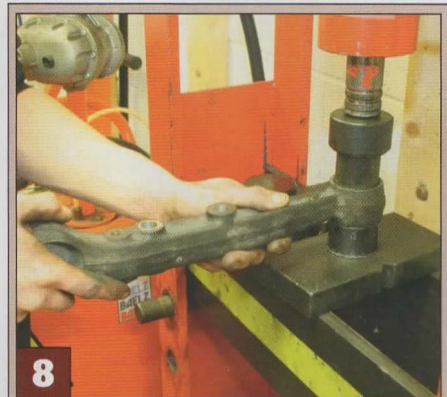
8

Both bushes have steel flanges, which unfortunately allow nowhere to support the arm while pressing them out. While the rear bush can be removed with just two sides of the arm exposed, it is much safer to chisel/hacksaw the entire flange off (below) and then use a suitable section of pipe to press against

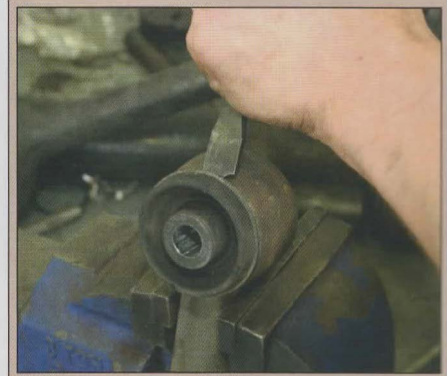
9

When fitting new bushes the correct Jaguar tool (shown in background) is essential to prevent damage to the rubber face. Position the new bush, flange facing forward in the arm, sit the specially shaped tool on top, and place the whole lot in the press, pushing the bush in until it seats fully

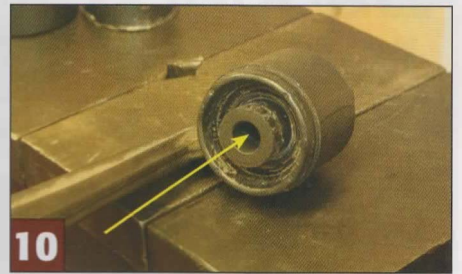
10

The procedure for replacing the front bush is basically the same, except in this case the flange must be removed completely in order that the remainder be pushed through in a continuation of the direction in which it was first fitted (see arrow). There are tools listed for removal of this bush without chiselling the flange off, however we have tried them and found them useless

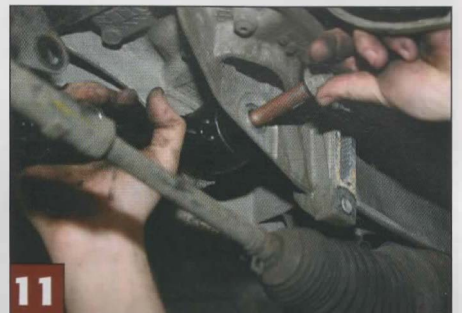
11

Reassembly is a reversal of the stripdown procedure, but with three important points to remember. Coat both the lower bush and drop link bolts with copper grease to prevent seizure in the future. Clean the T60 Torx bolts thoroughly and recoat with Loctite or similar. Only tighten the lower bush and drop link bolts with the weight of the car on the suspension, otherwise the bushes will remain permanently twisted, leading to premature failure
