600-03

**Part-Load Engine Breather – Partial Blockage
of Restrictor – Scheduled Cleaning –
Service Action S474**

MODEL
1997-2001 MY XK Range
1998-2001 MY V8 XJ Series
VIN
001001-A13614
812256-F25708

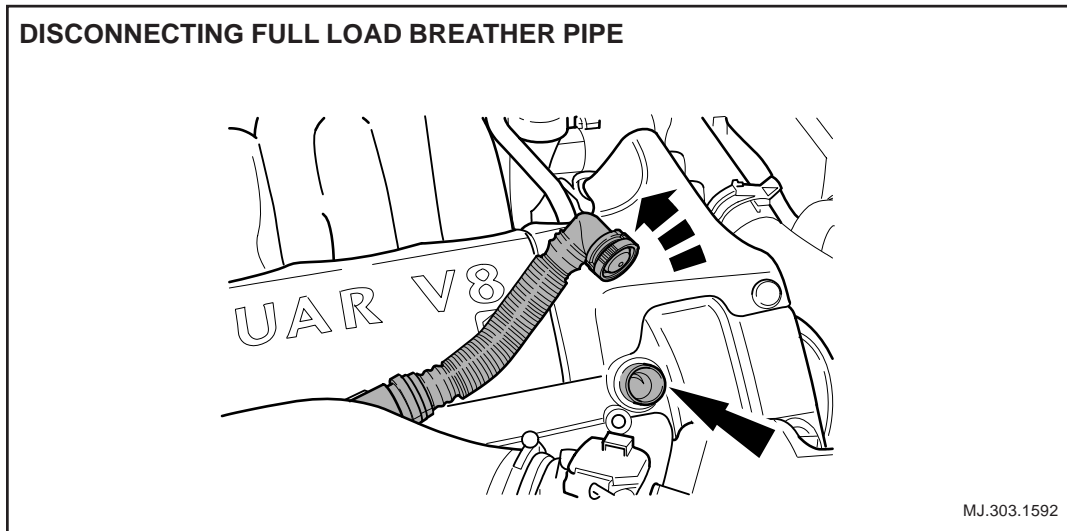
ILLUSTRATION 1

1. Open the hood. Cover the fenders with protective fender covers.
2. On normally aspirated engines, remove the engine cover from the left cylinder bank.
3. Start the engine.
4. Disconnect the full load breather line on the right camshaft cover, (Illustration 1).

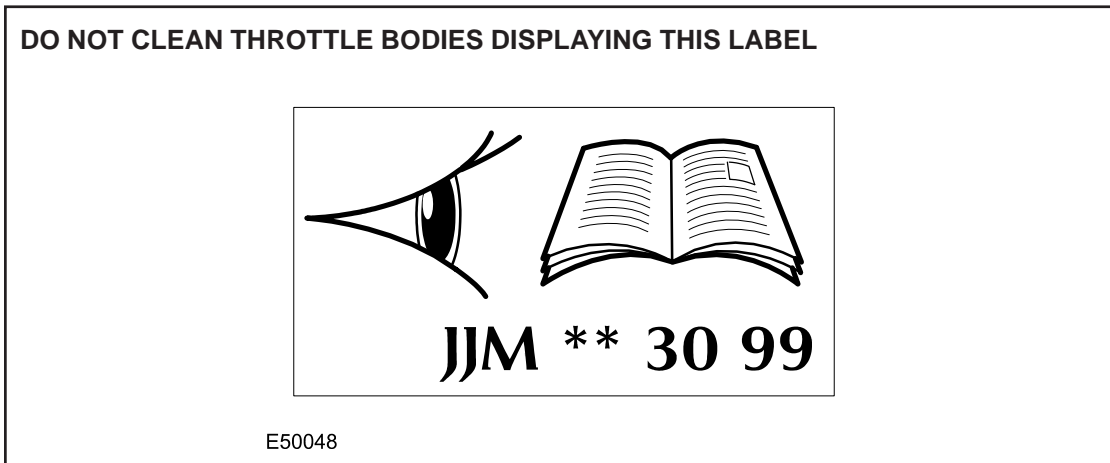
ILLUSTRATION 2

⚠ Caution: If the throttle body displays the label shown in Illustration 2, do not clean the throttle body bore and butterfly valve as damage to the vehicle can result.

Note: Failure to clean the throttle butterfly and bore on units without the label may result in engine start/driveability issues.

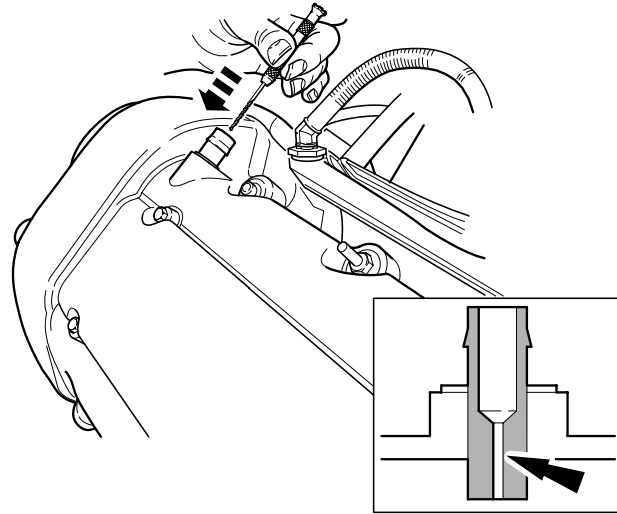
ILLUSTRATION 4

USING DRILL BIT TO CLEAN RESTRICTOR

7. Insert a **3/32"** (2.5 mm) diameter drill bit in a hand-held pin chuck such as Snap-on Tools® Part No. YA 806 (Illustration 4). **Verify that the drill bit does not exceed 3/32" (2.5 mm) diameter.**

⚠ Caution: Do not use a power drill under any circumstances. The drill bit must always be turned by hand only. Using a power drill can damage the restrictor or the breather stub which needs to provide a good seal to the connector of the flexible breather line.

⚠ Caution: Do not allow the diameter of the restrictor to increase. Use a micrometer to verify that the diameter of the drill bit does not exceed 0.098 inch (2.5 mm.).

8. Carefully push the drill tip into the breather stub and through the restrictor while slowly rotating the drill to clear any deposits that may have accumulated inside the restrictor. The top end of the restrictor is approximately 30 mm below the tip of the line stub and extends for an additional 5 mm into the camshaft cover.
As a result, the tip of the drill bit must penetrate into the stub at least 40 mm to ensure penetration through the entire length of the restrictor. No damage will occur if the tip of the drill bit penetrates 45 mm.
If available, use a 'long flute' type drill bit. - The additional length of flutes and shank will provide more clearance from surrounding components to ease rotation of the pin chuck and drill.
9. When the drill can be turned freely, all deposits have been cleared from the restrictor.
