# ***A Case of Mistaken Identity***

**Filler tube on JATCO five-speed  
proves to be somewhat elusive**

## Mistaken Identity: Jatco 5-Speed FWD Band Anchor Issues

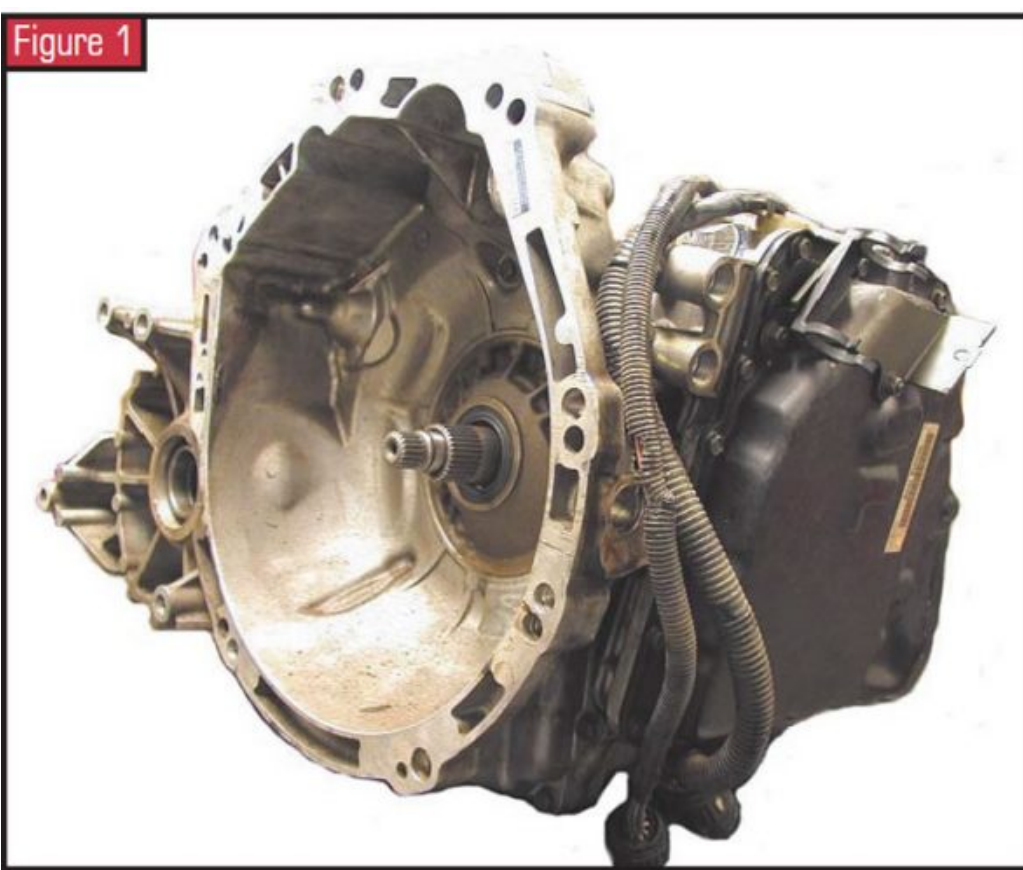
Figure 1

The recent JATCO five-speed automatic transaxle shown in **Figure 1** can be found in a variety of vehicles. In the Mazda6 and MPV it is known as the JA5A-EL; in the Jaguar X type it is known as the JF506E; in the VW Golf, GTI and Jetta it is known as the 09A; and in the Land Rover Freelander it is called the JF506E as in Jaguar vehicles.

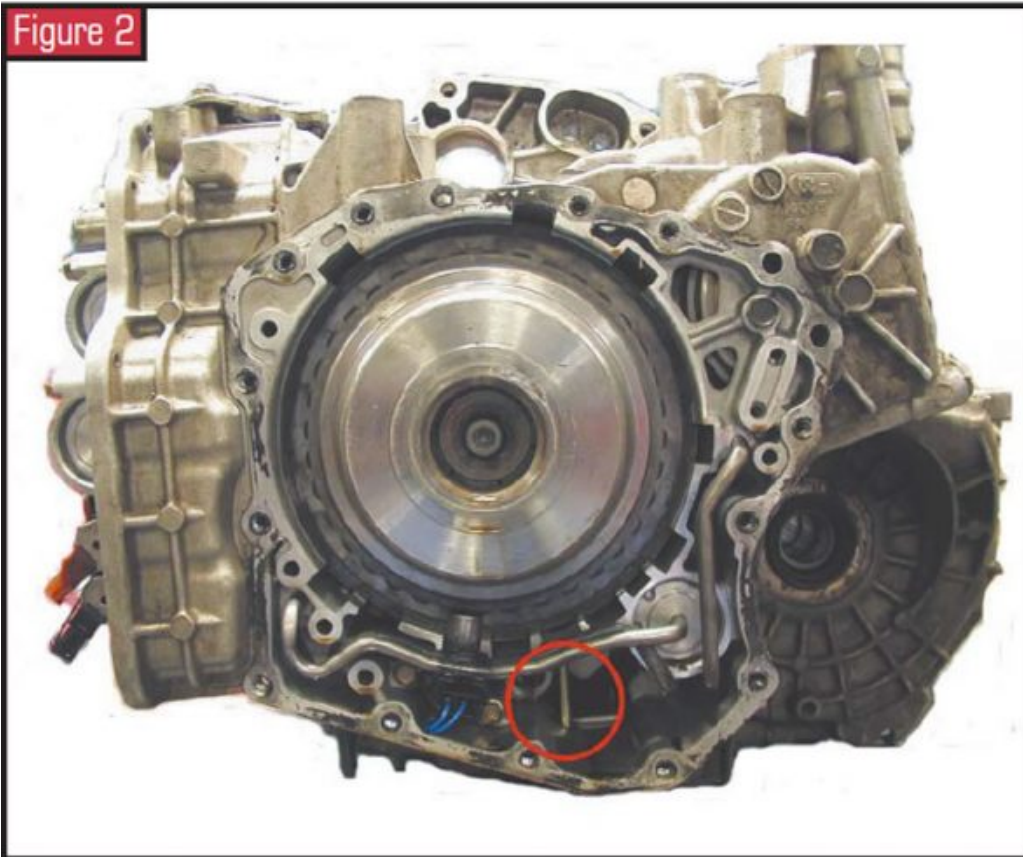
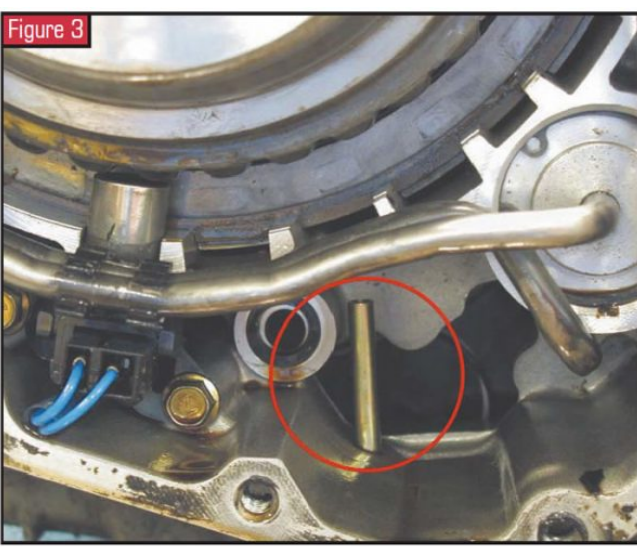
When you remove the back cover of this transmission, you will see a familiar fluid-level check pipe (**figures 2 and 3**). To fill the transmission, you remove the plug at the bottom of the case (see **figures 4 and 5**) and add fluid until it overflows the check pipe.
