## 6 Speed Transmission mechatronic sleeve replacement

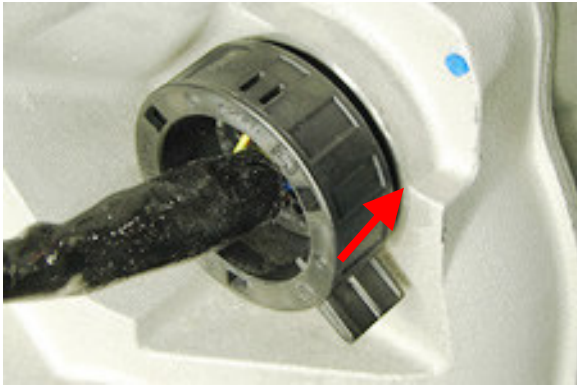
1. **Drain the transmission fluid and remove the transmission oil pan.**  
On applications with steel oil pan also remove the oil filter.
2. **Unlock and disconnect the vehicle electrical connector from the transmission.**

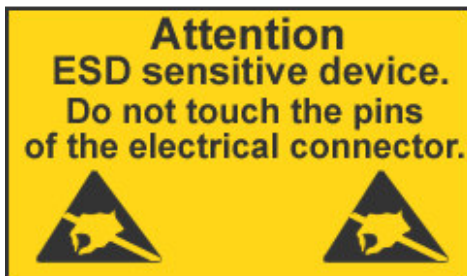
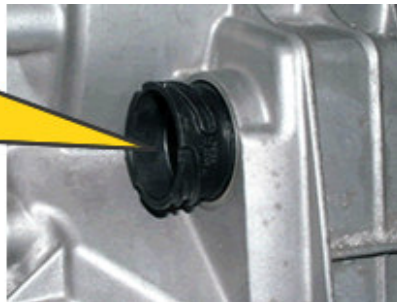
The Mechatronic (electronic valve body) located within the transmission is a electrostatic sensitive device, avoid touching any electrical pins to prevent ESD (electrostatic discharge) damage.

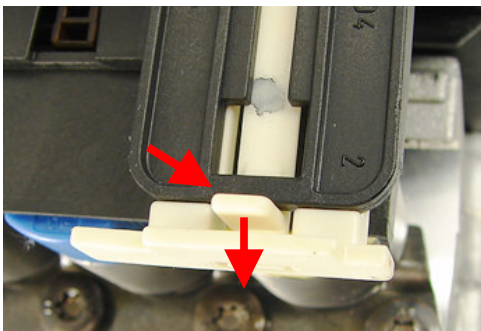
3. **Pull the sealing sleeve locking mechanism to the unlocked position.**  
The locking tab is located on the bottom of the mechatronic below the sealing sleeve.

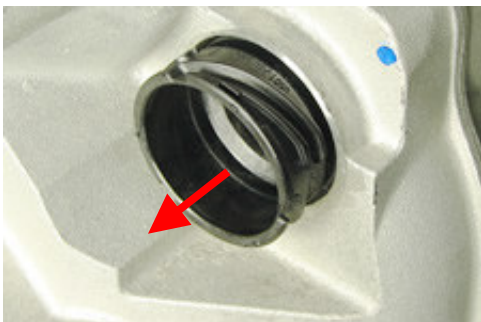
4. **Pull out the sealing sleeve without twisting or rotating motion.**  
The sleeve has a locating tab that might come in touch with the connector pins and cause damage.

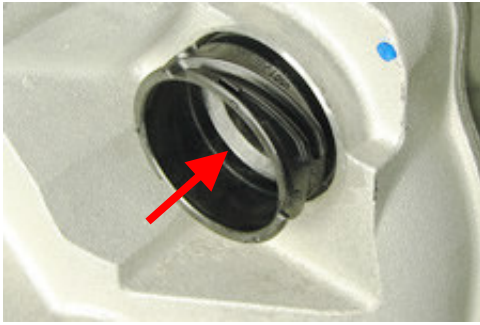
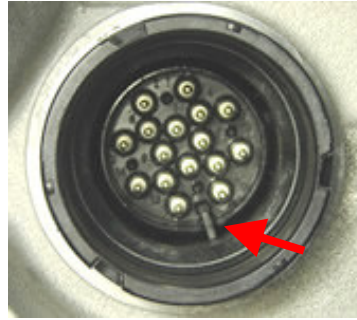
5. Lubricate the sealing sleeve o.-rings with Vaseline and push the sealing sleeve back into place. Avoid twisting or rotating of the sleeve as this may cause damage to the connector pins. Do not force the sleeve in place and pay close attention to the proper alignment of the locking tab.

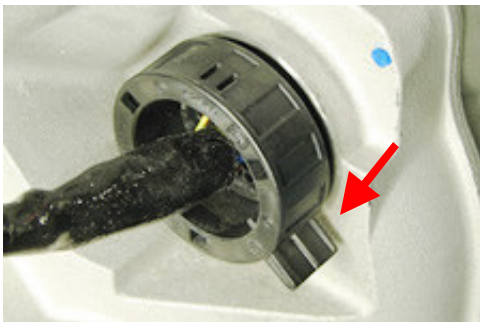
7. Install the oil pan and adjust the fluid level as described in the appropriate transmission fluid level procedure.
8. Reconnect and lock the vehicle electrical connector to the transmission.
