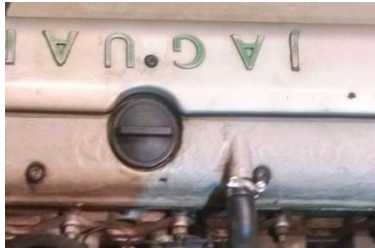
Loosen the hose clamp (6mm socket) and disconnect the crankcase ventilation hose from the cam cover:

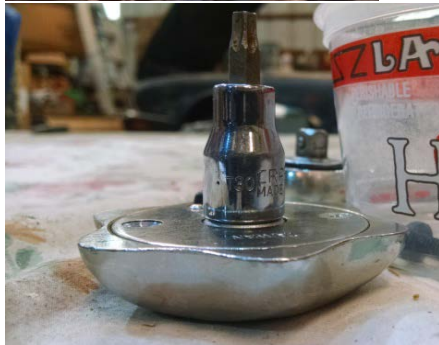
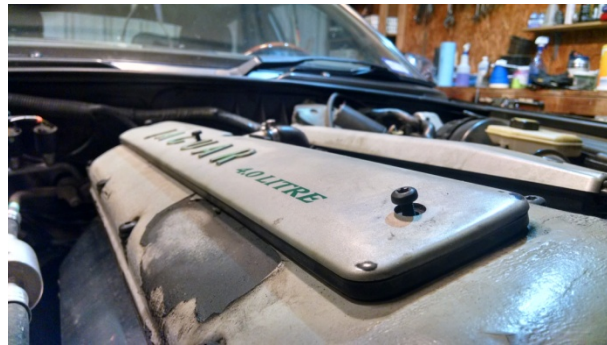
A T30 Torx bit will liberate the coil cover. Don't lose the rubber gasket. It will be re-useable:

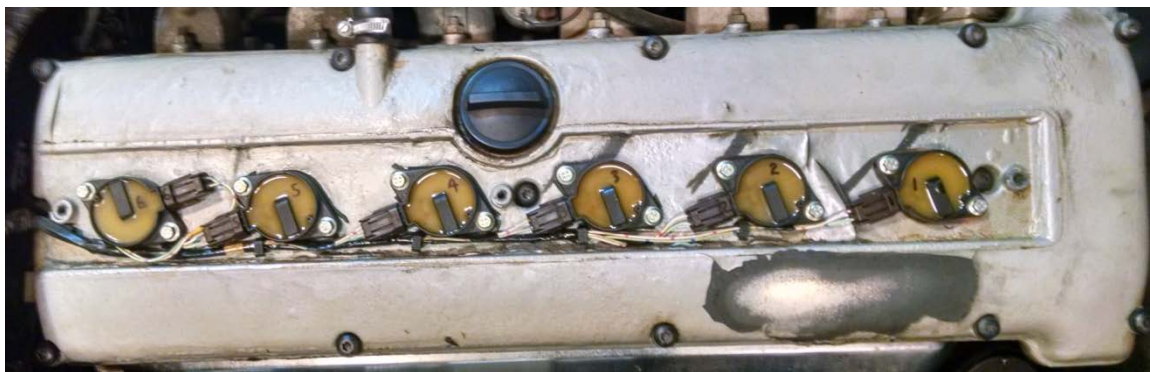
Before you go any further, you'll want to develop a system to prevent yourself from mixing up the connectors for the #5 and #6 coils. In my case, for both cars, I marked both the coils and the connectors with a sharpie. It really doesn't matter about the coils, but the connector position is critical. It may not be very visible in the picture, but each connector is also numbered.

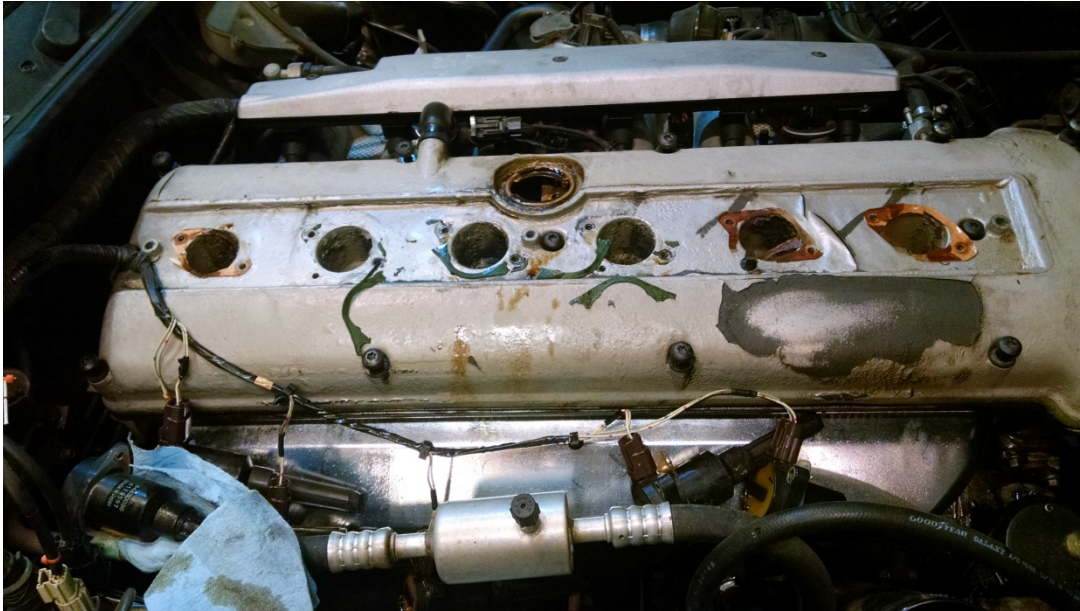
An 8mm socket will have the coil bolts out in no time,

and you can drape the coils along the exhaust cover without disconnecting the wiring if you wish:

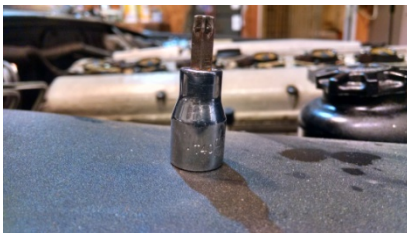
Torx T40 for the cam-cover fixings:

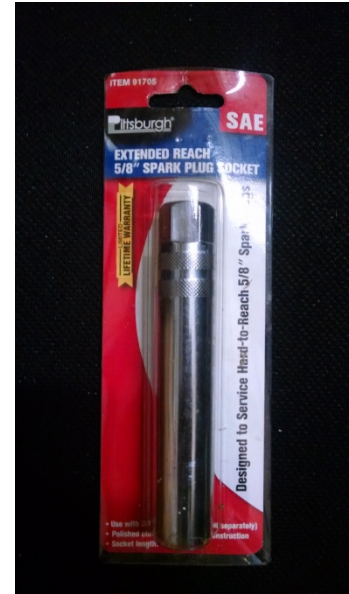
This is an excellent opportunity to renew your spark plugs. Some will argue that not using RC12YCC from Champion is the equivalent of “crossing the streams” in Ghostbusters, even though they are apparently no longer available. Due to this development, a few of these purists will now grudgingly allow the use of Champion RC12YC’s. The experience I have made is that crossing the streams really isn’t all that bad. I bought the car with 63k miles on it. At 85k, I renewed the plugs(I don’t recall what was fitted, likely

RC12YCC from original build) with NGK Iridiums. It wasn't missing or anything, I just didn't know if it had ever been done, had owned the car nearly a year, and figured it was time. Here we are nearly 5 years on, almost to 196k, and I'm just now getting round to renewing them again. This time, I have the proper RC12YC's as I found two boxes of 6 ea. in my "stash" that I suppose I ordered from Rock Auto when there was a promotion on after reading the horror stories about what I'd done by fitting the NGK's. So I fit one set to the SpruceBruce after I'd removed its cam cover, and another set to my daily driver when doing the cam cover swap on it. Having the cam cover off makes it a bit easier to remove the oil fouling the plug wells. Both boxes of mine were gapped to the proper 0.035" straight out of the box, and they should be torqued to 22-28 nm. The long-reach socket pictured isn't really necessary. In fact, on the first one, I used a normal spark-plug socket and extension having forgot about this one hanging nearby on the pegboard.

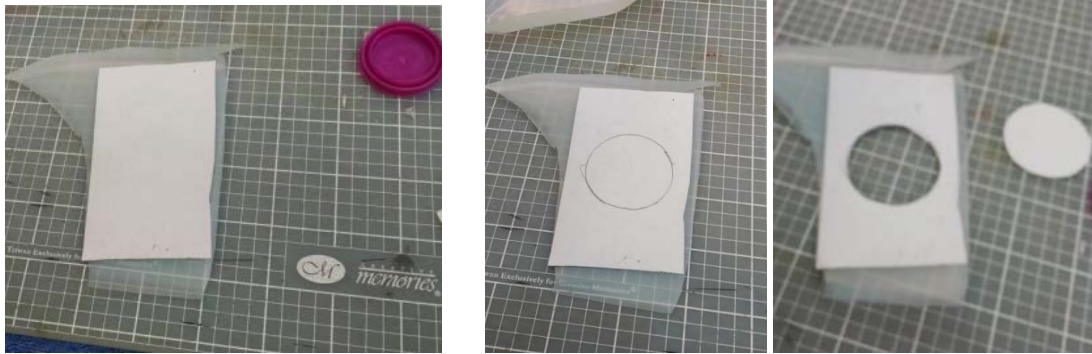
As is evident, my paper coil gaskets were destroyed. I found a couple that I had made back at the 85k mile plug swap when I took it apart. I don't remember EXACTLY what I constructed them from back then but it was some kind of plastic. They were still intact, but I made a full set this time from plastic water jug material. You'll need: Knife (I used an exacto), a couple of gallon water or milk jugs, most of a sheet of adhesive label paper, a pencil, and a hole punch. I found the cap (+ tracing clearance) on a gallon water jug was the perfect diameter to fit snugly around the coil boot: Cut out a flat piece of the jug large enough to cover the coil base and stick a piece of label paper to it:

Place the bottle cap in the center and trace around it and cut out the circle:

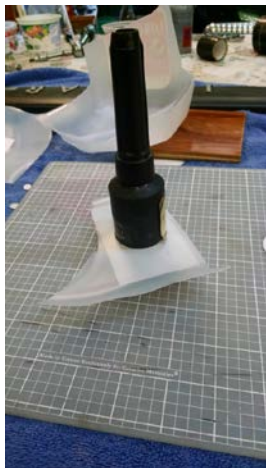
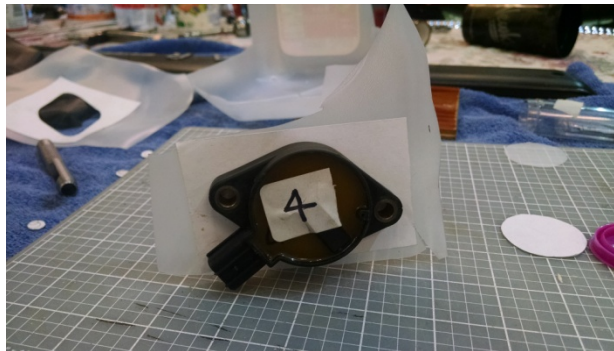
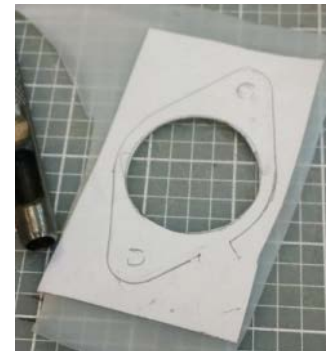
Slip it over the coil so the paper is against the flange on the coil. Hold it snugly and trace around the coil flange. Don't forget to mark the holes.

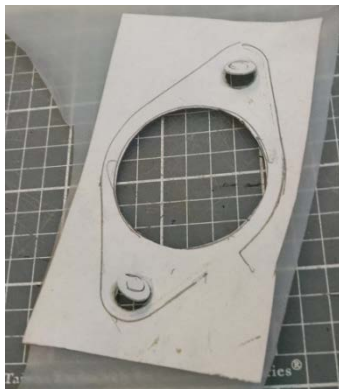
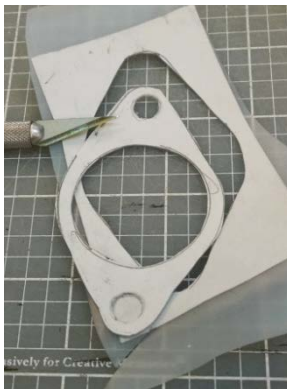
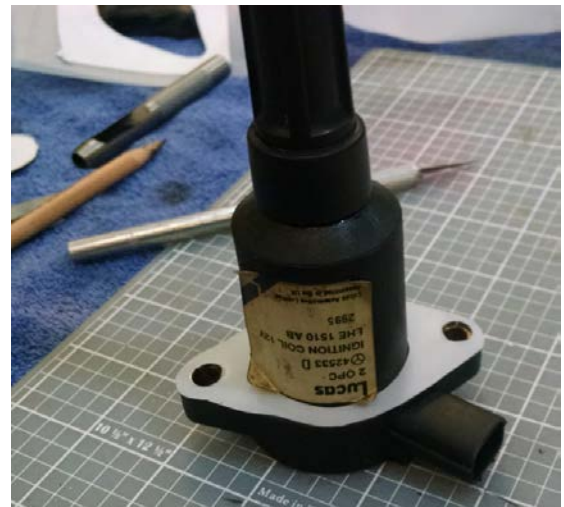
Punch the holes and cut it out and you are 1/6 of the way there!

I pulled one coil out after two weeks' of operation to see if the material was holding up to the heat, and it looked like it does here at initial construction.

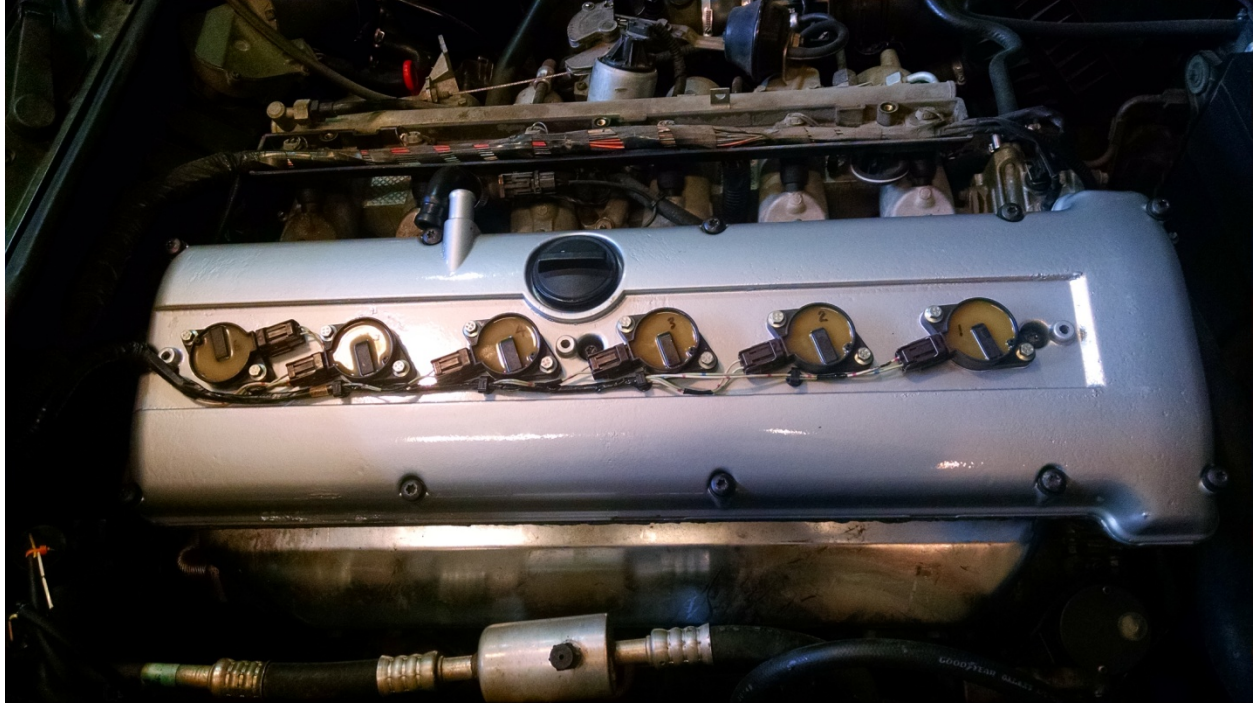
Not sure what the spec is for the coils, but I didn't use a torque wrench, just put them up snug with my hand on the pivot of the ratchet rather than the proper end of the handle. Since the Christmas-tree wiring loom retainers had lost most of their bite during removal, I added a dab of RTV to each before re-seating them in their holes.

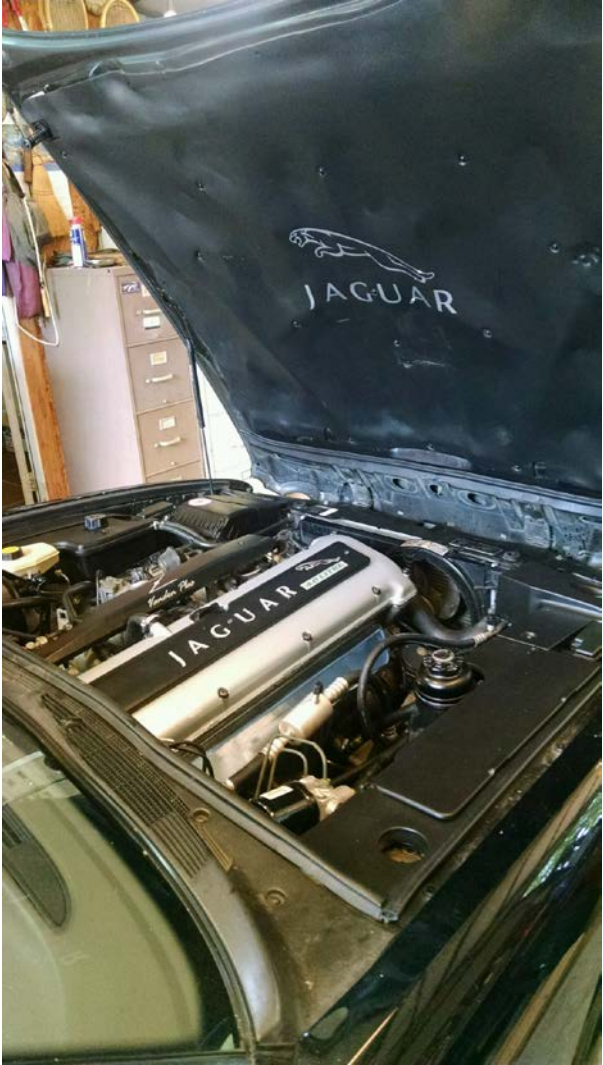
Refit the ventilation hose and install the coil-cover and you've got this one "saucer'd and blowed!"
