## Cleanup III: Grinding

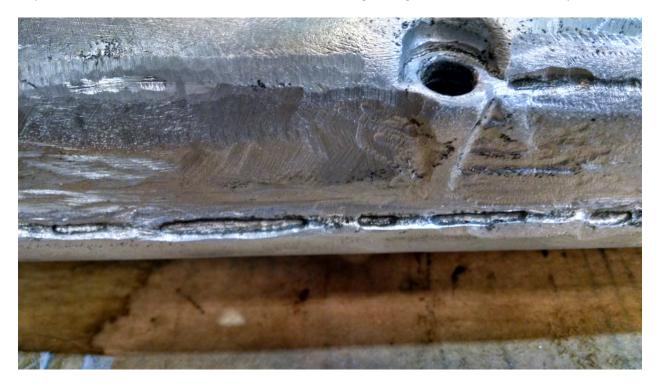
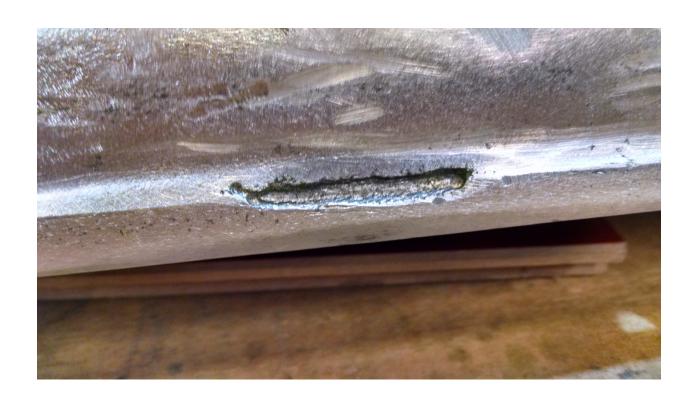
I referred previously to a Dremel rotary tool. I don't have one. What I've got is a very small, rotary tool "kit" from HF, "Chicago Electric" or some such, that came with a multitude of tiny cutting heads altogether on sale for \$9.99. Haven't found much use for it up until now. It was ideal to clean up some of these pitted areas. I was surprised how deep I needed to go in some spots to hit clean metal, and further surprised that I continued to find metal instead of breaking through on the other side of the piece!
