Sedan Range

TECHNICAL BULLETIN

Recall T493 - 1995 MY/Recall R493 - 1996-97
MY – AJ16 EGR System –
Replace PROMs and EGR Valve

MODEL 1995-97 MY
Sedan (4.0L) Range
VIN
720001-812255

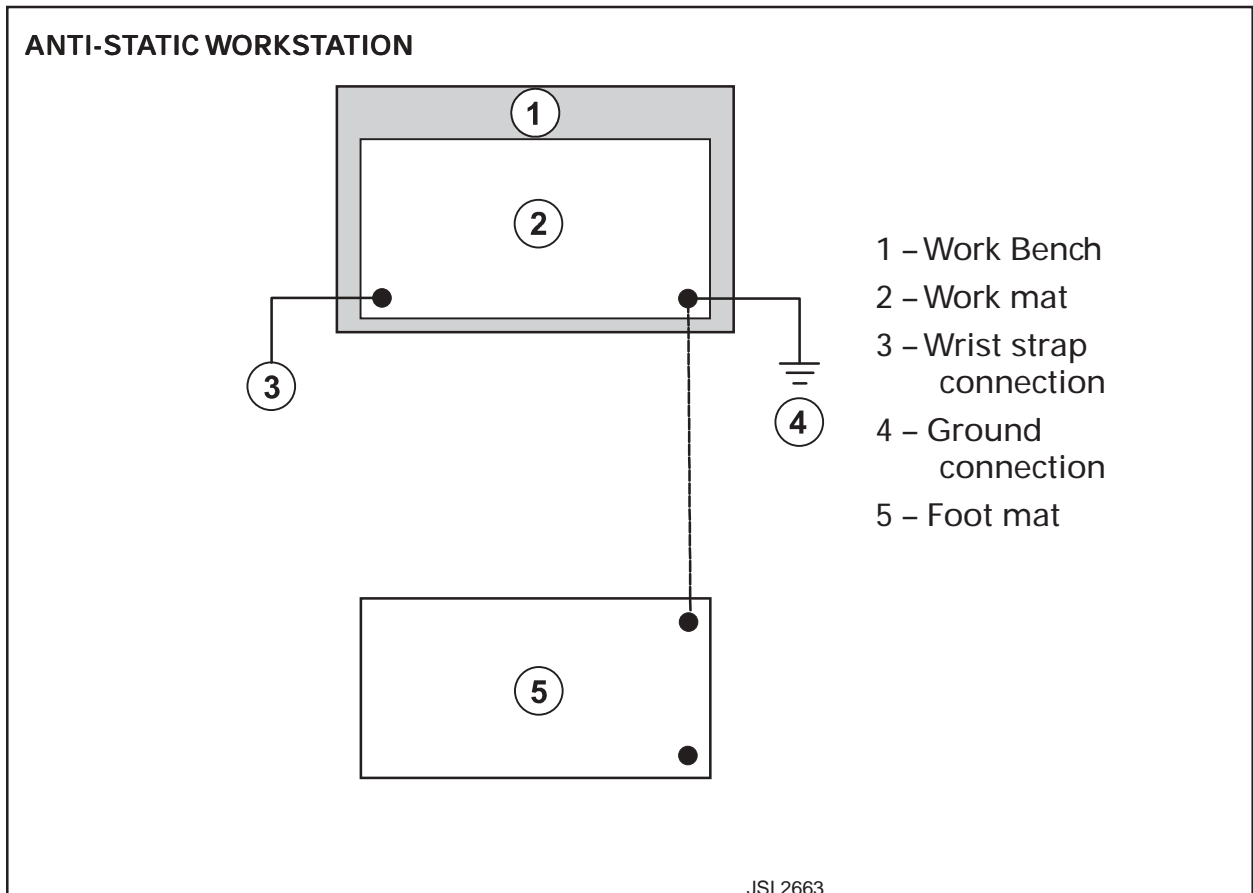
ILLUSTRATION 1

⚠ Caution: Perform the following operations at an antistatic workstation (previously supplied) while wearing a grounding wrist-strap (Illustration 1). Additional work mats can be sourced locally, such as Radio Shack cat. no. 910-3780.

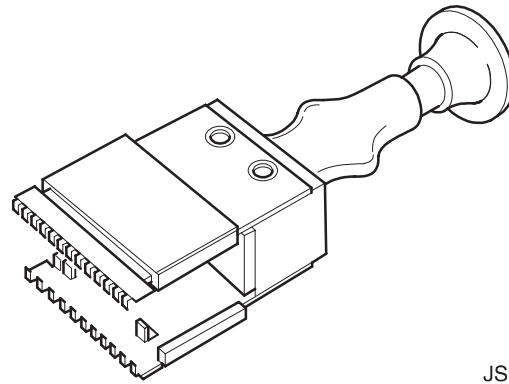
ILLUSTRATION 3

EXAMPLE OF CHIP REMOVAL TOOL

8. Remove the PROM microchips from the printed circuit board using a suitable proprietary removal/reinstallation tool (Illustrations 3 & 4).

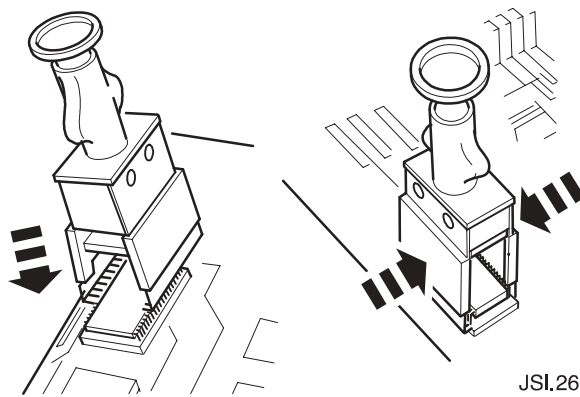
ILLUSTRATION 4

USE OF TYPICAL CHIP REMOVAL TOOL
