Notes from Transmission Rebuild on a '98 Vanden Plas. with a ZF-5HP24-015

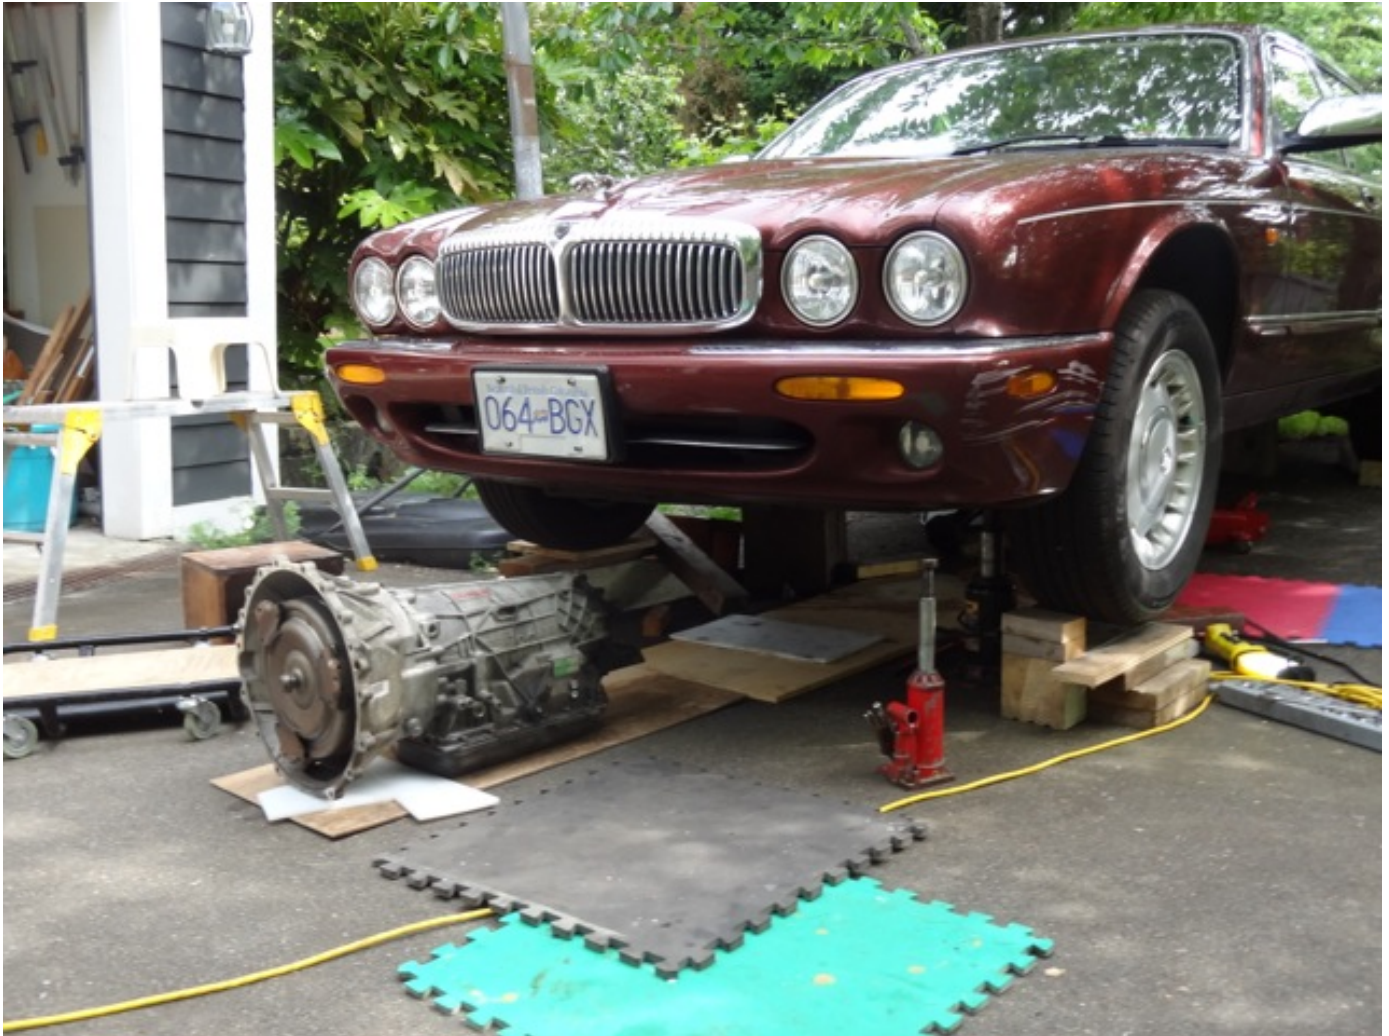
Removal requires at least 24" (62 cm) of clearance. In my case removal was easiest from the front.

To achieve this I jacked the car up and placed the wheels on blocks to give 26" of clearance. I left the tires on as their removal would have made no difference to the job and this left me more room underneath to move around and work.

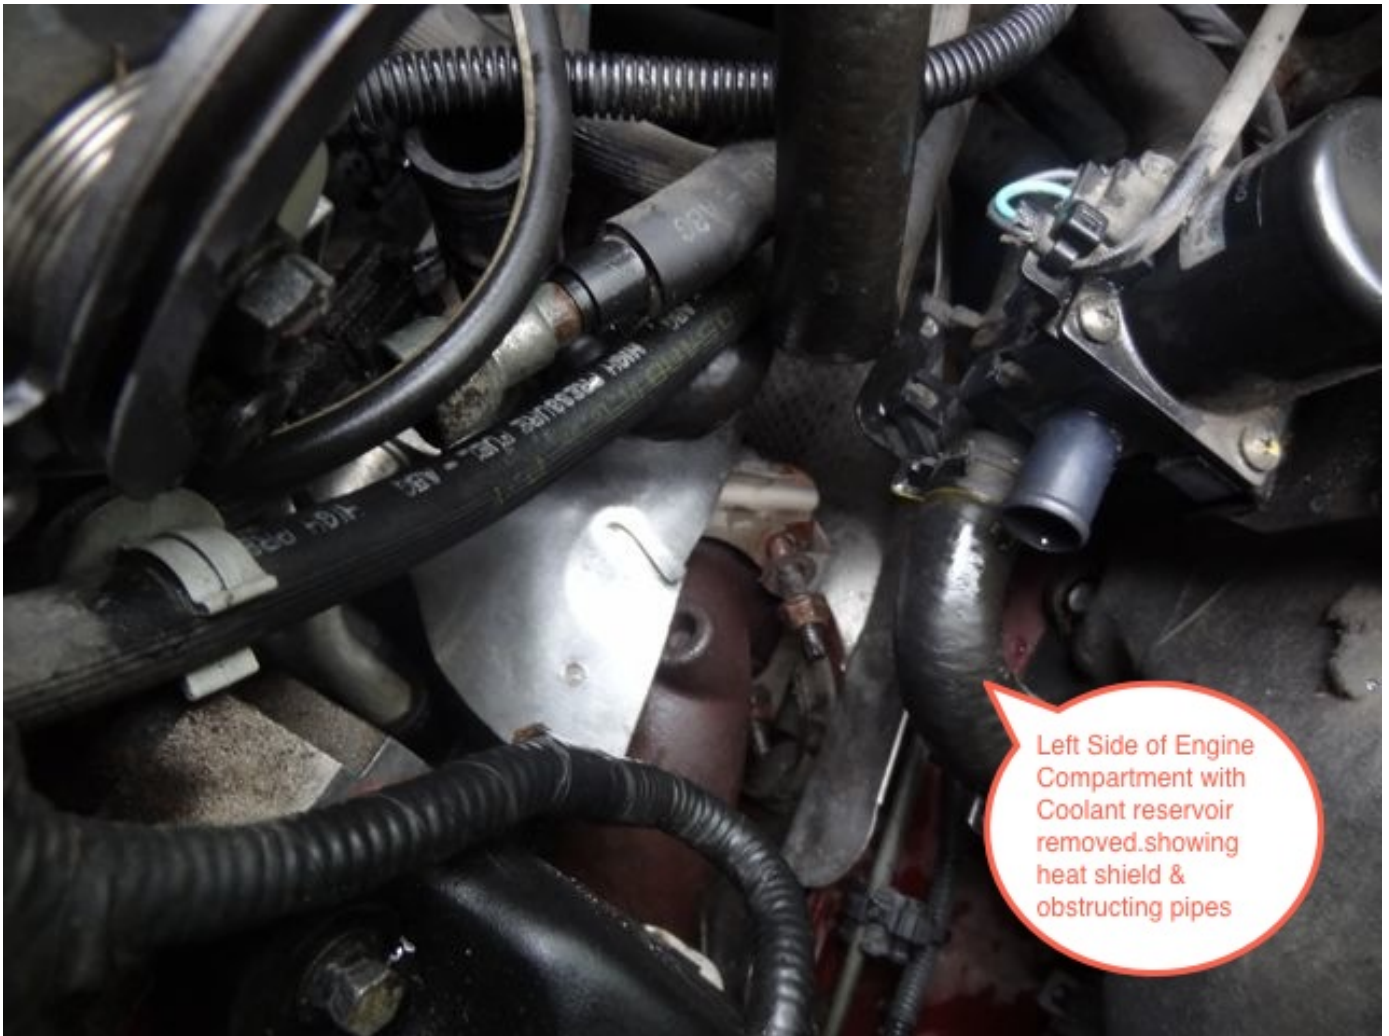
Access to the left side exhaust studs and bolts on the top of the transmission bell housing requires removal

of the coolant storage tank and draining of approximately 2 litres of coolant. Removal of the exhaust was the most awkward process of all as access on the left side of the engine compartment is tight and it is difficult to get a wrench on several bolts. I removed the exhaust as a unit from the manifold/catalytic converters to the rear mufflers. To free the left side exhaust pipe required the use of a rubber mallet as it was very tight and I wasn't able to open the sleeve until after the pipe was removed. There are 2 heat shields on the left side on top of the catalytic converter. The Jag manual is silent on them so take notes and pictures before removing them, as re-installing them from memory was a puzzle that challenged my spatial

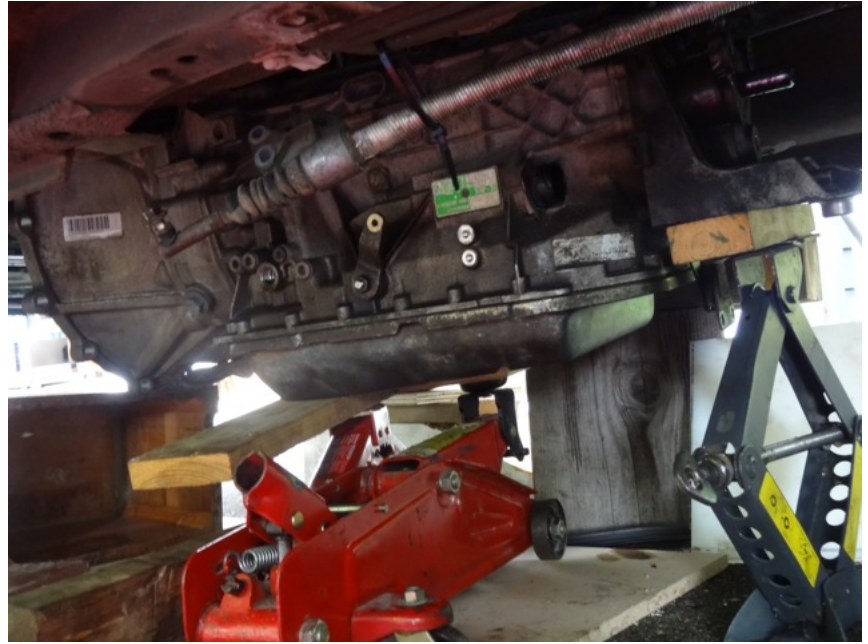
For transmission removal, I used a combination of rolling, bottle and scissor jacks with a combination of wood blocks made up from 2x6's and plywood to support the transmission as it was unbolted and lowered onto a piece of plywood used as a skid plate. This was definitely a place where 2 persons would be an advantage, but I was able to do the job on my own OK. When the transmission is removed, the engine assumed a nose down attitude with the rear about 3" higher than when the transmission is mated to it. The manual shows a brace being used to keep the engine in position. I didn't use it, but left the engine in the nose down position until re-installation, then used a jack located under the front of the oil pan to raise the engine to the correct attitude to accept the transmission.

For installation, which was a more finicky job due to the need to mate the transmission and engine while the transmission was raised on the jacks, I modified the process, using a home built rolling platform that 2 jacks sat on. In turn, the jacks bore against a plywood support sized to the transmission that made the job of lifting the transmission into place much easier. The balance point on the transmission is just in front of the pan & I found that fixing a pillow block made of a piece of 2x6 screwed to the plywood worked well to support the bell housing with the balance of the transmissions weight being carried on the pan. Installation was also simplified by making 2 guide pins about 4" long from M8 rod which I threaded and screwed into bolt locations, one on each side of the engine housing. These guides made it much easier to locate, then slide the transmission home so that it could be bolted up. While there are locator dowels on each side of the Bell housing, they are short so were of little use in guiding the assembly in place and too short to take any load without other bolts being partly threaded to hold the transmission in place.

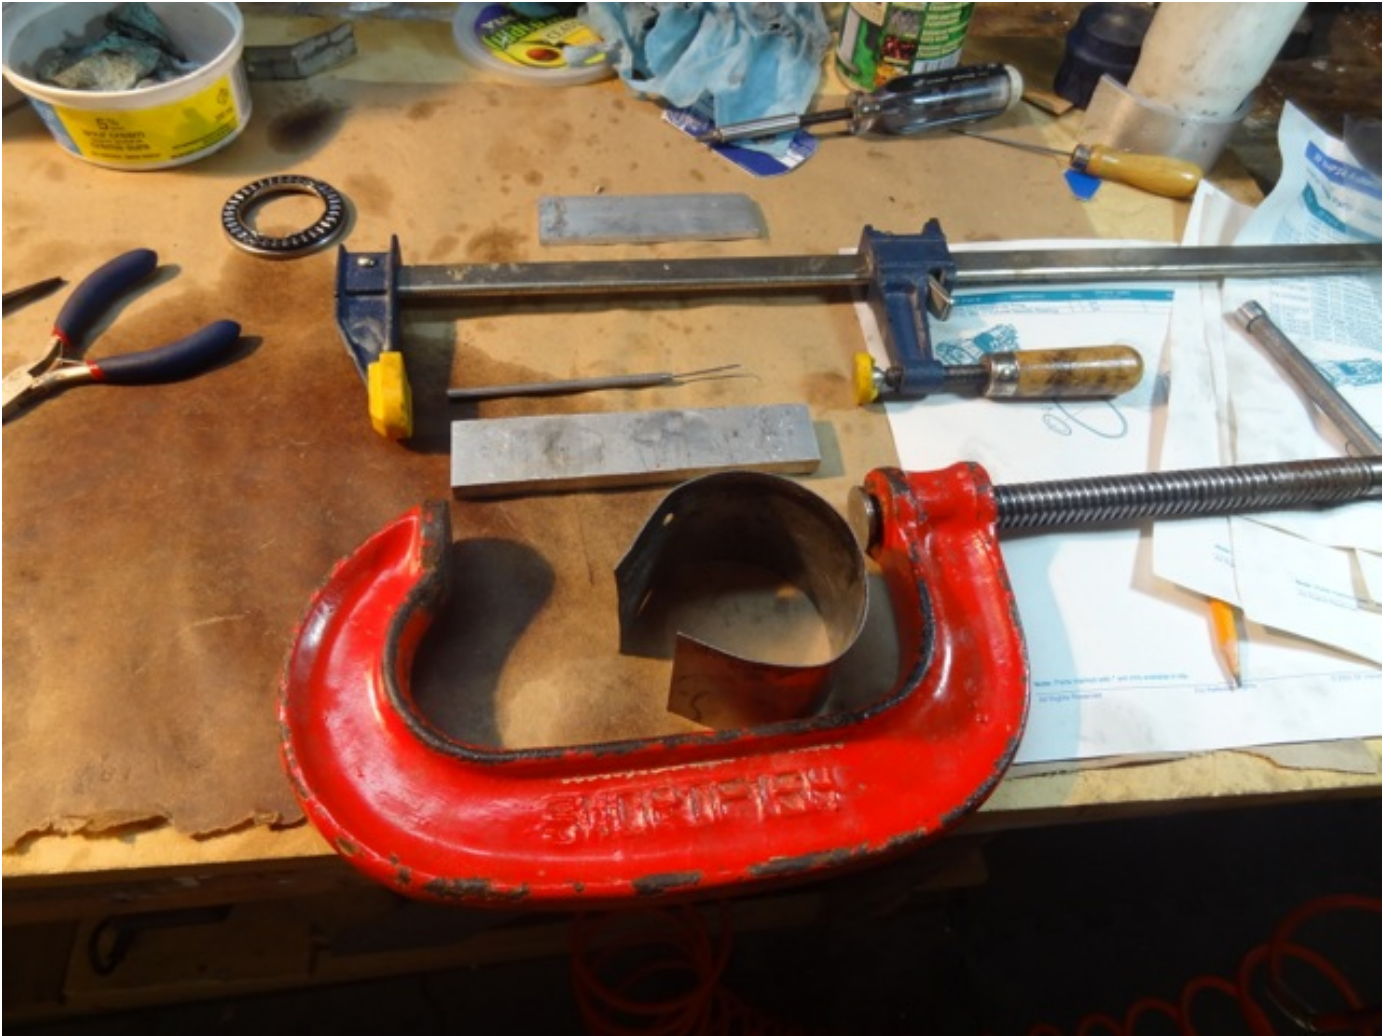
To rebuild the clutch packs, I built a kluge spring compressor using a 10" C Clamp and a 4"x8" wide strip of 1/16 aluminum which I rolled to the correct size for each drum. For larger assemblies where the C Clamp was too small, I substituted a pair of 24" woodworking screw clamps. The picture below shows all the components used.
