Notes from Transmission Rebuild on a '98 Vanden Plas. with a ZF-5HP24-015

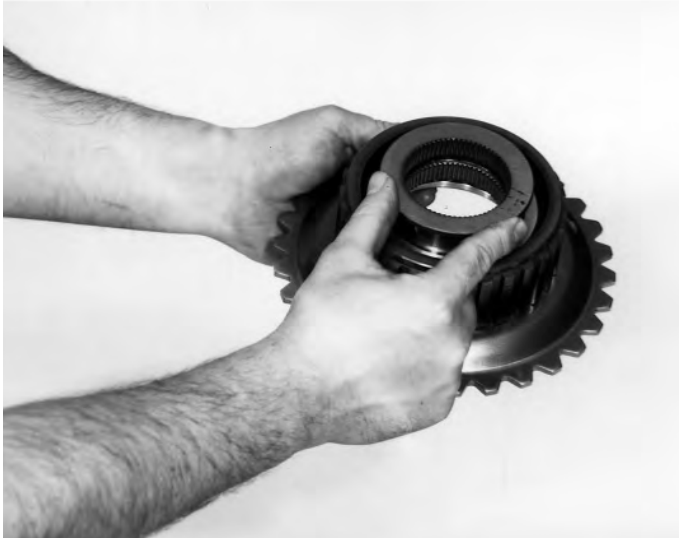
2. There is a 1-way bearing in the F Drum. Instructions are clear that it should only rotate clockwise once installed. However, I made the mistake of assuming this referred to the outer ring rather than to the bearing itself. This resulted in me assembling it backwards, requiring my 2nd removal and re-installation. All told a 3-day mistake for a 5 second lack of attention that a closer examination of the associated picture in the manual (below) would have clarified.

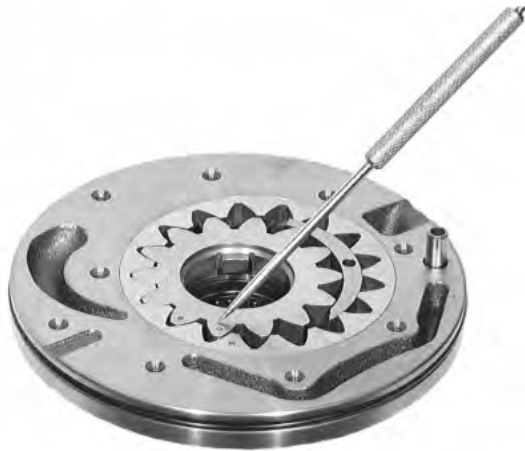
3. The instructions for re-assembly of the ring gear in the oil supply are to “*put the pump together in such a way that one marking can be seen on the pump ring gear and two can be seen on the pump gear*”. However, I could only find 1 marking on each. I was lucky to have a photo of the assembly taken before cleaning so I was able to put the ring gear back in the same orientation as the photo. I was unable to determine why this was important, as I could see no difference in any part of the ring gear.

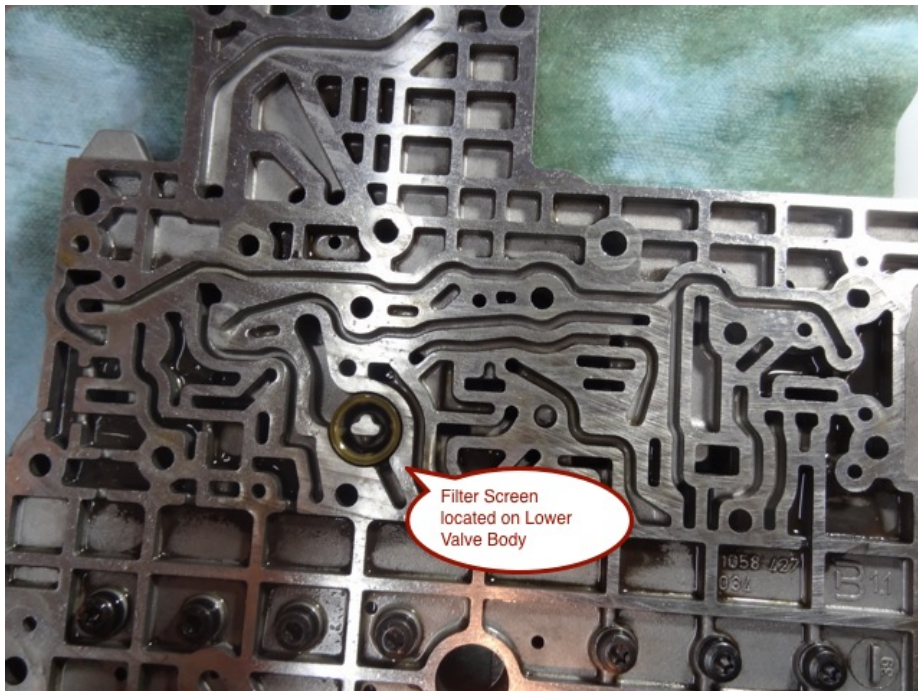
Other than finding some small shavings in the filter screen on the lower valve body, I found no material blocking any of the orifices or regulators. There are also filter screens on each solenoid, but I found nothing trapped on any of them. However, the valve body still contained a large amount of fluid post removal and while it was cleaner than the material drained from the transmission, it was clear there were fine particles in suspension in it as well, so I think it possible that had I not cleaned it the screens may have blocked or particles may have

entered the bores of the valves causing scoring or worse.
