Jaguar V8 Engines 1997-2000 Preventive Tensioner Replacement

In their Technical Service Bulletin No. X303-68 of February 2005, titled "Rattle From Engine on Start-up and Idle," Jaguar states:

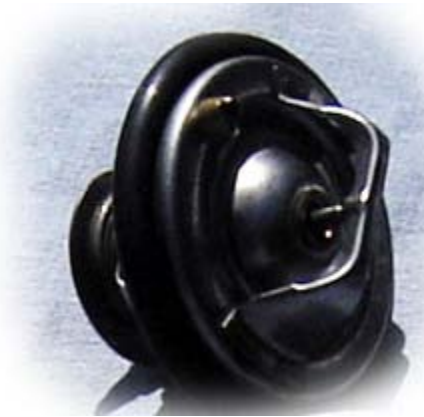
Could you experience the problem with the new tensioners after replacement is carried out? Jaguar's third-generation replacement tensioners are far more robust in design (see photos at left) and, though it is too soon to ascertain their longevity with complete certainty, we are confident that they will provide a "one-time" solution to the problem.

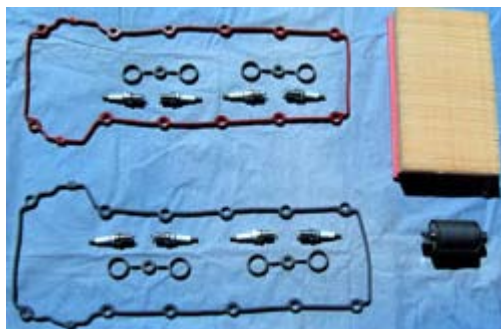
Another preventive maintenance item to consider: replacement spark plugs and/or ignition coils. The original units often deteriorate well before the manufacturer's 100K mile recommended replacement interval, and cause rough running and poor starting.
