© D. Jensen 2006	REPLACEMENT OF XK8 CONVERTIBLE REAR WINDOW REGULATOR	V. 1.0 September 2006
Distribution: www.jag-lovers.com

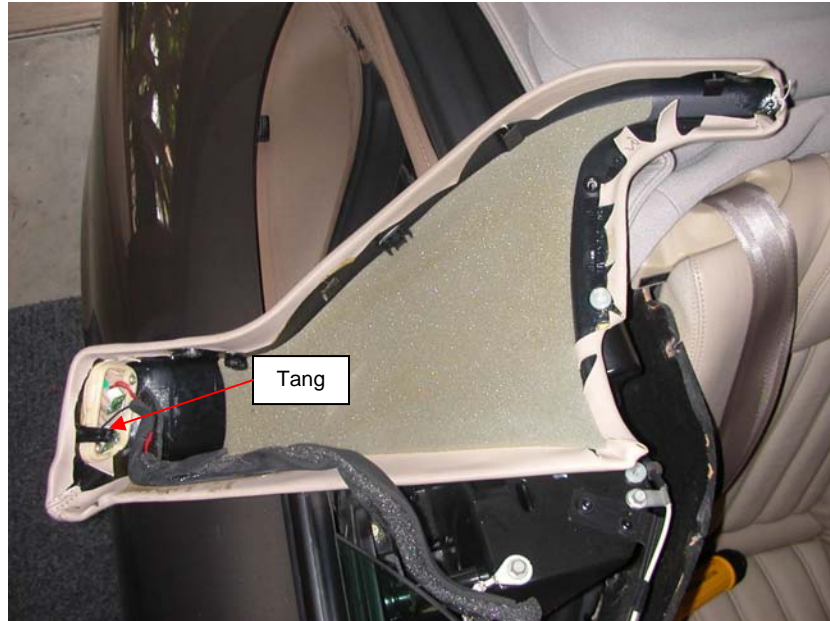
Fig. 4 Underside of rear quarter capping showing tang

2. Remove (a) the screw covered by the seat belt bracket, (b) the screw on the rear of capping, and (c) the 9-mm tonneau-cover fastener. Lift the capping off and disconnect the lead to the airbag passenger sensor, if your car has one. Note that there was a tang on my capping that keeps its front edge in place (see Fig. 4). I didn't realize this when I removed the capping, but fortunately I didn't break it off during removal. It was a bit tricky to reinstall the capping later due to the need to ensure the tang was positioned in its hole in the B post. Earlier XK8s have a screw where the passenger position sensor is located and thus may not have the tang.

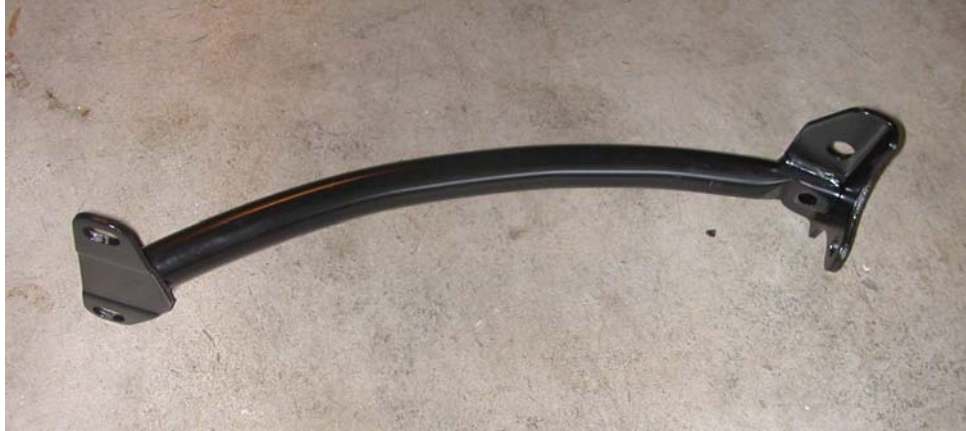
Fig. 10 Stiffening brace

6. Remove the four 13-mm bolts holding the stiffening brace (not introduced until the 1999 model year and not discussed in the instructions, but mentioned in "You & Your XK8" by Nigel Thorley, Haynes Publishing, 2006) in place (see Fig. 10). Note that the longer, anodized bolt threads into the hole that runs parallel to the squab back (not shown).

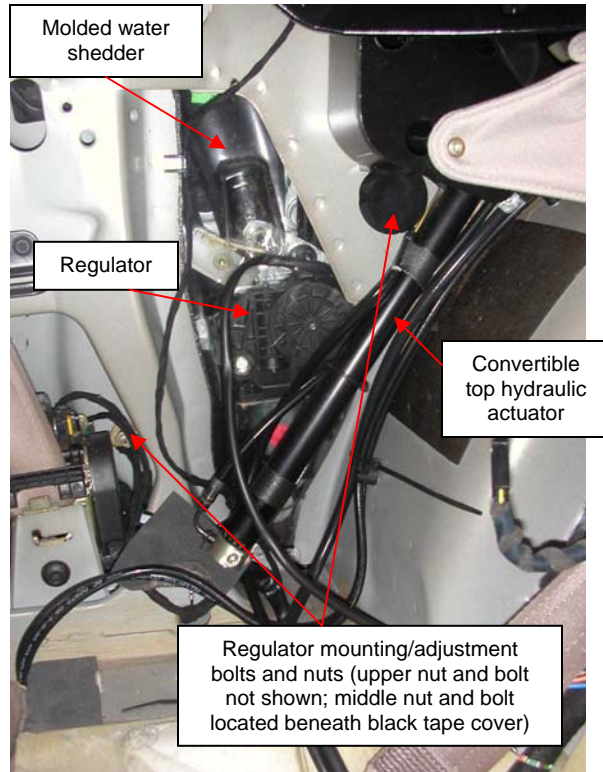
Fig. 12 Regulator as mounted

8. Note the location of (a) the window regulator, visible through the opening in the body and the clear, molded-plastic water shedder (see Fig. 12), and (b) the three adjusters/nuts. The lower nut/washer is held in place by silicone seal to ease installation (a big help). Remove the black, circular tape cover to gain access to the middle adjuster/nut. The top adjuster/nut is accessible as is. Note that the convertible top hydraulic actuator sits on a boss (not visible in photo) at about the midpoint of the actuator. It is not held in place by a fastener. Be sure to reposition it on the boss during reassembly.

14. Remove the upper and middle nuts holding the regulator in place and undo the lower nut (it will remain in place because the attached washer is held to the body by silicone sealer) (Sec. 86.25.11, Steps 12 and 13) (see Fig. 12 above). Route the feed link and multiplug connector through the water shedder. Once loose, push the regulator outward to free the adjustment bolts from their holes. As I inferred from the Jag instructions re removal of the top, I could not remove the window/regulator due to interference between the regulator motor and the convertible top bracket (see Fig. 19).
