SERVICE ACTION

Service Action Number: K117

Panoramic Roof Creak

Publication No.:	501-K117v3
Model:	XJ
Model Year:	2010-2012
VIN Dongo.	V00001 to V24464 (SWB)
VIN Range:	V00001 to V24700 (LWB)
Date of Issue:	9 th August 2012
Expiration Date:	28 th February 2014

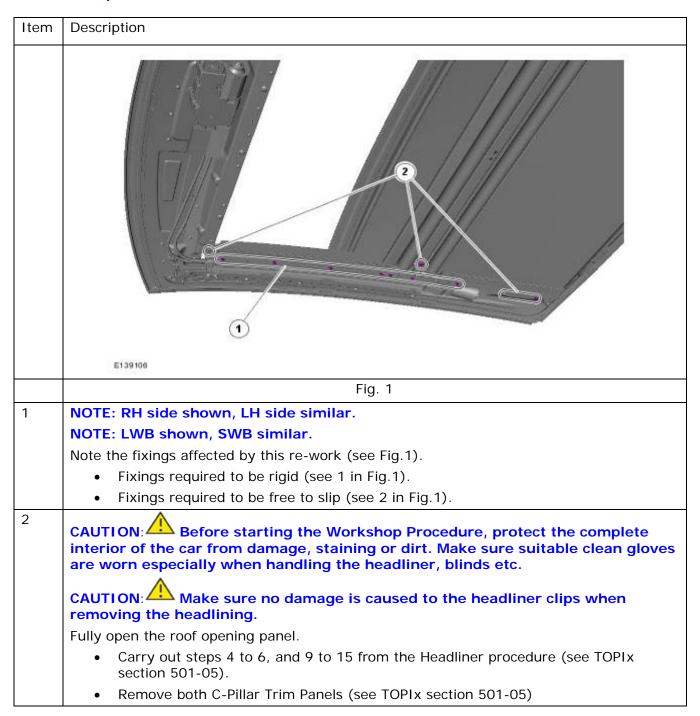
3 CAUTION: 4 Make sure the headlining is fully supported, and that the harnesses are not damaged during re-positioning. With the aid of another technician carry out steps 17 to 20 from the Headliner procedure (see TOPIx section 501-05). Re-position the front seats in to the fully forward position, fully lowered, with the seat back in the fully upright position and the head rests in the fully lowered position. 4 CAUTION: 4 The locating peg component can be released during this procedure, make sure that pressure is applied to the component to prevent this. CAUTION: 4 Note the fitted position of the wind deflector net, spring and locating peg component prior to removal. Release the wind deflector (see Fig. 2). Open the roof opening panel glass to the fully open position. Apply gentle pressure to the locating peg component. Using a suitable tool release the wind deflector arm. Repeat the process to the other side of the vehicle. Fig. 2 5 CAUTION: Make sure that the locating peg component is correctly installed, failure to follow this instruction may result in damage to the vehicle. If required, install the locating peg component (see Fig. 3). Repeat this process to the other side of the vehicle if required. Fig. 3
