Service Action

Code: 91CD

Subject 3G Cellular Network Sunset

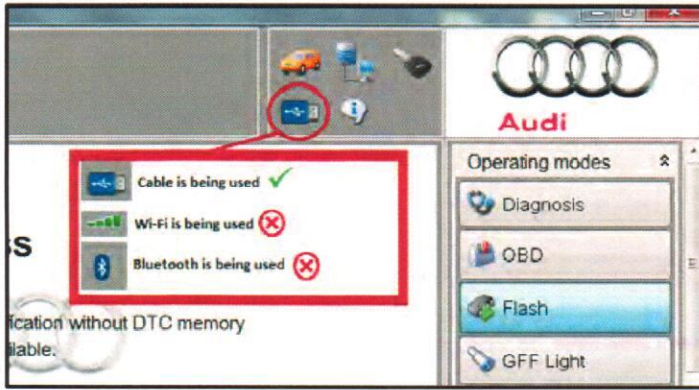
- Confirm that scan tool is communicating with the diagnostic head by USB cable.
 - If the Bluetooth or WiFi symbol is shown, then disconnect the diagnostic head from the vehicle and reconnect the USB cable to the diagnostic head and then reattach to the vehicle.

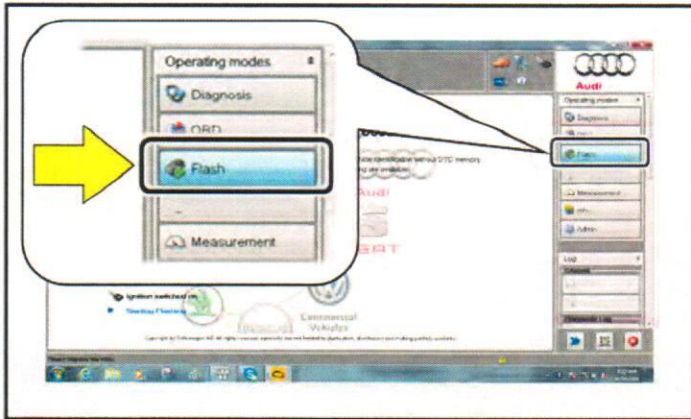
- From the home screen of the scan tool highlight "Flash" <1>.
- Follow the on-screen prompts.

NOTE
 Operating mode "Flash" must be used. Performing this update using "Diagnosis" (Guided Fault Finding) could result in non-payment of the claim.

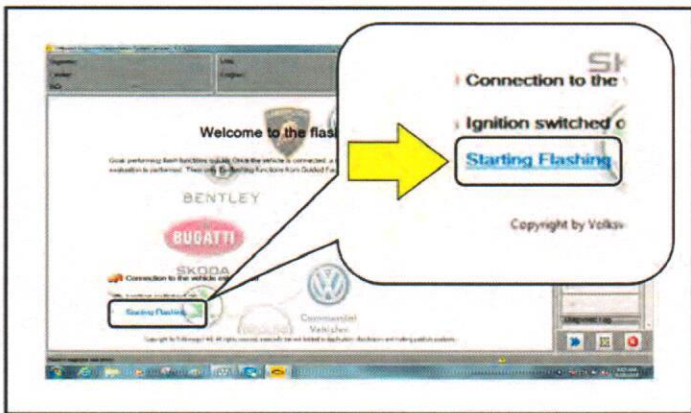
- Select "Starting Flashing" and follow the on-screen prompts.

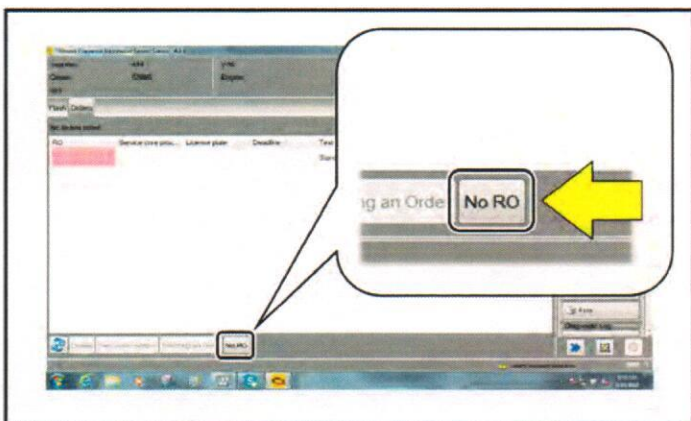
- Select "No RO".

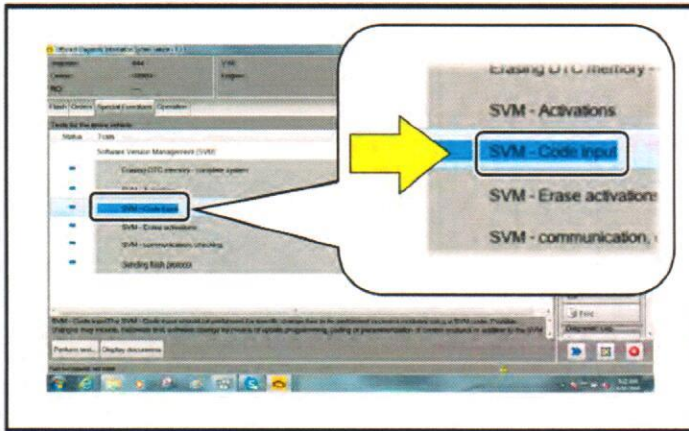
- Highlight “SVM – Code Input”.

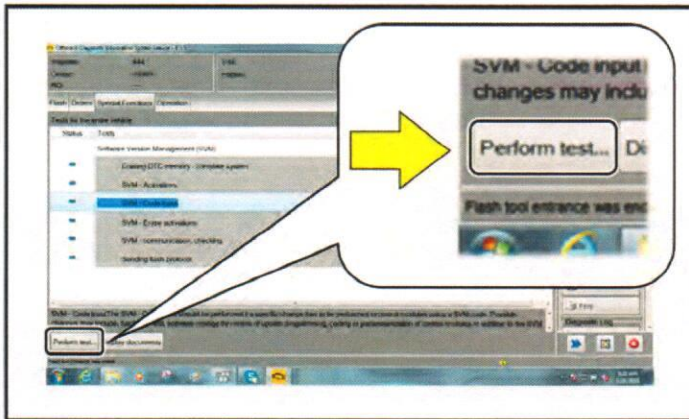
- Select “Perform test”.

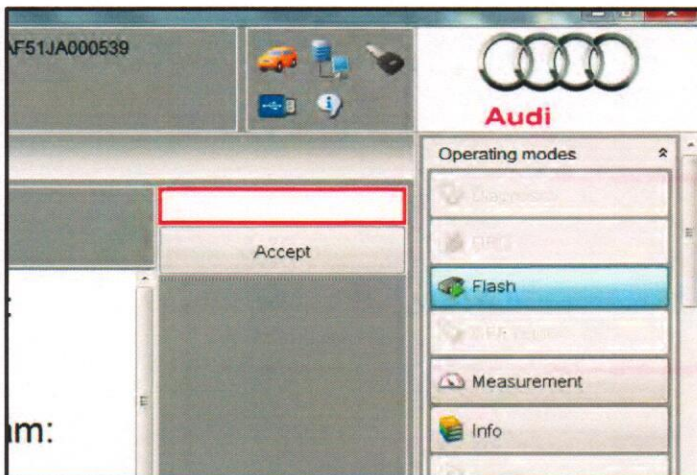
- Enter the corrective action code (SVM code) as listed below.

SVM code
91CDA108

- Select “Accept”.
- Follow the on-screen prompts.

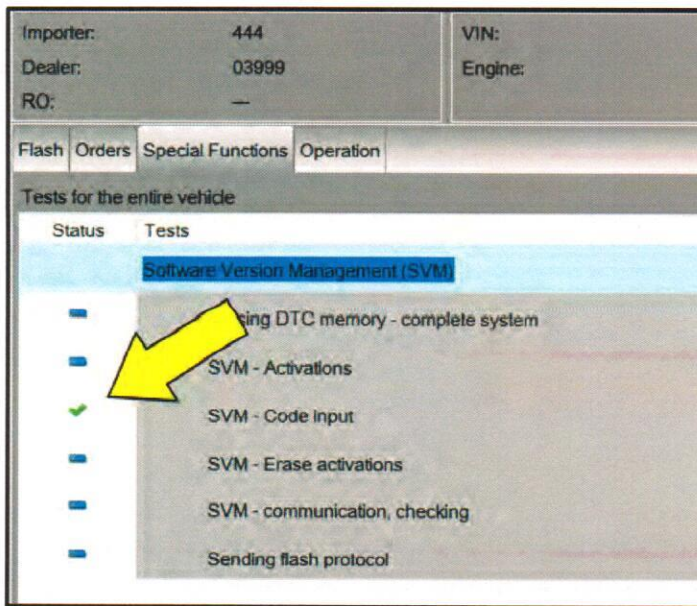
This extra ignition cycle step must be followed, otherwise faults stored during the update may not be cleared upon exiting the Flash program.

- After receiving confirmation that the update completed successfully (green check mark) <arrow>, the ignition must be turned off for 60 seconds and then turned back on.

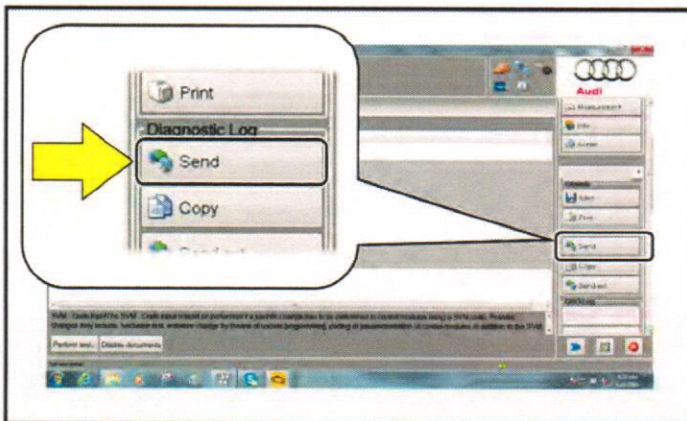
- After receiving confirmation that the flash completed successfully, select “Send” to send the diagnostic protocol online.
- Follow the on-screen prompts.

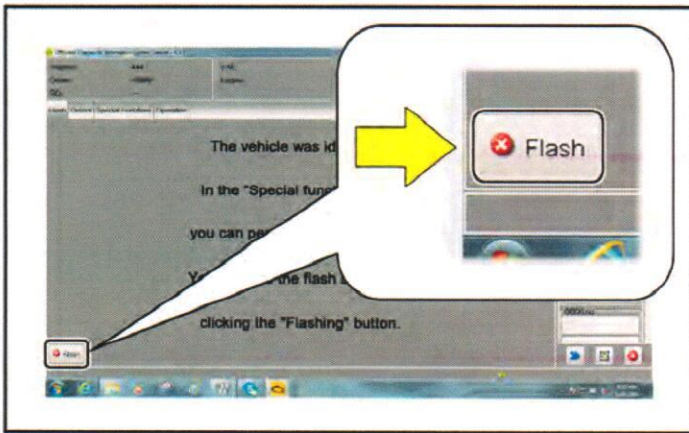
- Click "Flash" to exit the flash session.
- Various event memory entries may be generated after the flashing procedure on some vehicles. Put the vehicle in a corresponding bus sleep mode after performing the update in order to clear the faults.

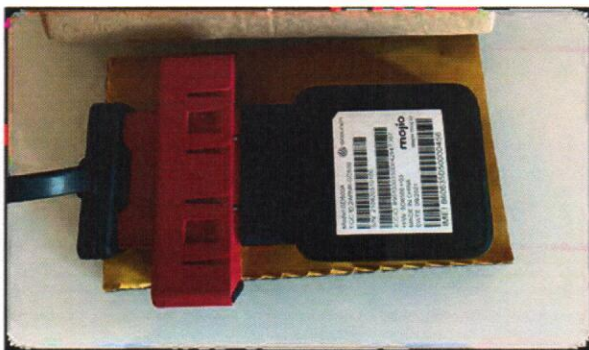
- For the Q7, the insulation material must be placed on the warning label side. The barcode will be exposed.

The barcode on the LTE Retrofit Telematics Device must be point upwards because of the position of GNSS antenna.

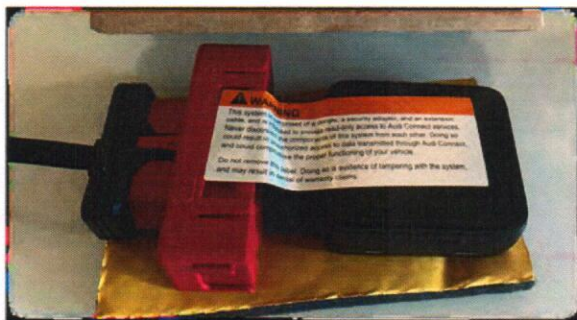
- For the A4 and A5 variants, the insulation material must be placed on the bar code side. The warning label will be exposed.

The warning label on the LTE Retrofit Telematics Device must be point upwards because of the position of GNSS antenna.

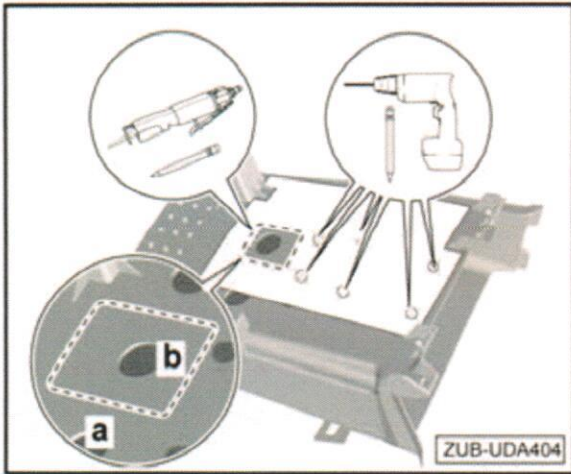
- Cut out the template.
- Position the template for the LTE Retrofit Telematics Device on the storage compartment in the installation position and mark the holes for the cable ties and cable ducts.
- Drill M5 holes for the cable ties.
- Using suitable workshop equipment, drill and deburr the opening -a-b- for the OBDII extension cable.

Drilling pilot holes at the corners of the -a-b- cutout will make cutting easier.

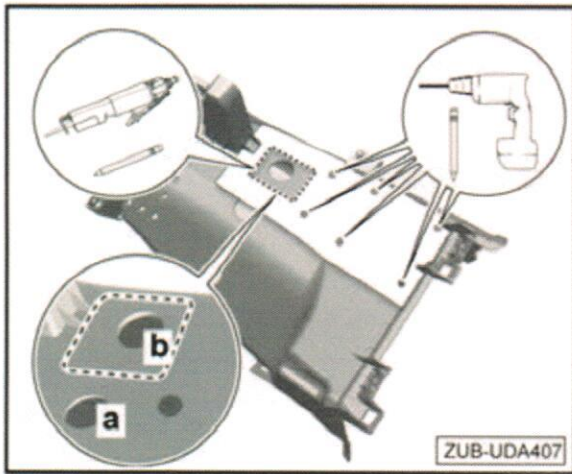
- Cut out the template.
- Position the template for the LTE Retrofit Telematics Device on the storage compartment in the installation position and mark the holes for the cable ties and cable ducts.
- Drill M5 holes for the cable ties.
- Using suitable workshop equipment, drill and deburr the opening -a-b- for the OBDII extension cable.

Drilling pilot holes at the corners of the -a-b- cutout will make cutting easier.

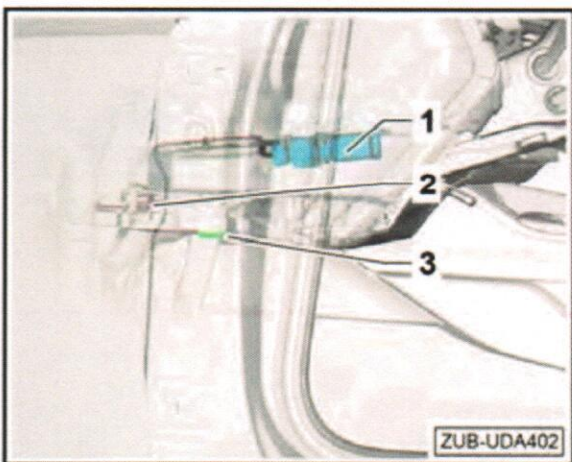
- Install the storage compartment with footwell cover.

- Connect the OBDII extension cable -2- on the vehicle to the OBDII slot -3-.
- Secure the OBDII extension cable -2- in a suitable place using cable ties with adhesive pad -6- to prevent noise from occurring.

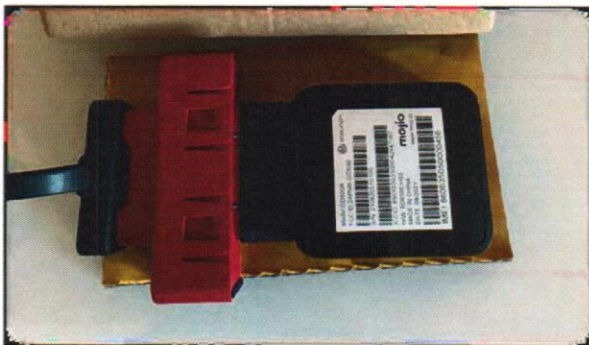
- For the Q5, the insulation material must be placed on the warning label side. The barcode will be exposed.

The barcode on the LTE Retrofit Telematics Device must be point upwards because of the position of GNSS antenna.

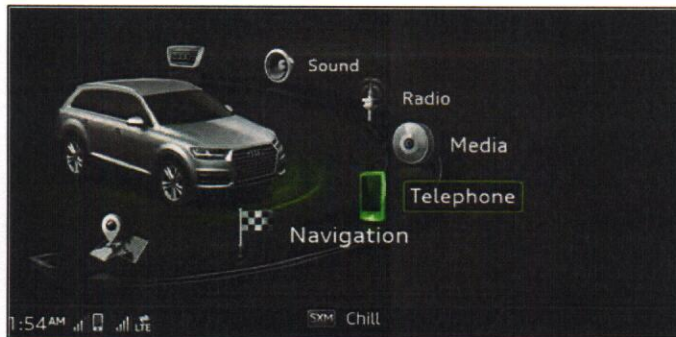
- Select “Telephone”

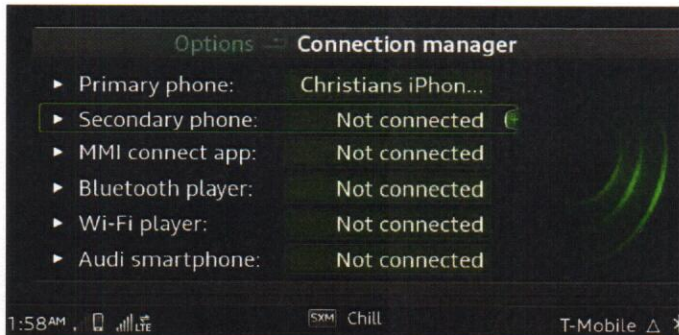
- Select "Secondary phone"

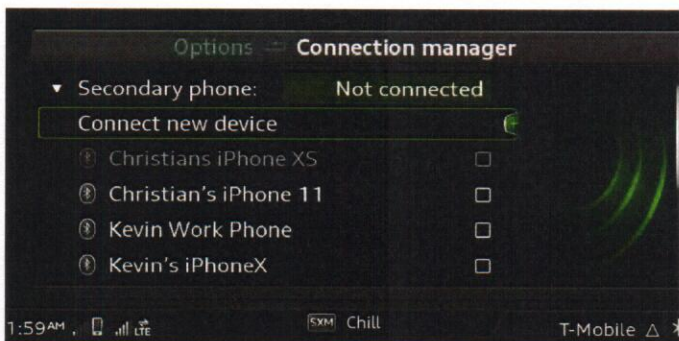
- Select "Connect new device"

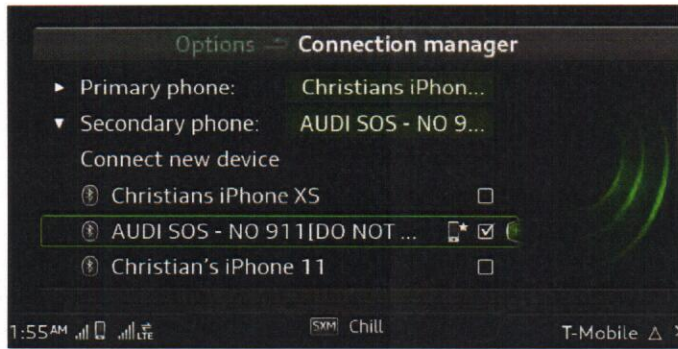
- LTE Retrofit device is now a secondary connected device.

- Ensure “AUDI SOS – NO 911 [DO NOT DELETE]” is selected as the default device.

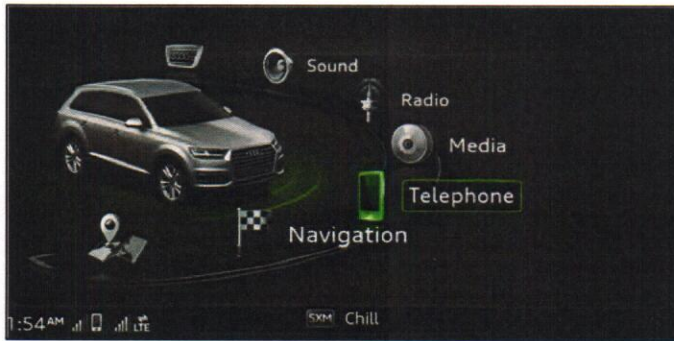
- The vehicle is stationary and the ignition is switched on.
- LTE Retrofit Telematics Device connected to OBD2 and ready for operation.
- The MMI is not connected to any mobile phone.

- Select "Telephone"

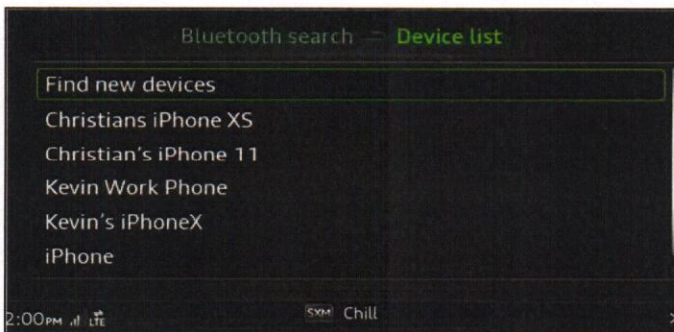
- Select "Find new devices"

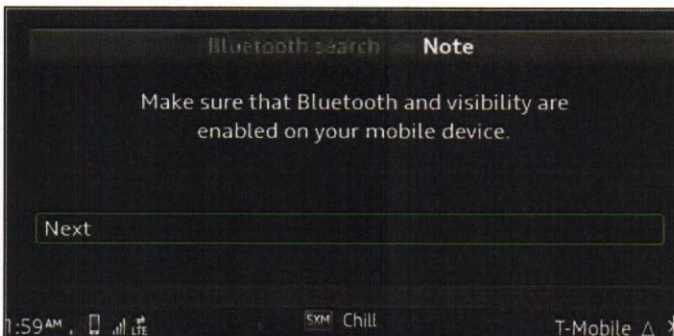
- Select "Next"

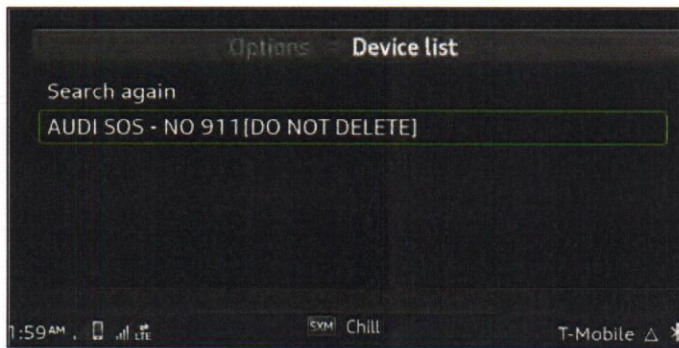
- Select “AUDI SOS – NO 911 [DO NOT DELETE]” from the device list.

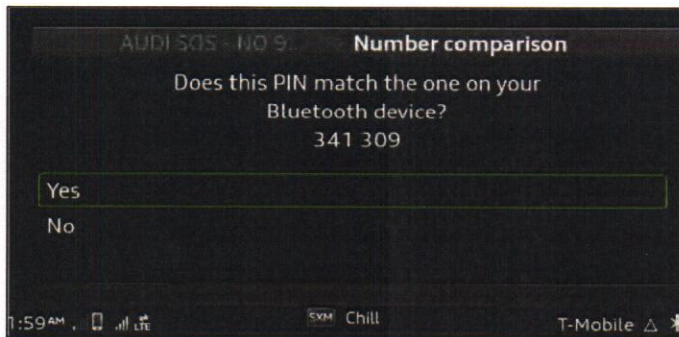
- Confirm the PIN by selecting “Yes”
- *NOTE: there is no need to confirm PIN on telematics device*

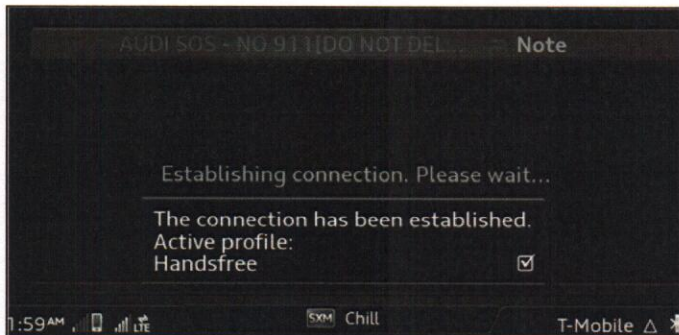
- The Bluetooth connection will be established.

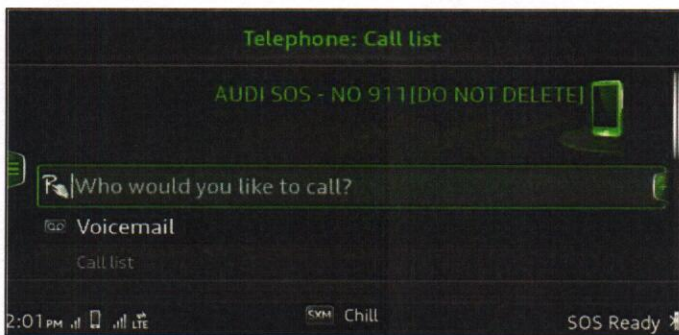
- “AUDI SOS – NO 911 [DO NOT DELETE]” shown as connected device.

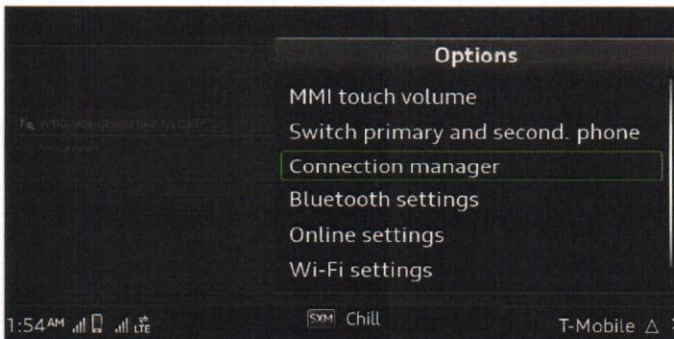
- Select "Connection manager"

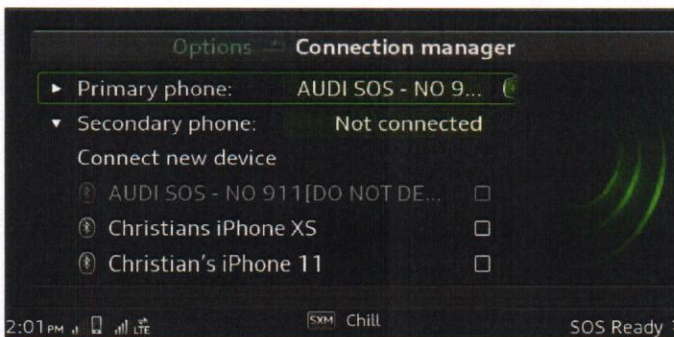
- Select "Primary phone"

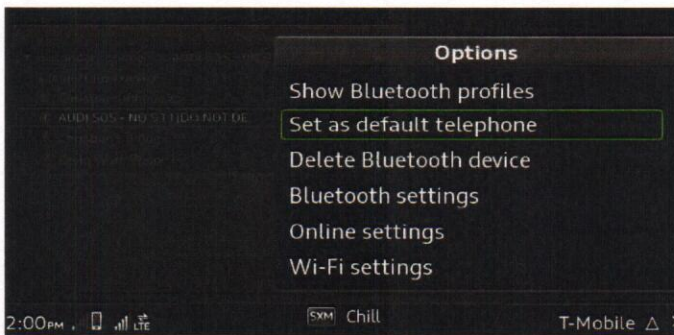
- Select "Set as default telephone"

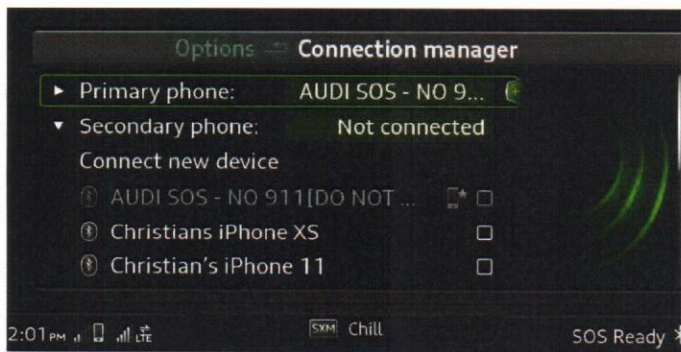
- LTE Retrofit device is now the primary connected device.
