$Heated oxygensens or sare fitted to the downpipe assembly \ (1Fig.1) which is connected to the manifold \ (2Fig.1). There are two sensors for the ROW and Japan \ (3Fig.1) and two additional sensors \ (4Fig.1) for NAS markets.$

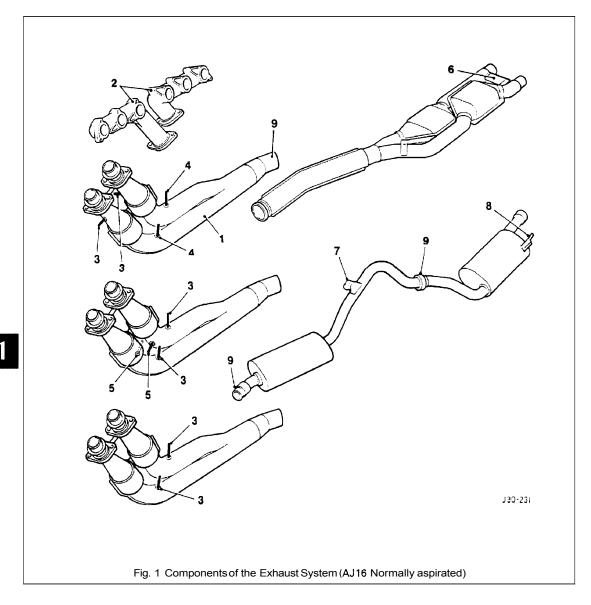
The sensors are located upstream and downstream of catalytic converters.

Apart from two heated oxygen sensors, the exhaust system for vehicles destined for the Japanese market are also fitted with two exhaust gas temperature sensors (5 Fig.1).

The exhaust system is held in a predetermined position by a fixing arrangement to the manifold by exhaust centre mountings (6Fig.1), by rear axis mountings (7Fig.1), and tail pipe mountings (8Fig.1).

Clamps (9Fig.1) used on each slip joint are welded to the pipes and tightened to a higher torque setting than non-welded clamps.
