# TECHNICAL BULLETIN

JTB00432v2

### Vibrations And/Or Rattles When Listening To The Entertainment System

##### **F-TYPE (X152)**

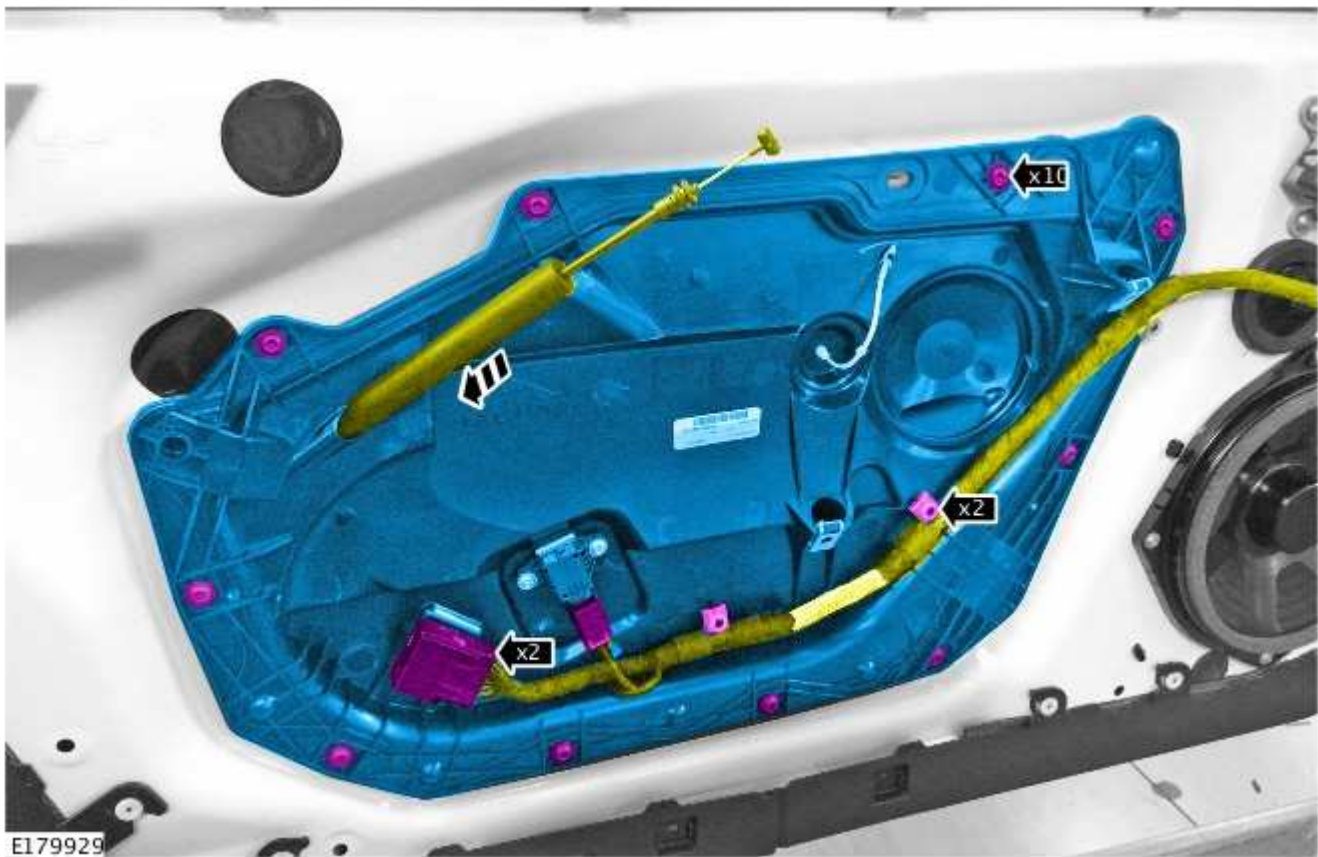
**3** Remove the door panel.

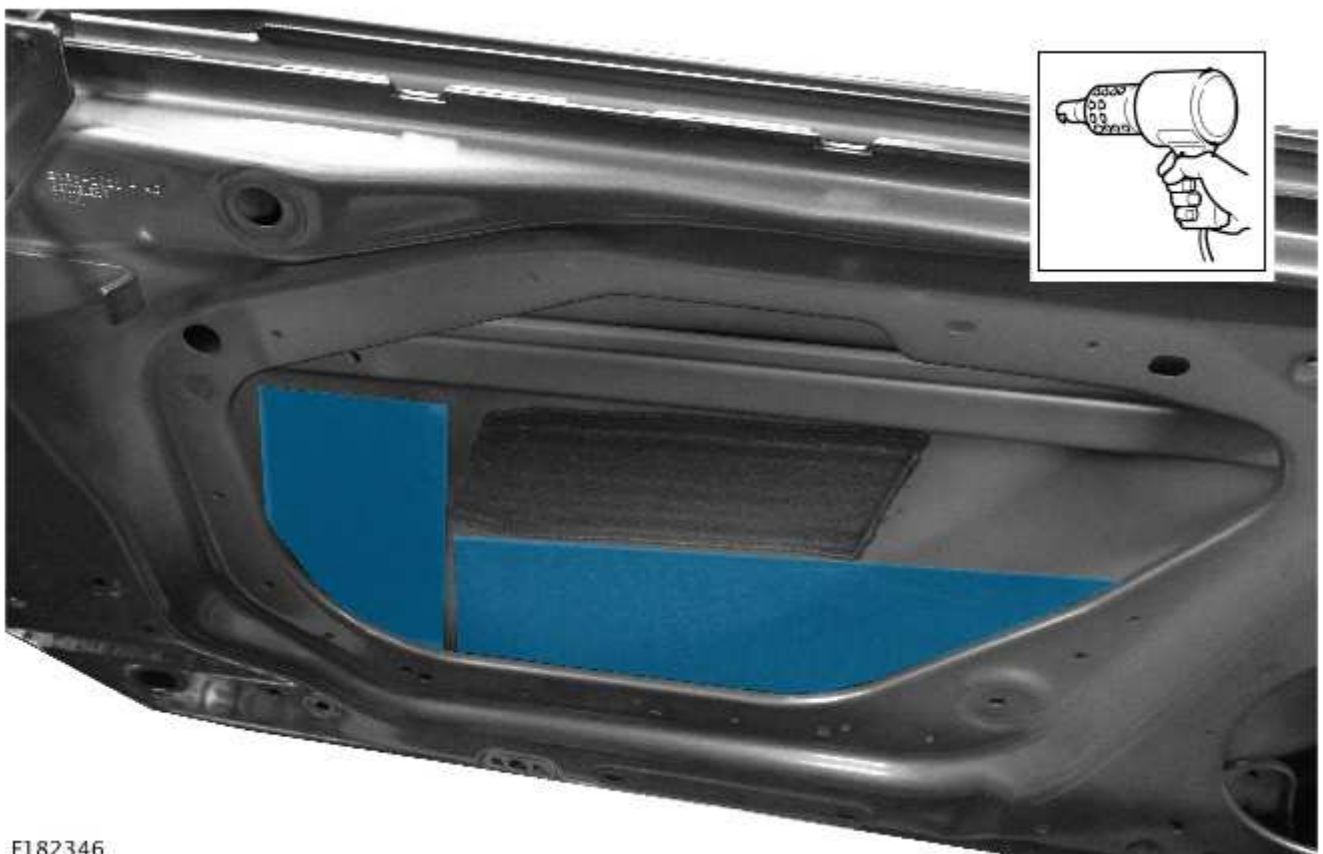
**CAUTION:** The Noise, Vibration and Harshness (NVH) pads must be installed at a temperature of 74 °F to adhere correctly.

Install the NVH pads inside the door as shown.

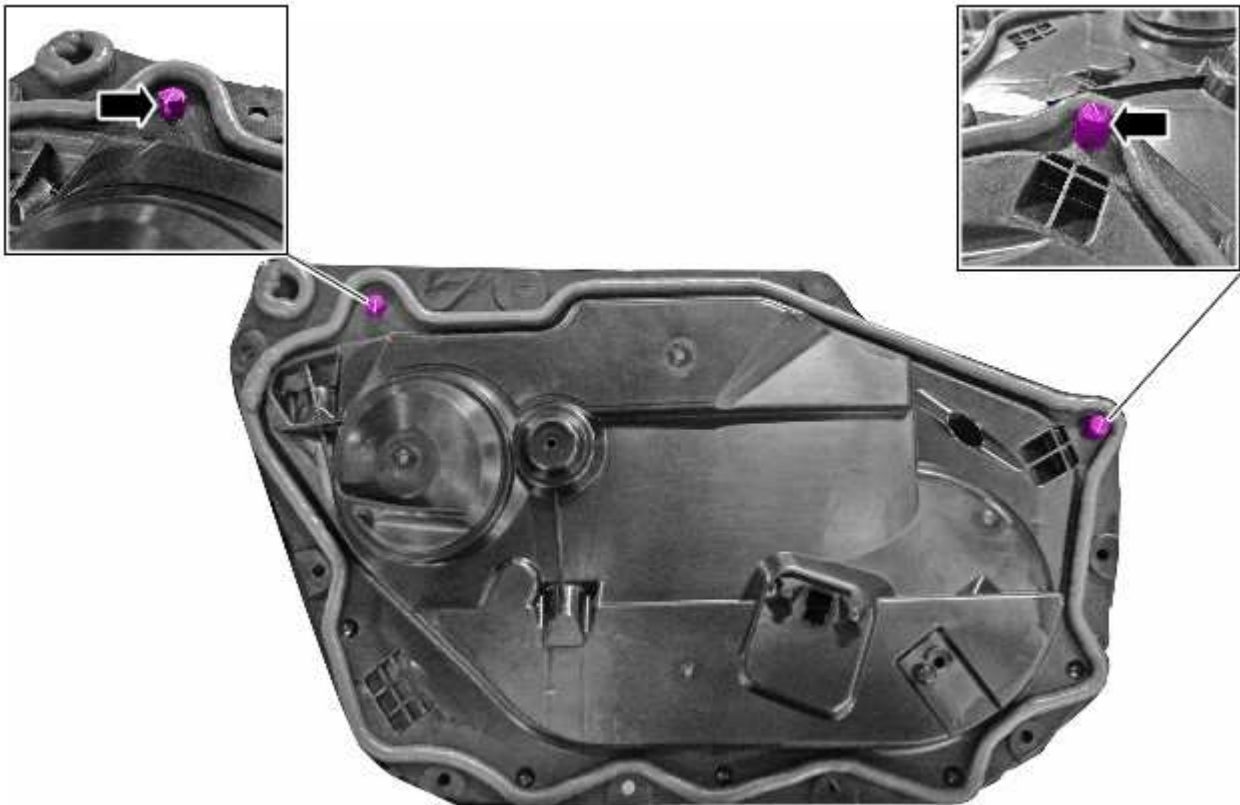
E179789

**17** When installing the door panel make sure that the locating lugs are correctly located into the door.

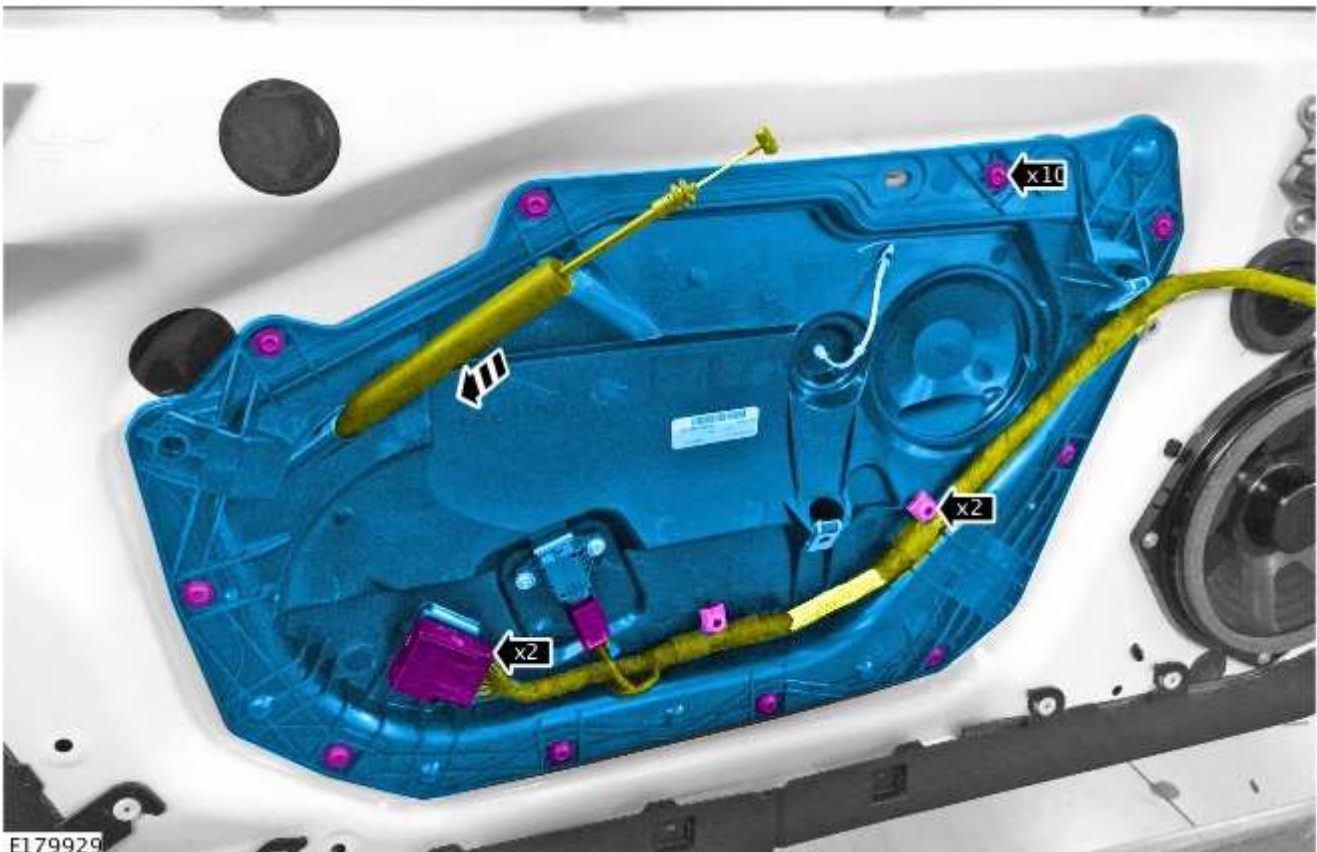
E179929

**NOTE: Do not tighten the retaining screws at this stage.**

Install the door panel.

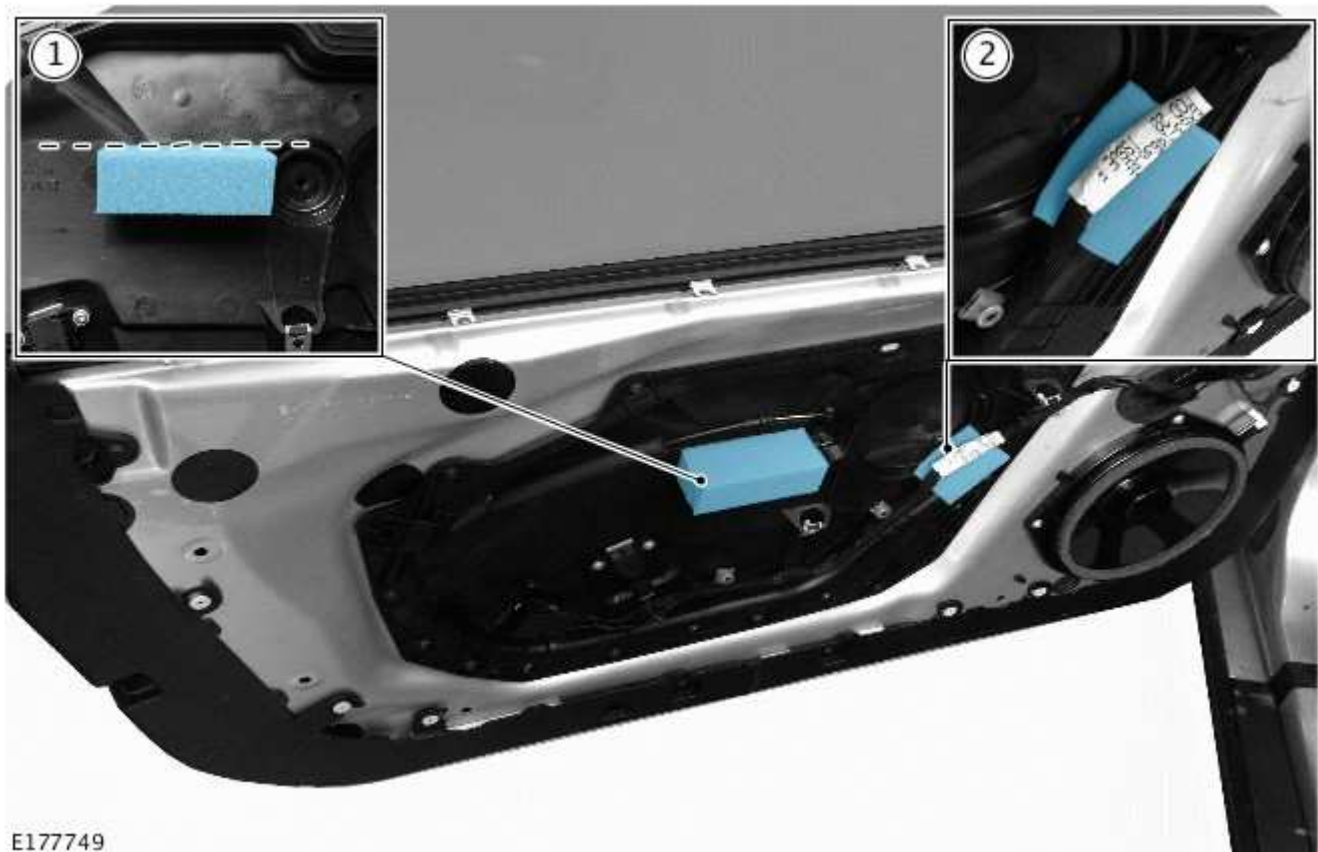
**20** Install the foam noise insulators to the door.

- The foam block should be aligned with the door panel (1).
- The foam pad must be installed behind the label on the door electrical wiring harness, the exact location of the label may vary between vehicles (2).

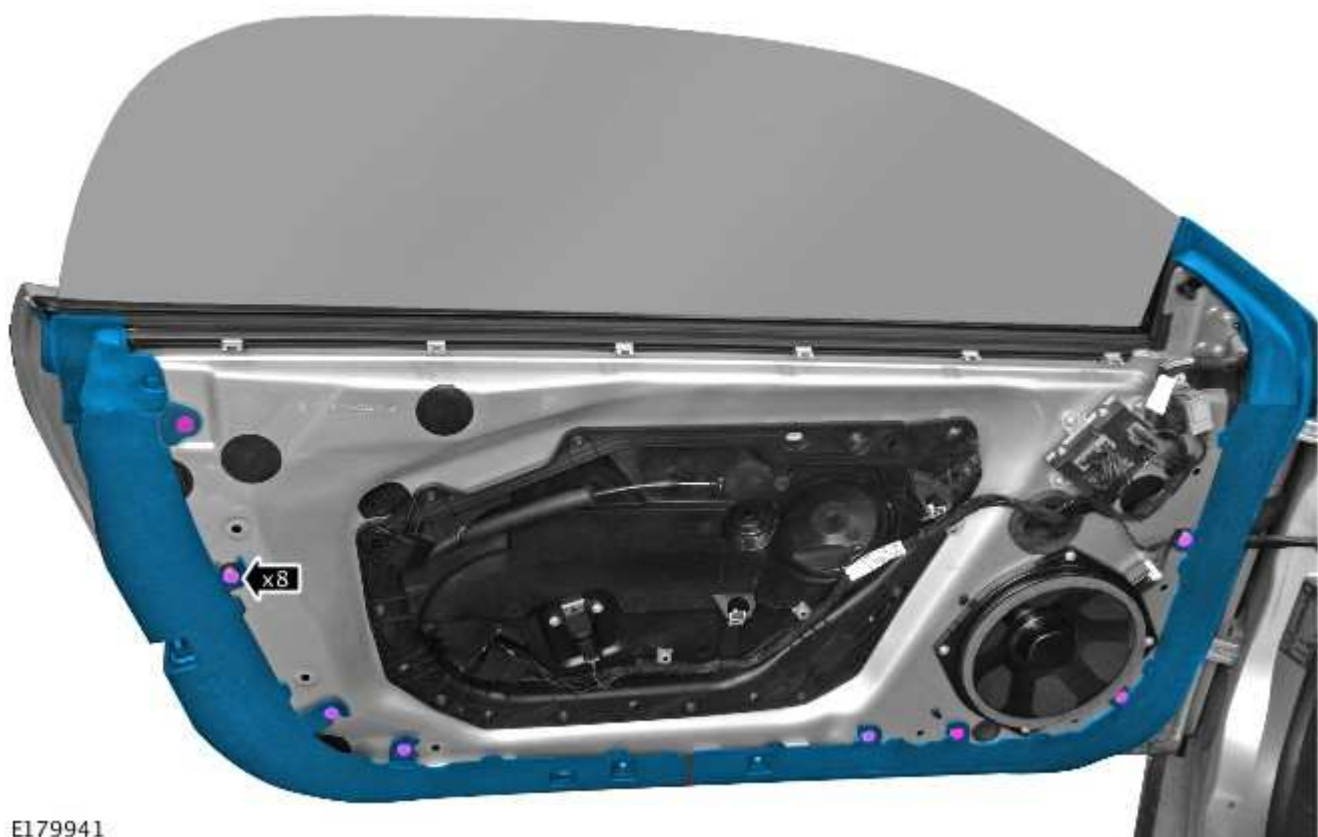
**21** Remove the door trims.

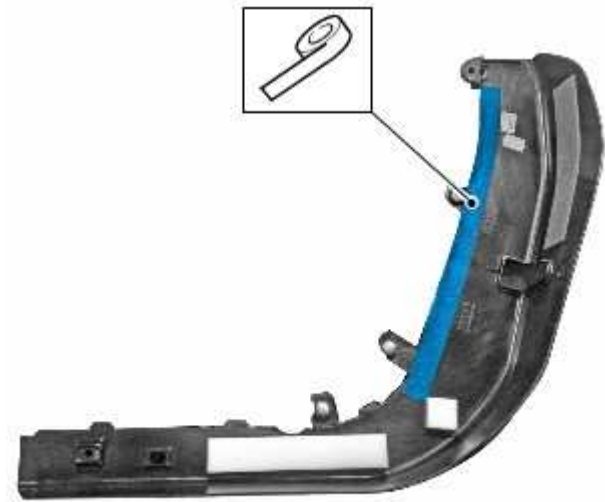
E179792

**22** Install 0.5mm felt insulation tape to the door trim as shown.

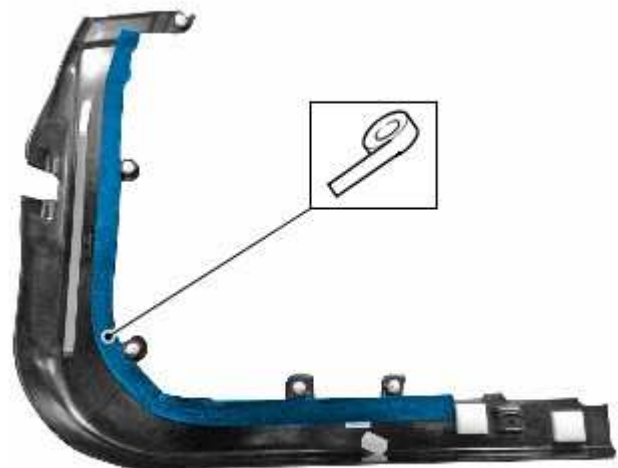
E179793

**23** Install 0.5mm felt insulation tape to the door trim as shown.

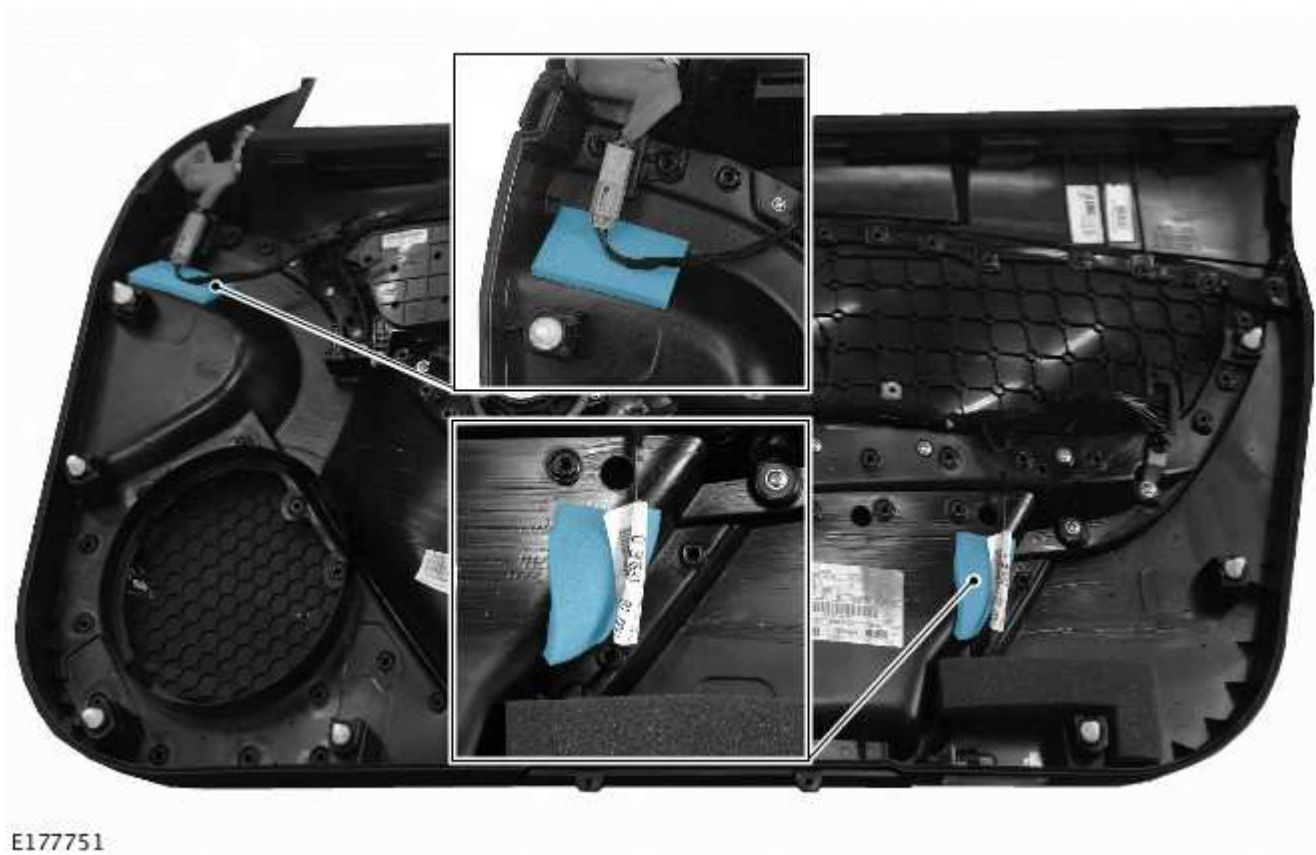
E177751

**24** Install the foam pads behind the door trim panel electrical wiring harness.

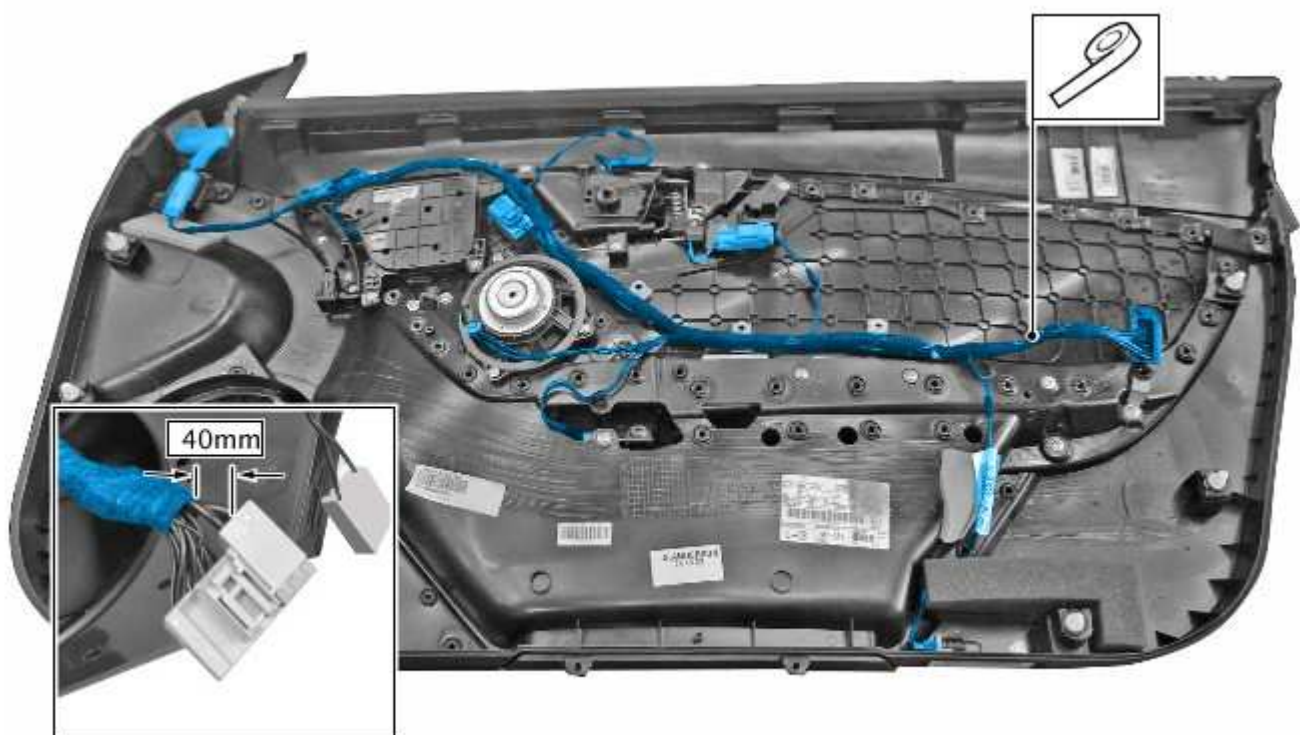
E179794

**CAUTION:** Make sure when installing the felt insulation tape a gap of 40 mm is left at the connector end to allow for electrical wiring harness movement.

Install felt insulation tape to the door trim electrical wiring harness.

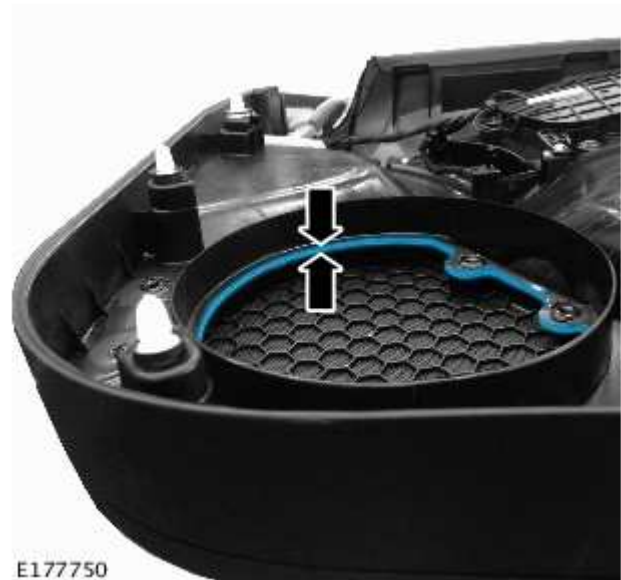
**26**Inspect the speaker grille on the door trim panel.

- Using a suitable feeler gauge check the clearance between the speaker baffle and the door trim panel.
- If a clearance is found proceed to step 24. If no clearance is found proceed to Step 25

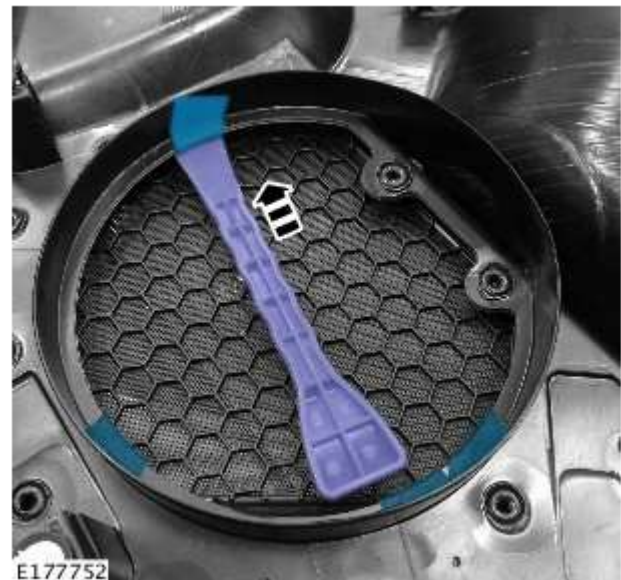
**27**Using a suitable trim tool, install felt tape between the speaker baffle and the door panel trim.

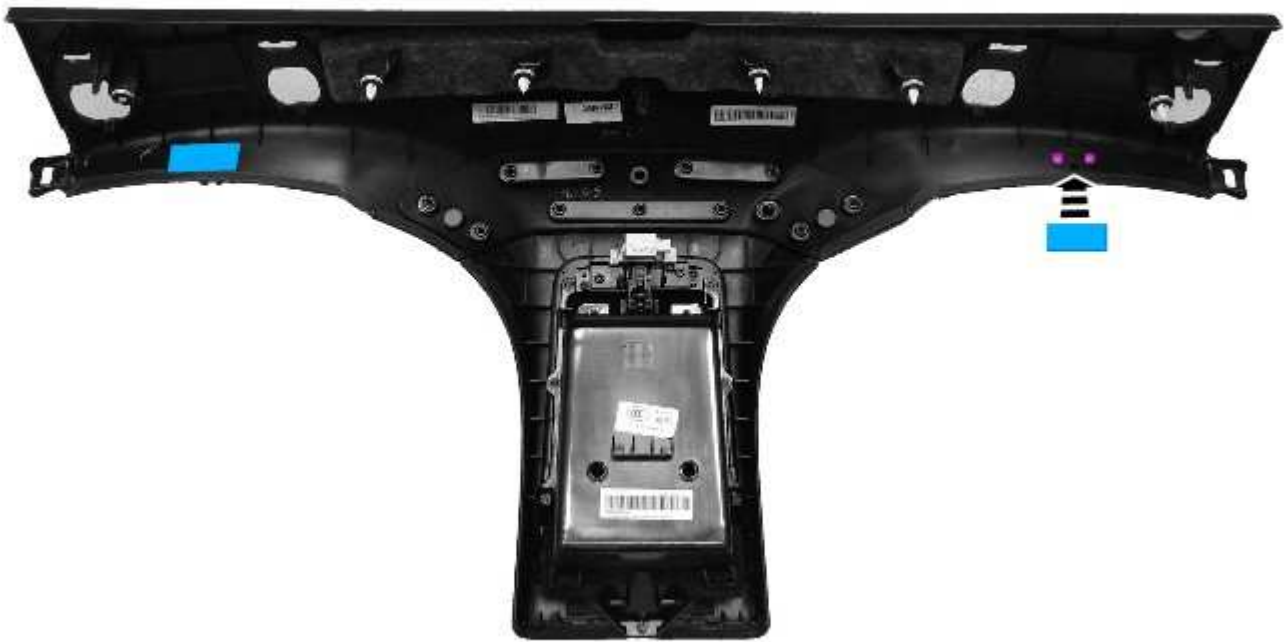
E177756

**NOTE: Folding top shown, Coupe similar.**

When the parcel shelf is removed install foam pads to the contact areas shown.

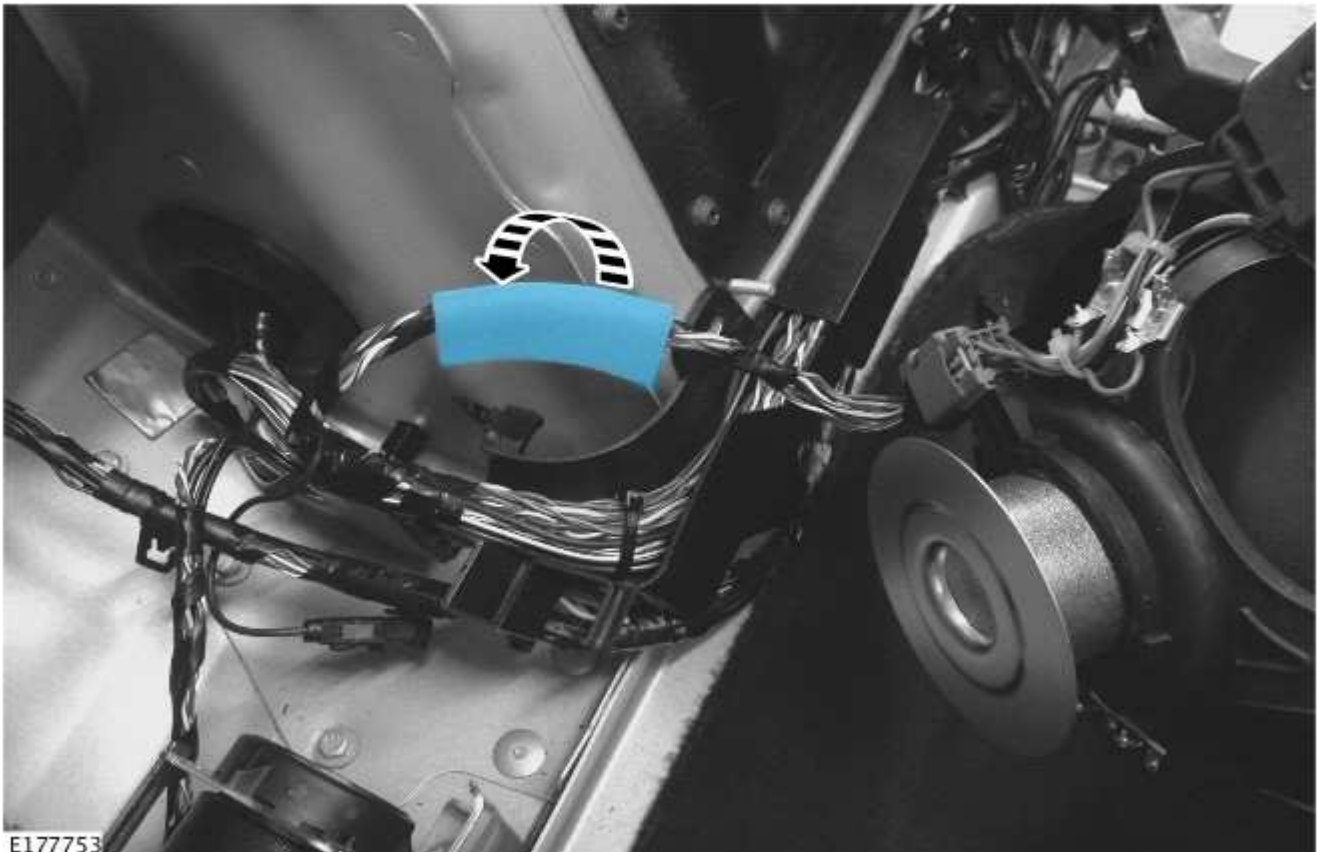
E177753

**NOTE: The exact position and quantity of the foam pad(s) necessary to install will be determined by the routing of the electrical wiring harness.**

Install the foam pad(s) where the electrical wiring harness is in contact with the vehicle body when the subwoofer speaker is installed.

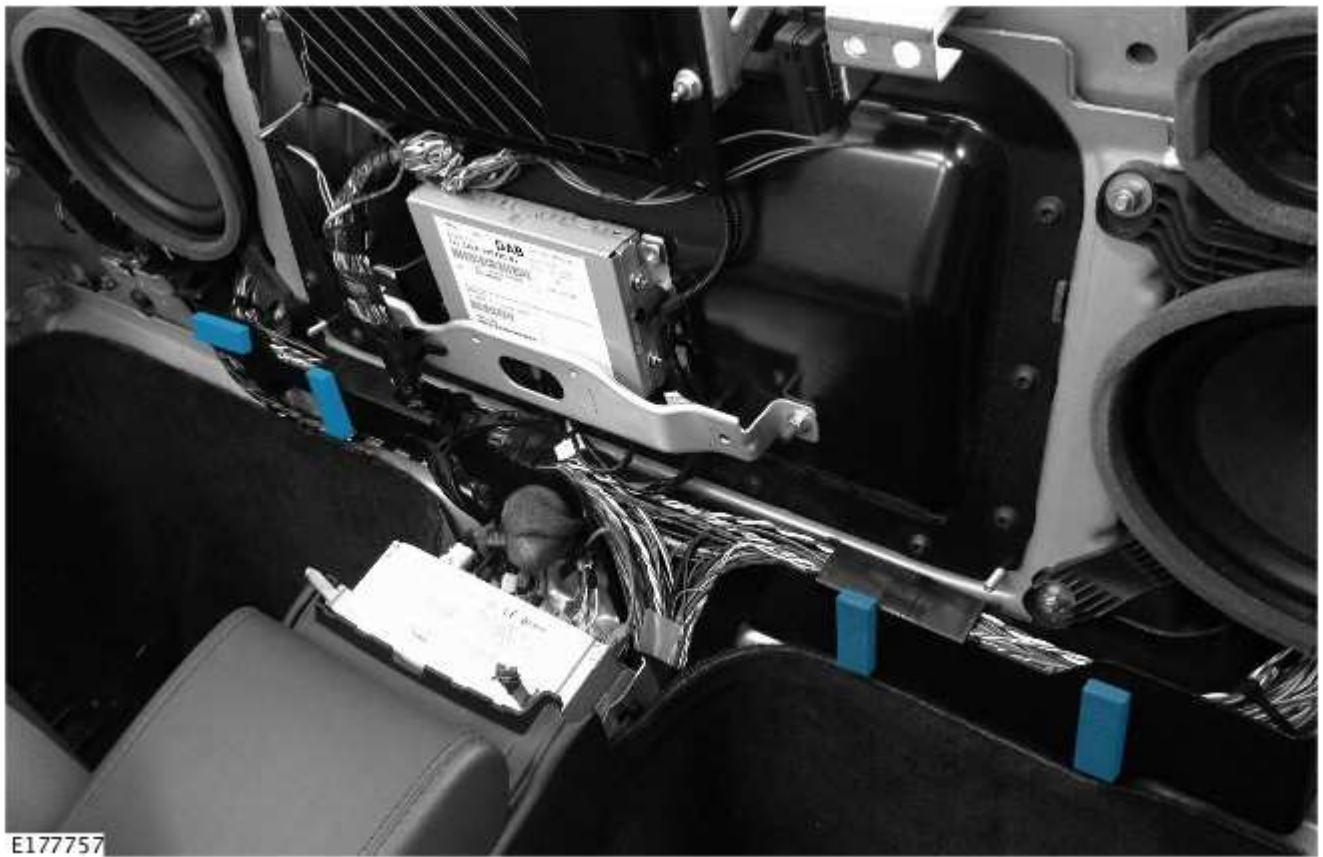
**7** Install the foam pads on the electrical wiring harness conduit.
