| <b>TECHNICAL BULLETIN</b> | | |

| Subject<br>GEAR SELECTOR PARK SOLENOID RELEASE<br>PROCEDURE | Model S-TYPE<br>Year 1999.25<br>VIN L00600 ONWARDS |

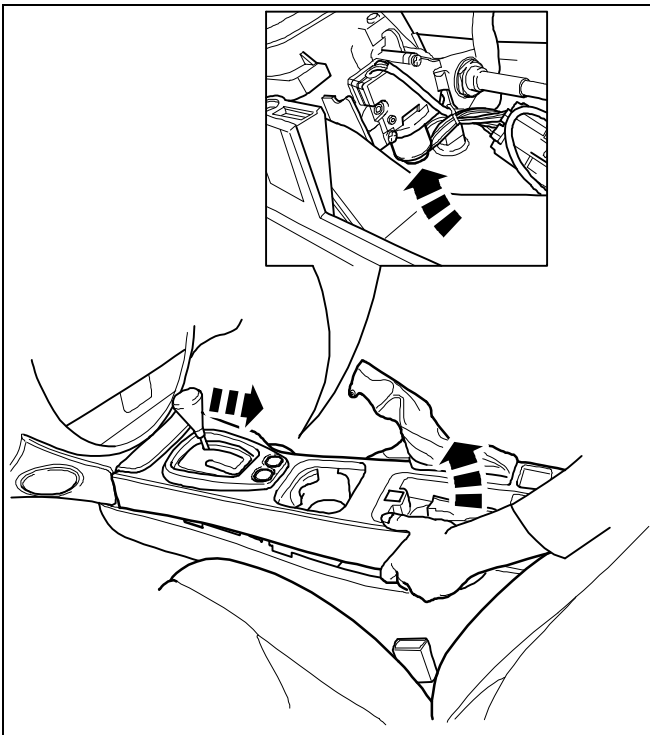
On vehicles equipped with automatic transmission, the situation may arise that the gear selector lever remains locked in the 'P' position, rendering the vehicle immobilised. While a discharged battery might be the primary cause of such a concern, other electrical malfunctions could also result in the same situation.

The following procedure will allow manual release of the interlock mechanism, allowing 'N' to be selected so that the vehicle may be moved or towed.

- 1 Enter left hand side of vehicle.
- 2 Pull hand brake into fully up position
- 3 Release the hand brake trim press stud.
- 4 Lift centre console lid.
- 5 Lift upper console from the rear. (Clips should stay in place)
- 6 Access to the gear shift interlock manual release is now possible.
- 7 Slide hand under right hand side of console
- 8 and raise manual release plunger.
- 9 While holding plunger in raised position, move gear selector level from 'P' to 'N'.  
Reassemble.

When raising/lowering the upper console, be careful not to displace or damage the plastic trim fitted to the selector aperture.
