S-TYPE

S501-25

TECHNICAL BULLETIN

Sun Visor Mirror Bulb – Now Available Separately – Replacement Procedure MODEL 2003 MY-ON S-TYPE

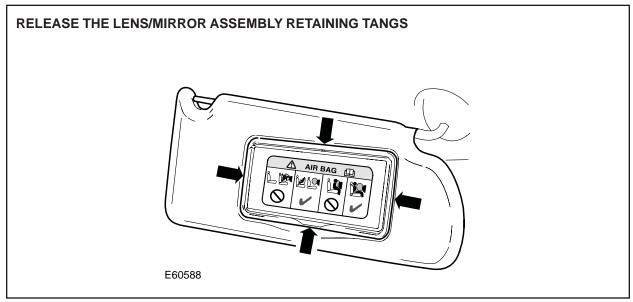
ILLUSTRATION 1

- Open door.
- 2. Reposition sun visor downwards for access.
- 3. Using a suitable tool, release the lens/mirror assembly retaining tangs, and remove lens/mirror assembly (Illustration 1).

- Remove defective bulb from lens/mirror assembly. 4.
- 5. Align and install the new bulb to the sun visor.

- Install lens/mirror assembly in the sun visor, check operation of sun visor and bulbs.
- 7. Close the illuminated sun visor mirror cover.
- 8. Reposition the sun visor upwards.
- 9. Close door.
