PUBLISHED: 11-MAY-2011  
2012.0 XF (X250), 501-12

## INSTRUMENT PANEL AND CONSOLE OVERHEAD CONSOLE [G1061424]

### REMOVAL AND INSTALLATION

76.13.69	ROOF CONSOLE - RENEW	ALL DERIVATIVES	0.20	USED WITHINS	+
----------	----------------------------	--------------------	------	--------------	---

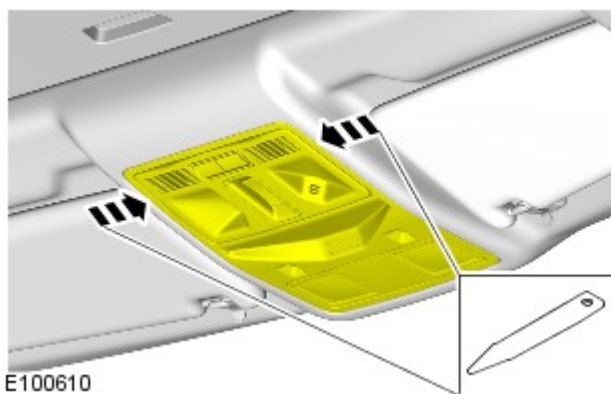
1.

**CAUTION:**

Take extra care not to damage the edges of the component.

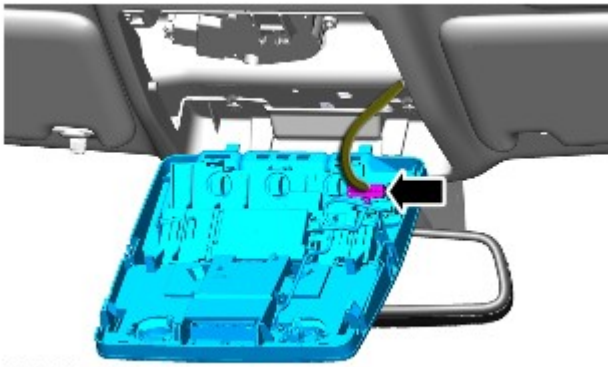
E99884

2.

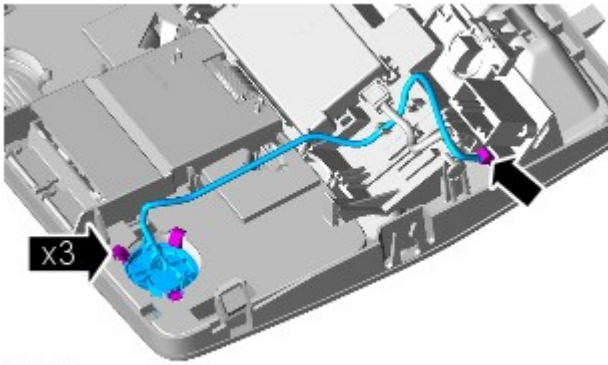
E99885

3.

**NOTE:**

Do not disassemble further if the component is removed for access only.

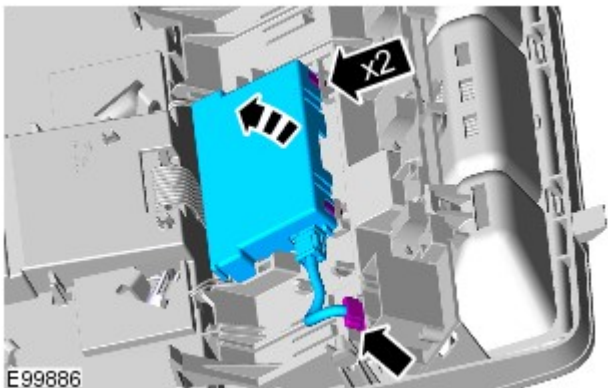
E99886

4.

**CAUTION:**

Take extra care not to damage the wiring harnesses.

- Take precautions to avoid any electrostatic charging, which could damage this component.

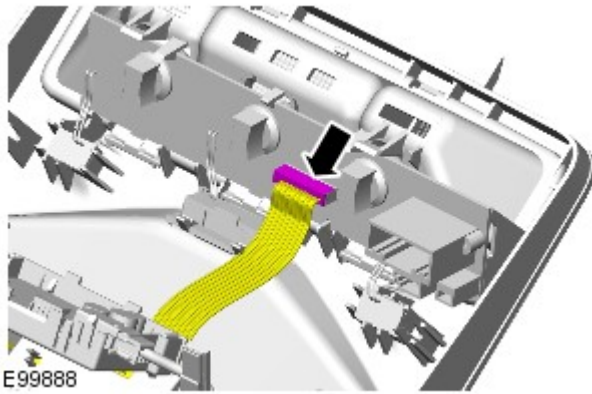
6.

**CAUTION:**

Take extra care not to damage the wiring harnesses.
