2011.75 XJ RANGE (X351), 501-10

REAR SEAT BACKREST [C272975]

REMOVAL AND INSTALLATION

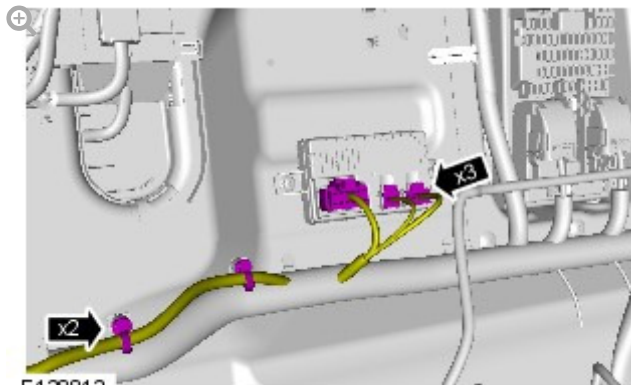
E128812

Note the position of the wiring harnesses to aid installation.
