Connector: **C2ME14A**

Description: **Integrated control panel**

Harness: **INSTRUMENT PANEL LHD HARNESS**

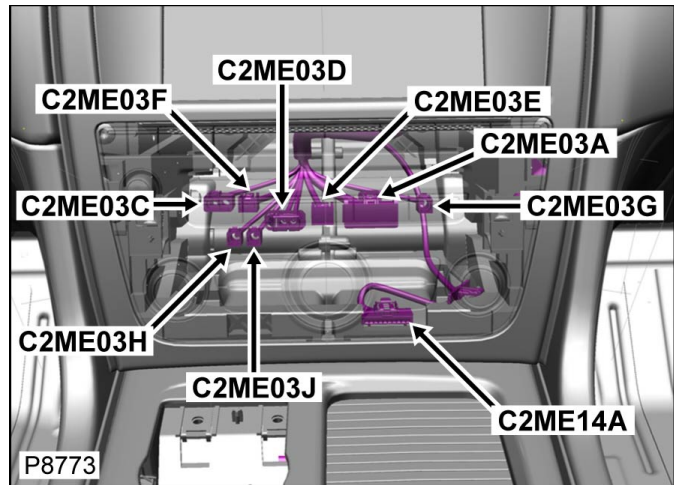
Location: **Behind center of Instrument panel**

Cavities: **10WY**
