Power Steering Fluid Cooler (57.15.11)

Removal

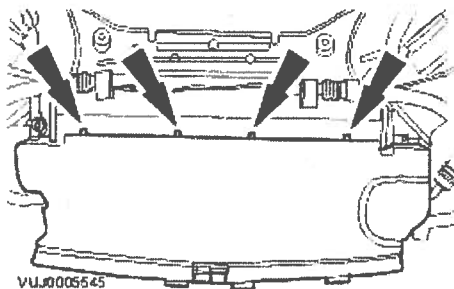
2. Remove the lower cowl.

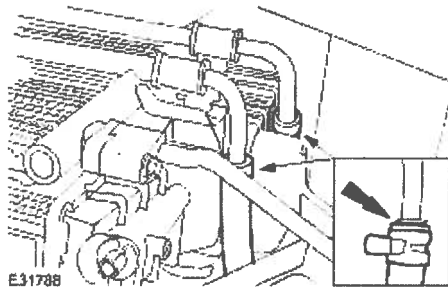
3.

**CAUTION:** If power steering fluid comes into contact with the paintwork, the affected area must be immediately washed down with cold water.

**CAUTION:** Cap the power steering line to prevent loss of fluid and prevent dirt ingress.

Disconnect the power steering fluid cooler lines.

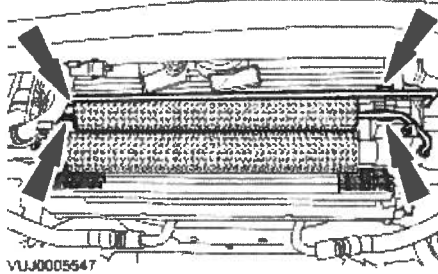
Vehicles with supercharger

- 4 . Remove the power steering fluid cooler.

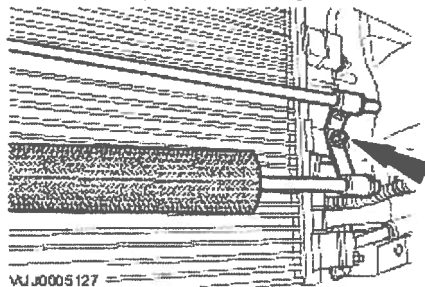
Vehicles without supercharger

- 5 . **NOTE:**

Left-hand shown, right-hand similar.

- Remove the power steering fluid cooler.

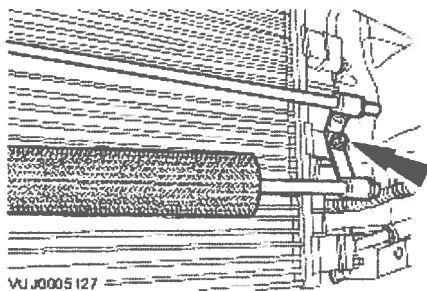
- 1 . To install, reverse the removal procedure.

➤ Tighten to 7 Nm.
