MODEL  
S-TYPE  
XJ, XK

NUMBER  
JTB00084  
(Issue 1)

## TECHNICAL BULLETIN

### Electronic Parking Brake: Diagnostic Aid

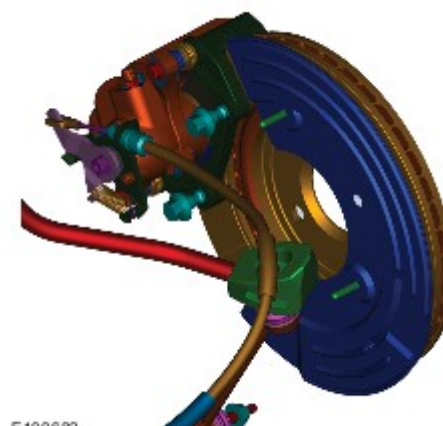
Figure 3

**FIGURE 3:** EPB Cable Routing – S-TYPE and XJ (Normally Aspirated: pre-06MY) and S-TYPE, XJ and XK (07MY-onwards – all derivatives). Detail of cable routing over stabilizer bar deflector blocks.

2. Check the cable routing is correct.
3. Check that the secondary cables move freely within their outer sleeves.
4. On vehicles where the cable routing goes over the top of the stabilizer bar links, confirm that the rubber deflector blocks on top of the stabilizer bar links are securely fixed and that there is no indication that the cables have been dropping down to the rear side of the stabilizer bar links.
5. Check that the cable abutments are correctly located and that the abutment retaining tags are intact. When the cables are slack, it should not be possible to pull them out of the abutment brackets.
6. Check that the parking brake primary C-clip is securely fixed in position and that the cable is free to slide within the C-clip. Ensure that the primary cable is not damaged where it passes through the C-clip.
7. Connect the cables to the calipers.

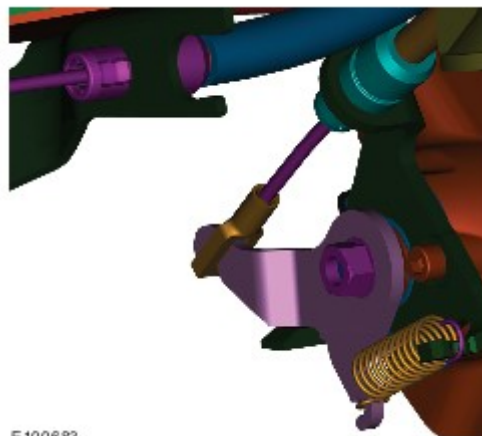
Figure 4

**FIGURE 4:** Detail of outer cable abutment. Ensure that the abutment retaining clips are intact so that the outer cable does not pull out, even when slack.

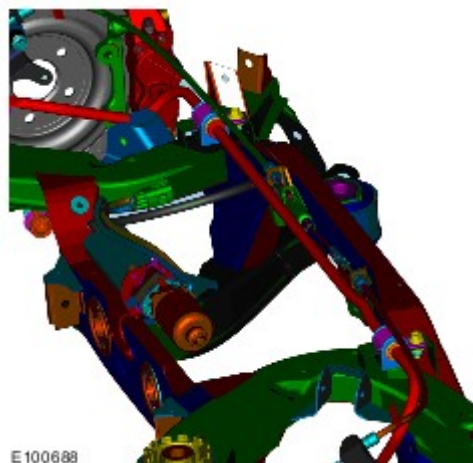
Figure 9

**FIGURE 9:** EPB Cable Routing – XKR (Supercharged: 07MY-onwards). Primary cable routing around subframe.
