QUIESCENT CURRENT DRAIN

... what is it?
... why is it important?
... and how do we measure it?

notes by "cat_as_trophy" for JF in April/June '14

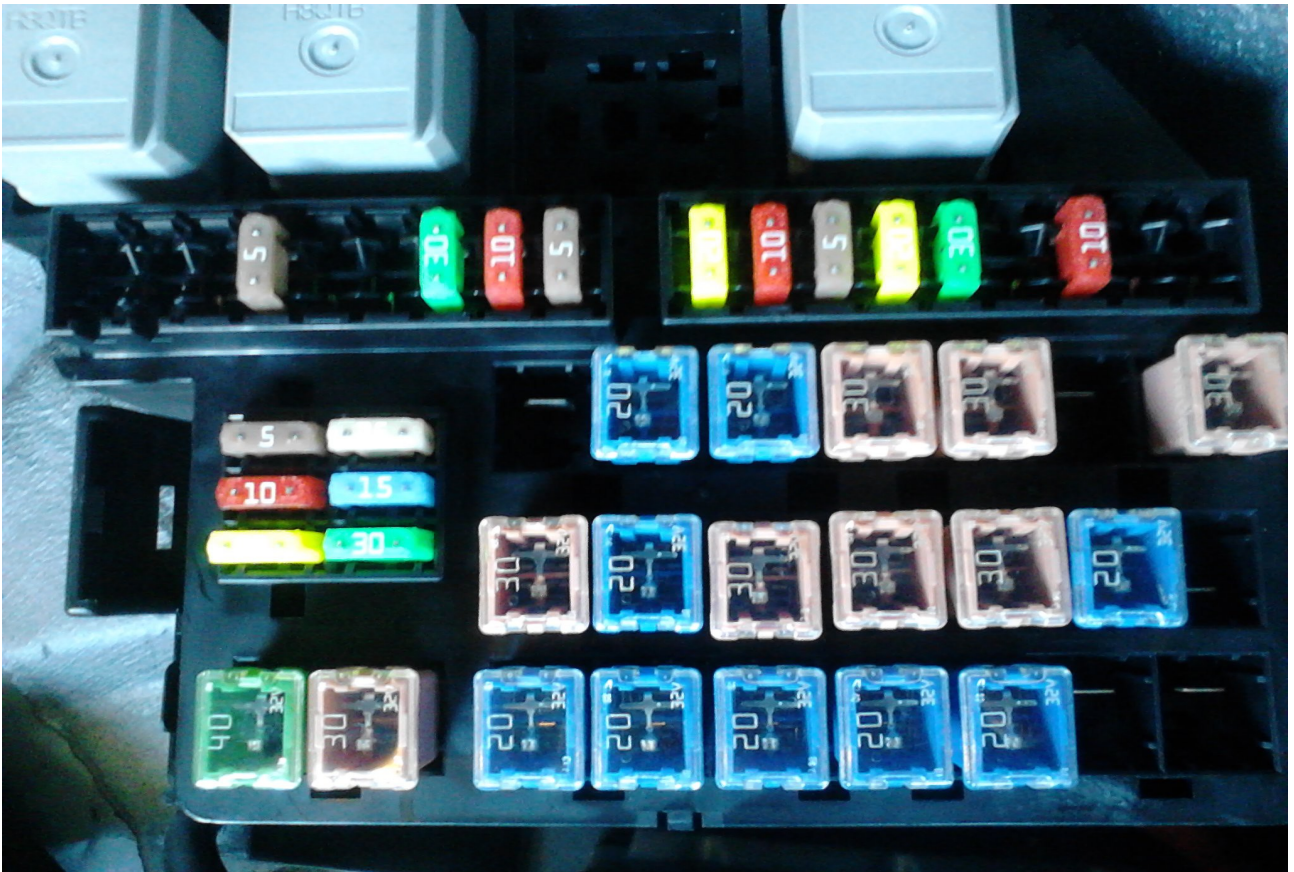
Rear Power Distribution Fuse Box in 2007 S-Type with 40A Fuse #1 at lower left corner.

Using the S-Type as example, Fuse #25 (<2002.5) or Fuse #1 (2002.5>) feeds power to the PJB/Cabin Fuse Box (obvious source for all devices fitted inside cabin). Test may need to be repeated; first for all circuits in total then if indicated, separate circuits one at a time.

1. unlock car; remove Fuse #25 (or #1); relock car; wait for shut-down; record drain.

2. unlock car; replace Fuse #25 (or #1); then remove first fuse in PJB that is fed by Fuse #25 (or #1); relock car; wait for shut-down period and record drain.

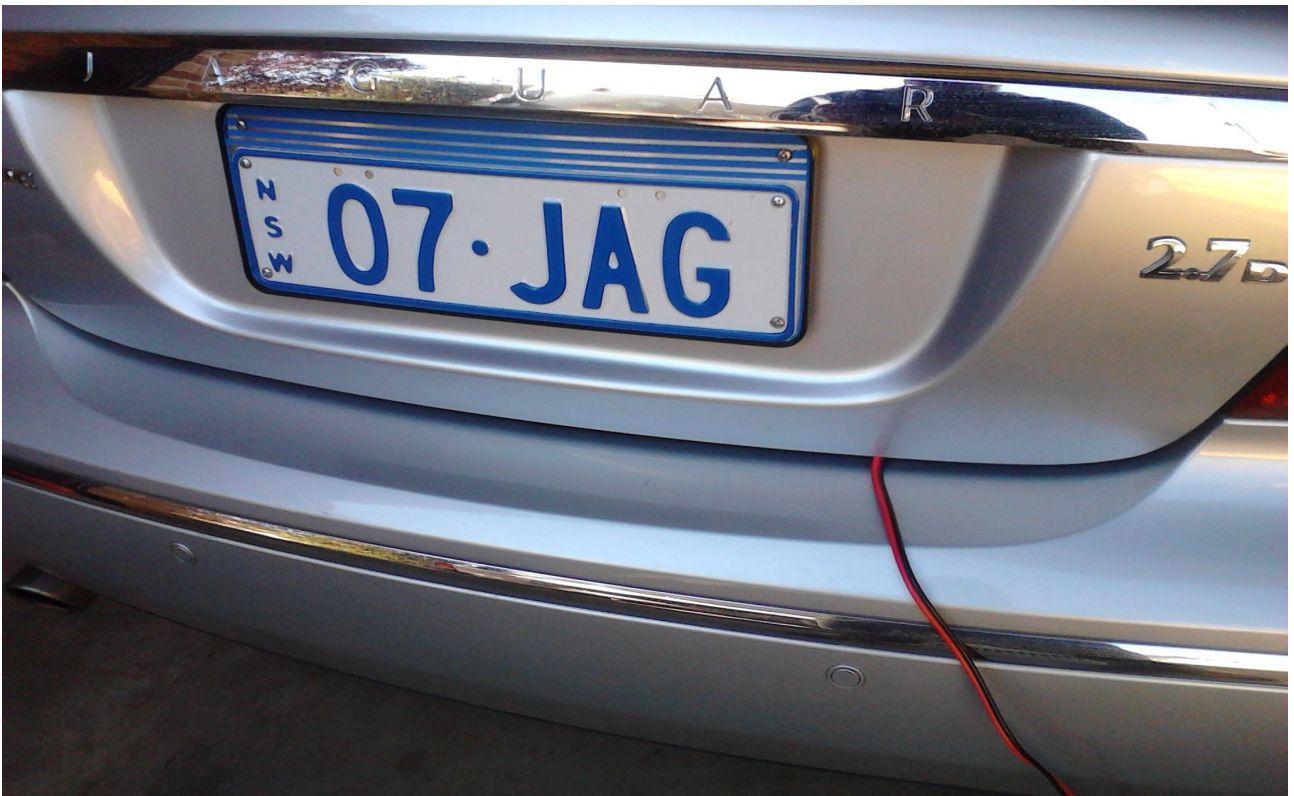
Boot/trunk lid closed to allow shut-down ... soft dust seal prevents damage to car or leads.

4. as we cannot leave either bonnet/hood nor boot/trunk open during tests (the car will never sleep!), arrange sufficiently long leads from car battery area to read the meter from outside locked car ... the boot dust seal is supple enough to prevent damage;
