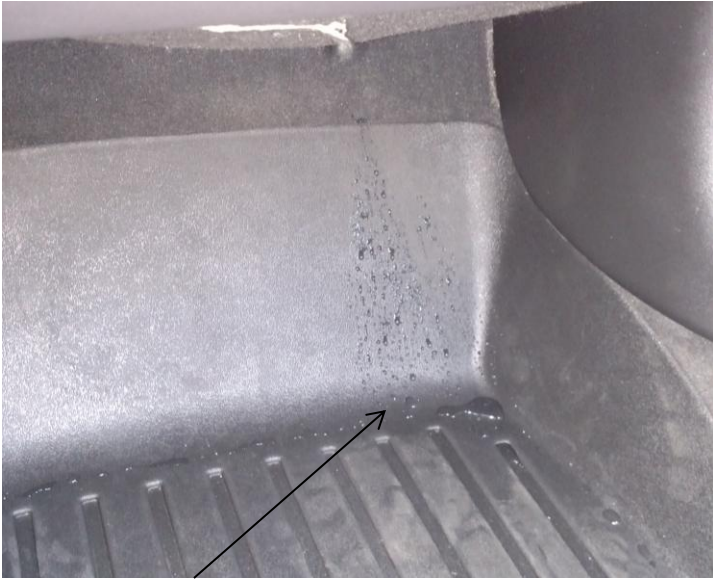
Used tapping method to get dripping but wouldn't last very long. Would switch to econ mode when I would see water in the foot well.

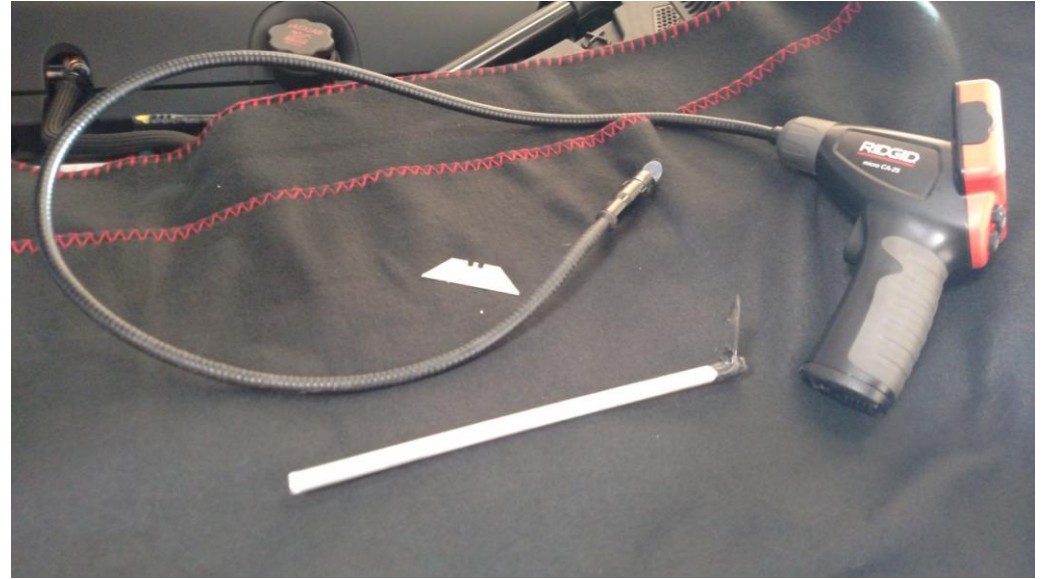
Tools I used; didn't use razor blade just for ref, made knife from a razor blade. Picked up inspection camera from home depot for \$79.00 to locate duck bill.

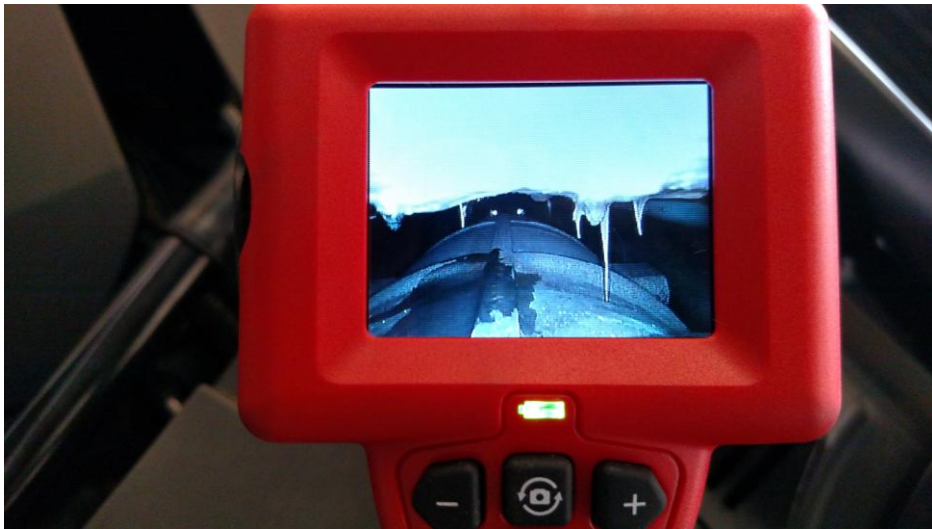
View from camera where water is dropping on transmission.

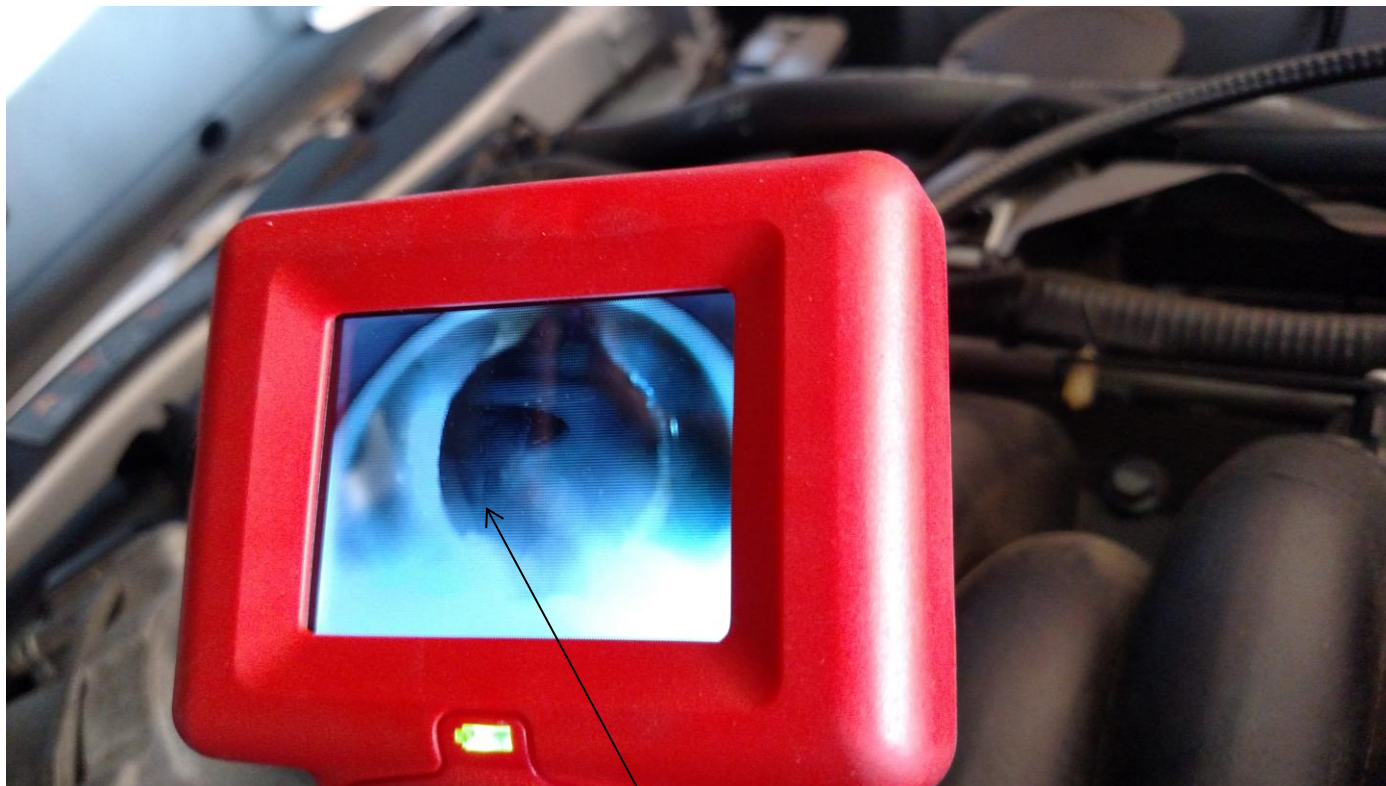
View from camera with mirror attached to look up into hole. After using blade to pry open you can see duck bill is open. Goal was to cut off one half of duck bill but need longer blade to reach. Was able to cut the lower half.
