TECHNICAL SERVICE BULLETIN

reissue No. **JTB00008v2/2006**

Subject/Concern:	Creak from Front Brake Caliper	
Model:		
The New XK - Normally Aspirated	VIN Range: B00379-B15857	
S-TYPE - Normally Aspirated and Diesel Only	VIN Range: N52048-N80901	
XJ Range - Normally Aspirated	VIN Range: G49701-H16364

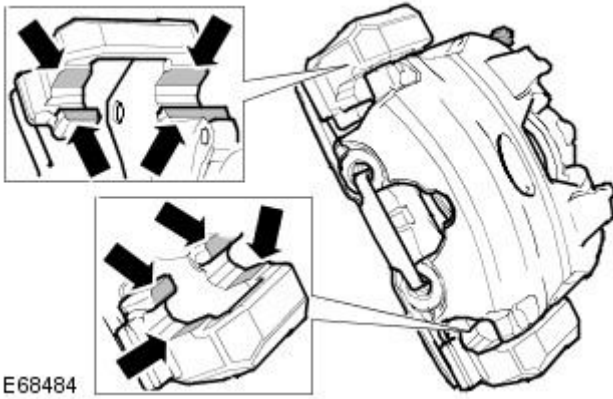
E68484

2. Clean and apply grease to the front brake caliper (see E68484).

3. Carry out step 2 to the opposite side front brake caliper.
4. Install new front brake pads (see Global Technical Reference GTR Workshop Manual, section: 206-03).
