Michael Fang's Weblog

CD Changer Repair

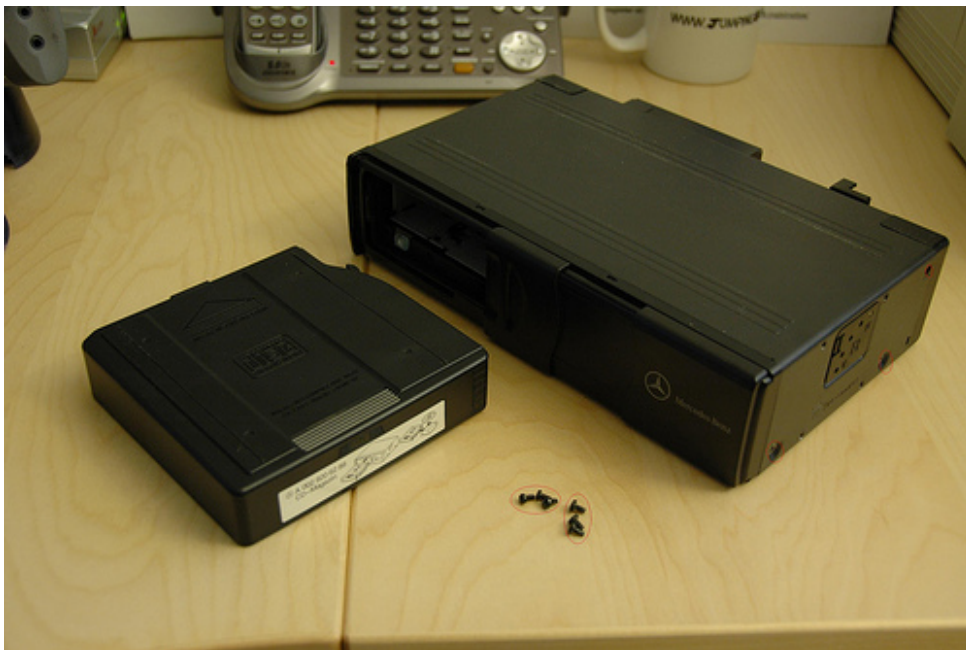
Now, with the changer sitting on my desk, remove the screws on the side of the changer as shown below.

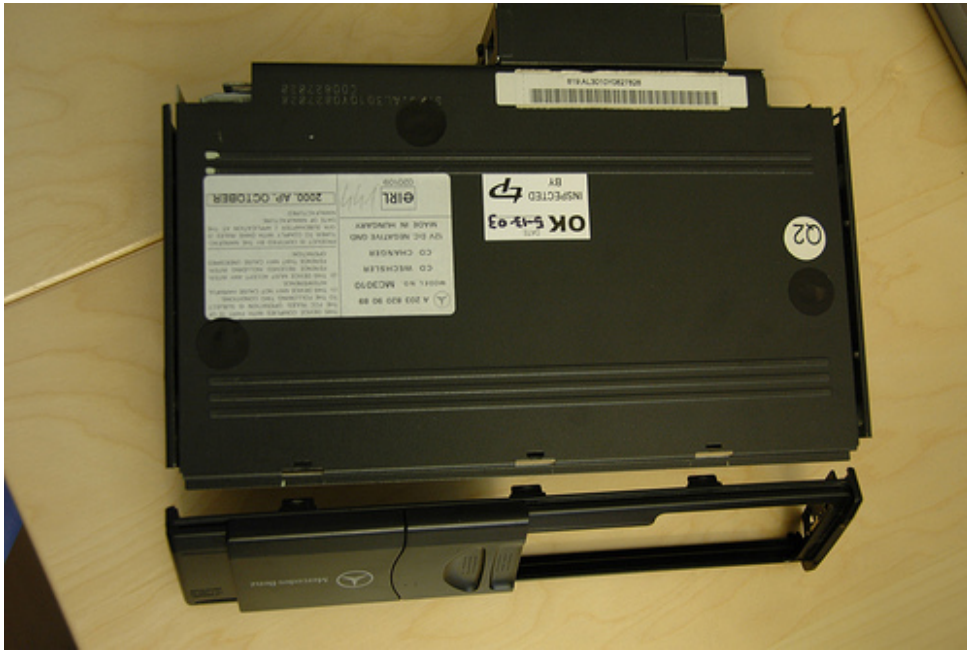
Then, pop out the plastic clips to remove the front panel.

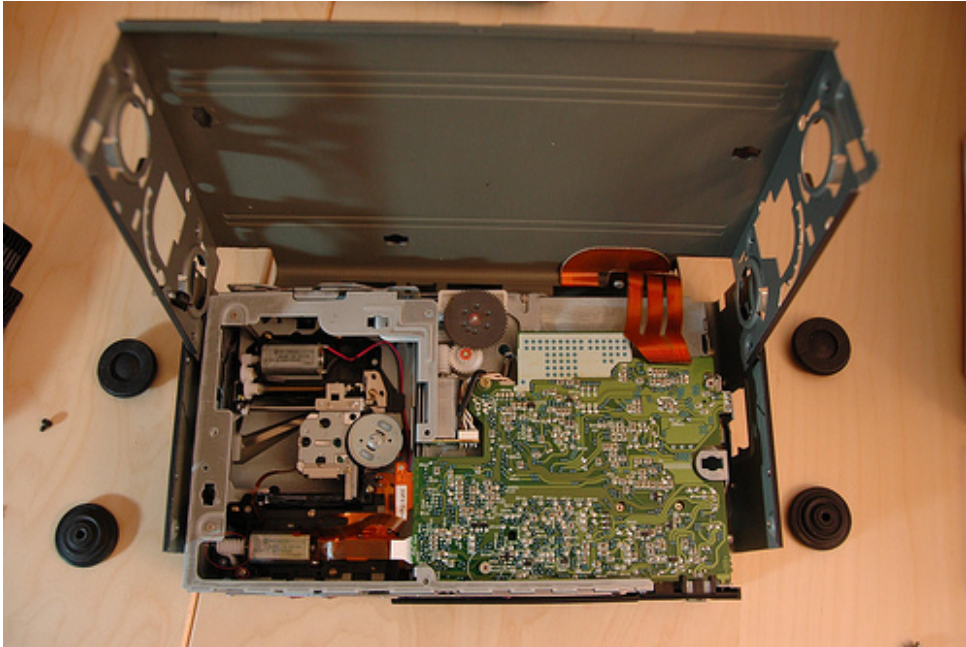
Then, remove the 4 rubber bushings by hand, and open up the case as shown below.
